**Town of Cape Elizabeth**  
Seven Building Facility Study  
*Cape Elizabeth, Maine*

**Introduction****Town of Cape Elizabeth Facilities Study**

*Facility Study Process*

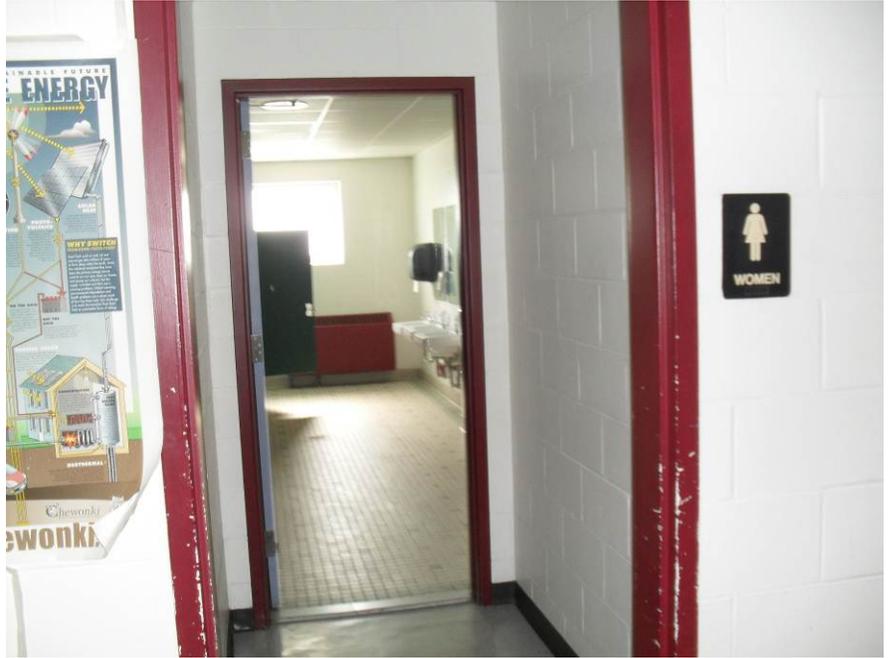
The students toilet door entrances are not ADA compliant for clearances on pull side of door. Recommend minimum renovation to make entrances compliant.

*Doors to Student Toilets*

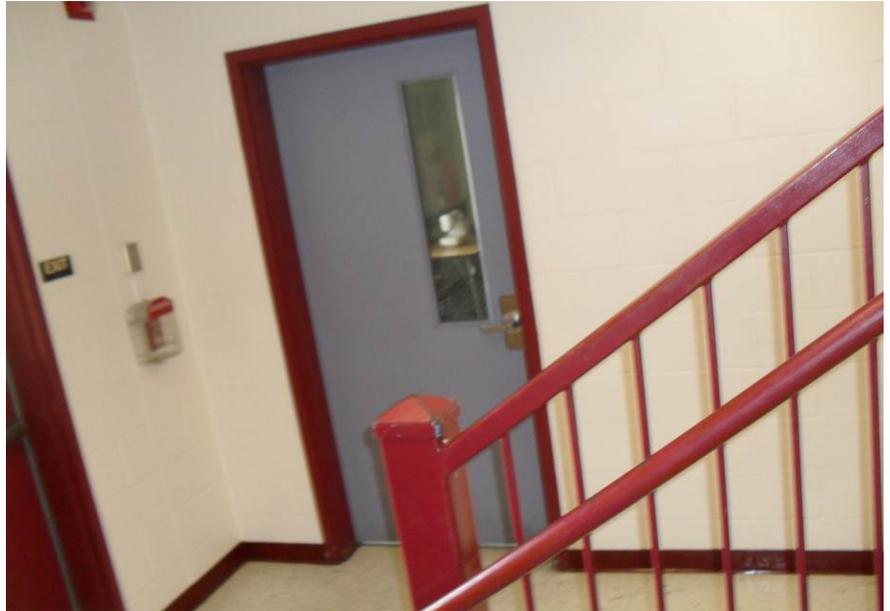
*Door to Room Exits  
Into Stairwell*

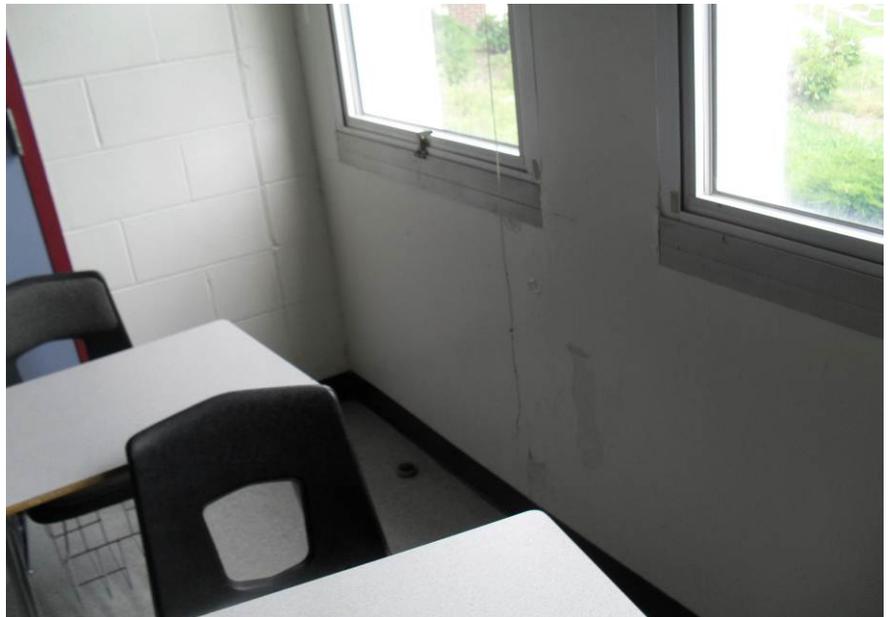
Viewing the interior drywall panels around the windows it is apparent that water penetration around the windows and panels is the direct cause of the paint peeling and drywall failures and cracks you are witnessing. The window system is as originally constructed, a narrow-line non-thermally broken aluminum window frame and sash with a single glazed panel. Most of the window units have had the single pane glazing replaced with an insulated window glazing panel that appears to be around 3/4" thick.

There are areas above the suspended ceiling where the back of the panel is un-insulated or a layer of insulation is applied without a drywall layer. The manner in which this whole assembly is constructed provides an environment for condensation to build over time. Even though every room with this assembly was not observed, the rooms viewed shows signs of cracking and peeling or recent repair due to previous damage.

*Peeling Paint on Drywall  
at Windows*

We would recommend to the Cape Elizabeth School Department that this becomes a very high priority on your Capital Improvement Project list. The potential for mold build-up behind the drywall is very high and in the present school environment of constantly minimizing health and safety risks the potential liability exposure could be become very serious.

We would recommend a forensic analysis to verify and confirm our suspicions and an appropriate plan of action be put in place to repair this condition.

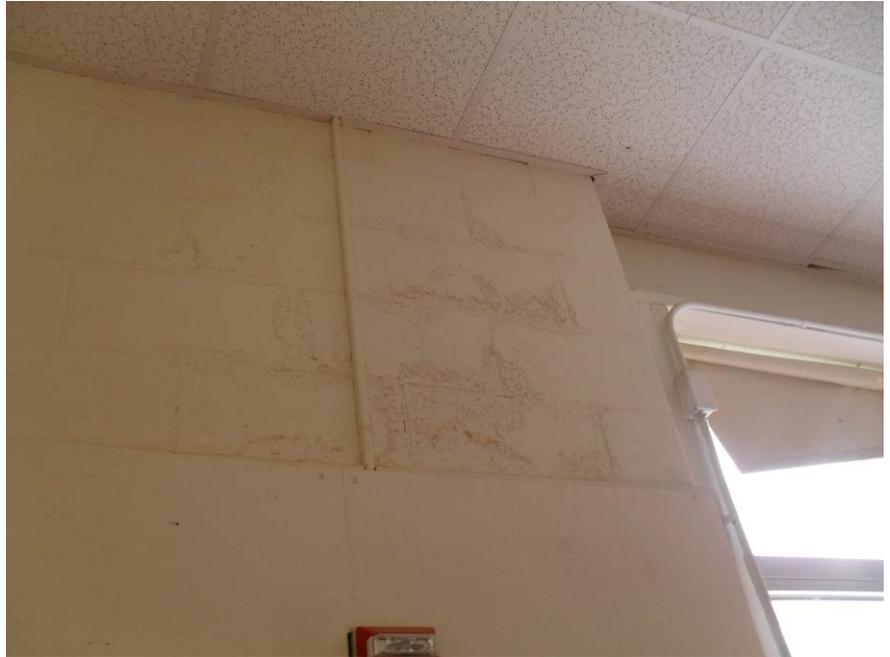
The second photo shows a similar condition on the exterior wall of the art room. In this room the damage is relatively close to the precast concrete window panel system which suggests that the entry point may be related to a flashing or joint system failure.

*Exterior Wall – Art  
Room Wall Damage*

If the source of water entry is unknown then we would recommend a forensic study to find and correct your water entry source before you repair the walls and repaint.

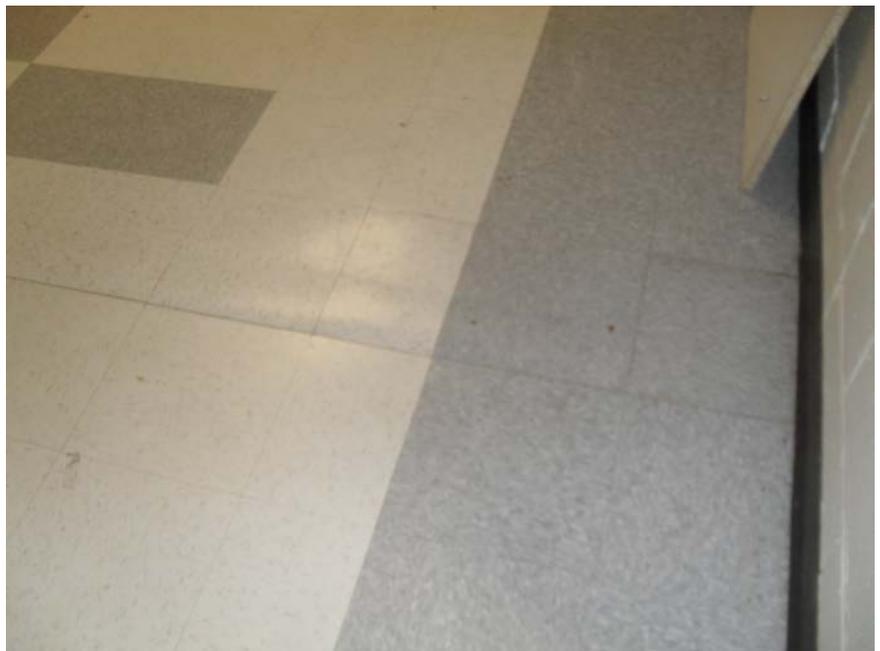
At the transition area of the second and third floor corridors there was a hump in the floor tile going wall to wall across the corridor. Research of the construction documents indicates that this hump is a location of a floor control joint system.

Recommended repair would be to cut out the existing control joint system and install a new metal floor expansion joint system with a VCT insert.

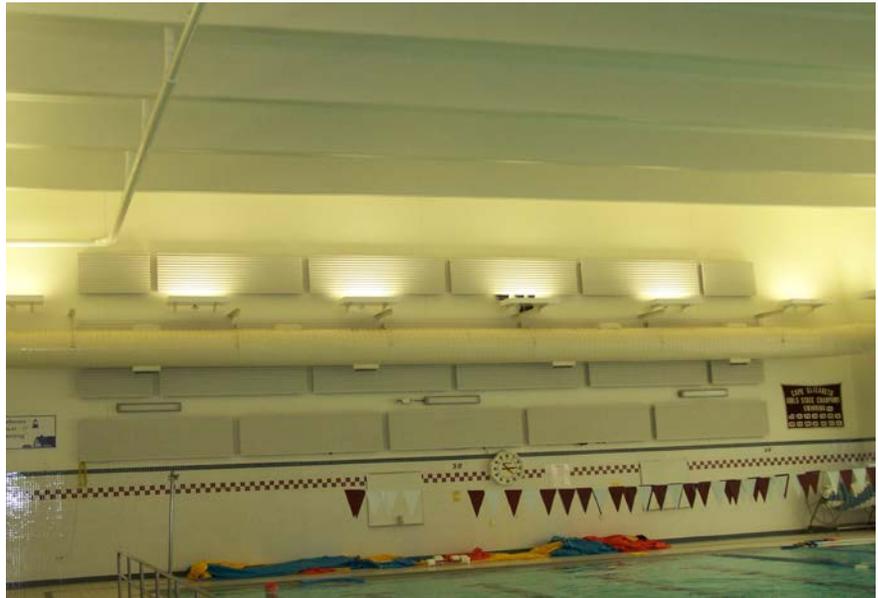
During our site visit it was noted that the issue of ADA Accessibility to the pool and spa was noted, as the facility is non-compliant relative to access. There are products that can assist with accessibility issues. There is concern with adapting the spa pool. The spa pool has no physical room to mount these systems, and we would not recommend a wall mounted unit unless a structural upgrade to the wall is conducted.

The lack of ADA accessibility has become an issue for the town.

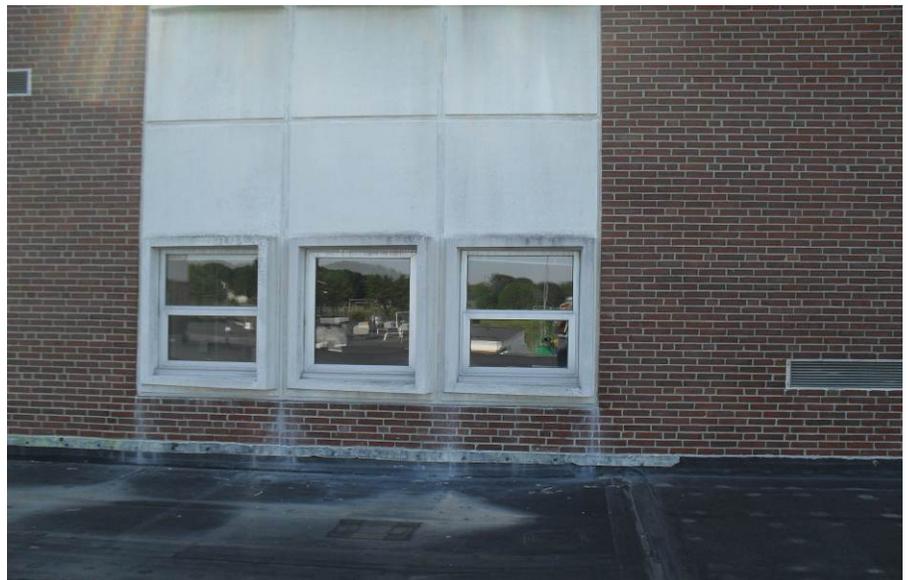
*Window Panel Requiring  
Work*

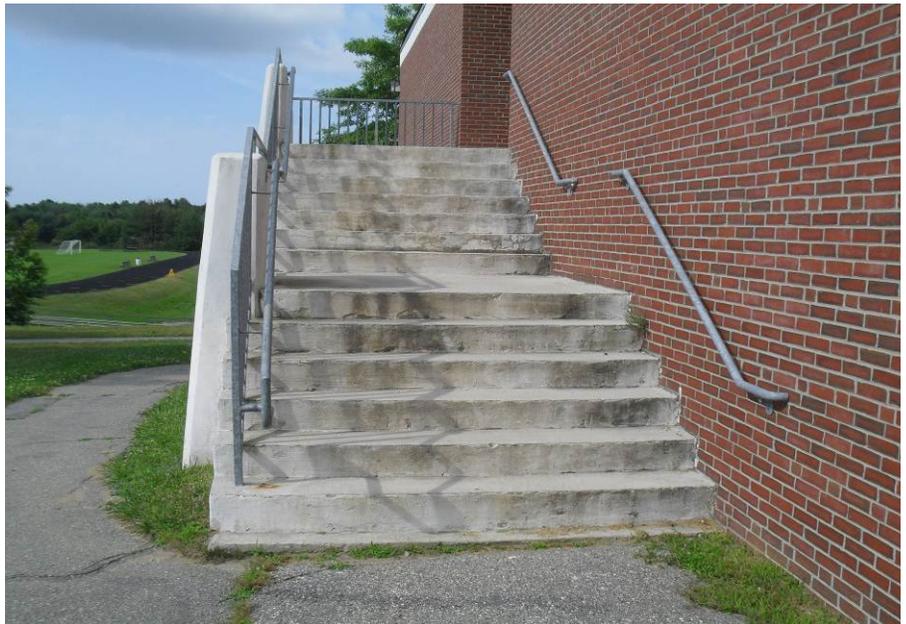
Exterior concrete exit stairs are in bad shape and the cement based parging system used to patch the stairs has deteriorated and is falling off due to temperature and weather exposure. We would recommend replacement of these stairs with a new poured in place concrete stair and metal cast in nosing.

*Exterior Stairs*

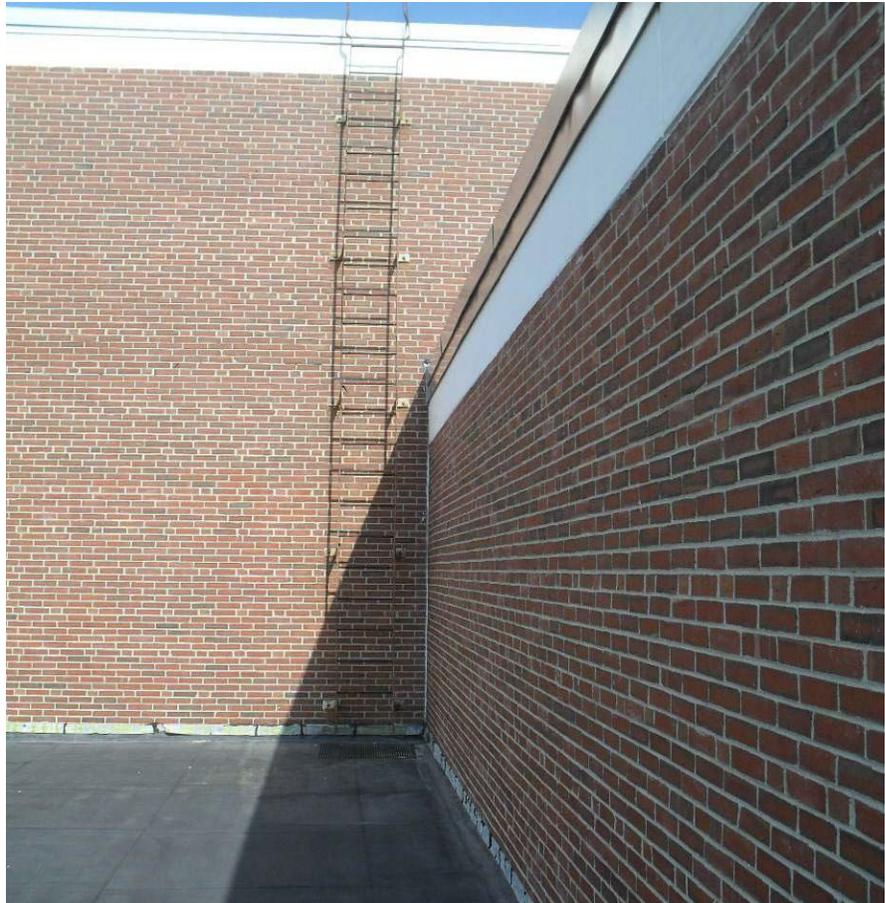
*Non-Compliant Ladder*

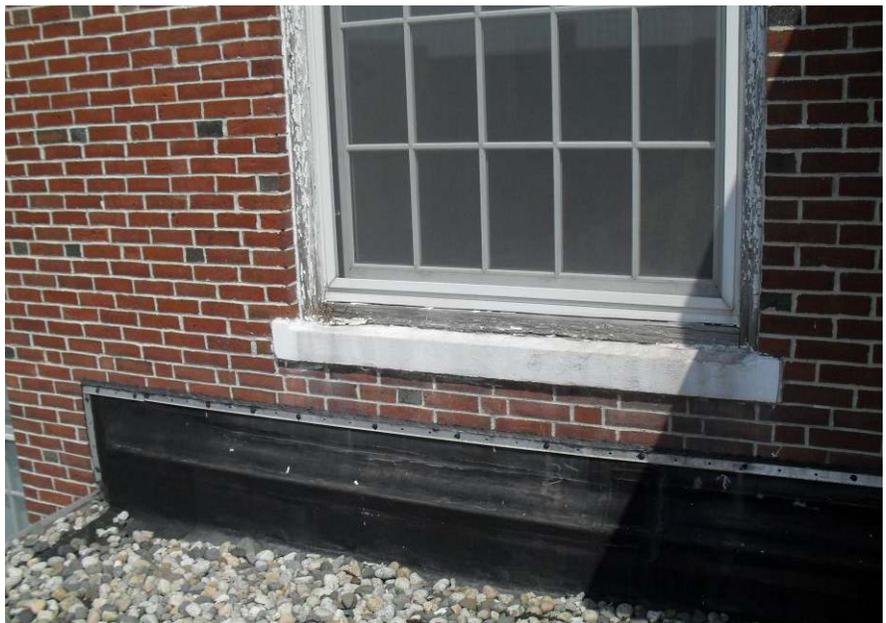
*Existing Wood Window Frame Badly Deteriorated*

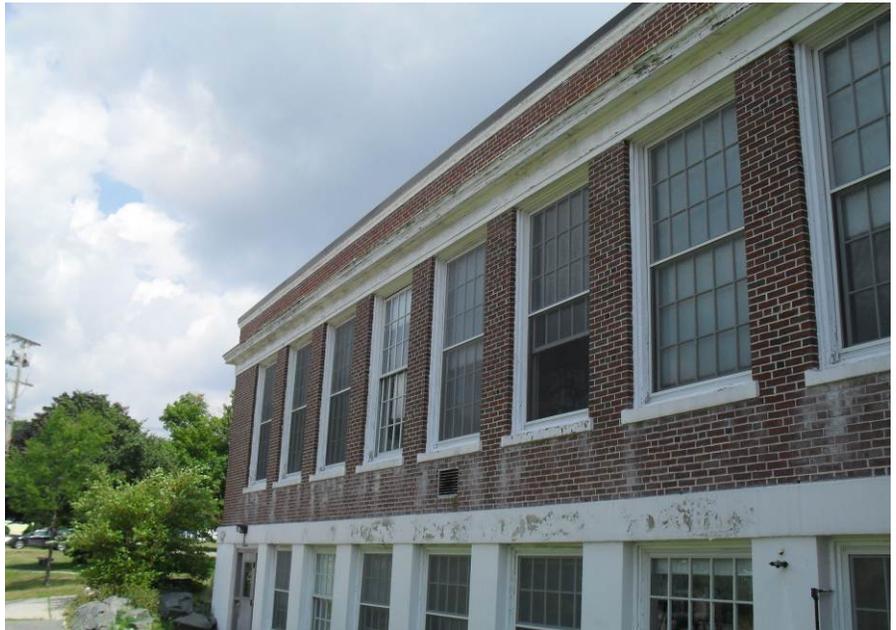
*Broken Window Sills –  
Concrete Requiring  
Repainting*

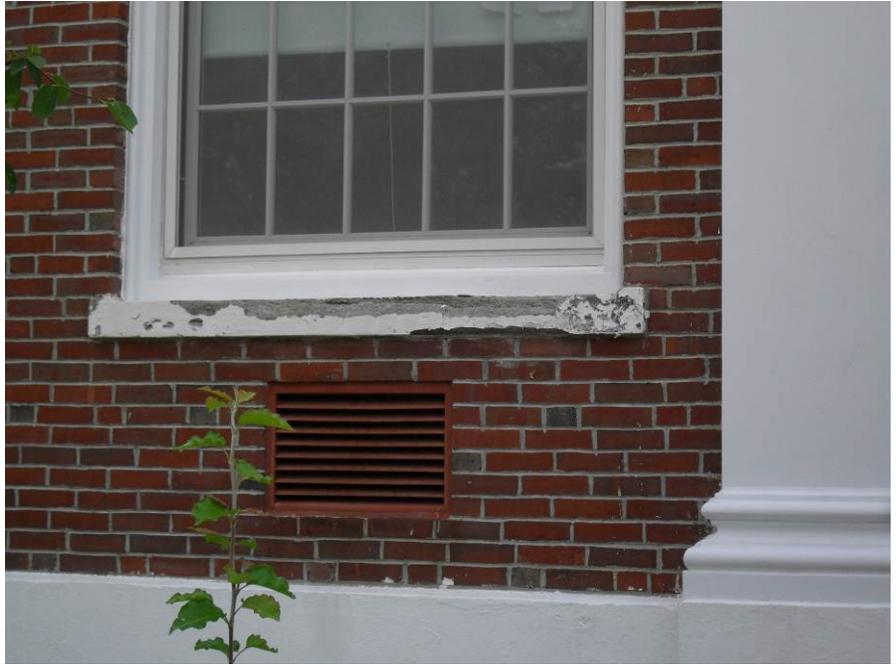
*Broken Cast Stone  
Window Sill*

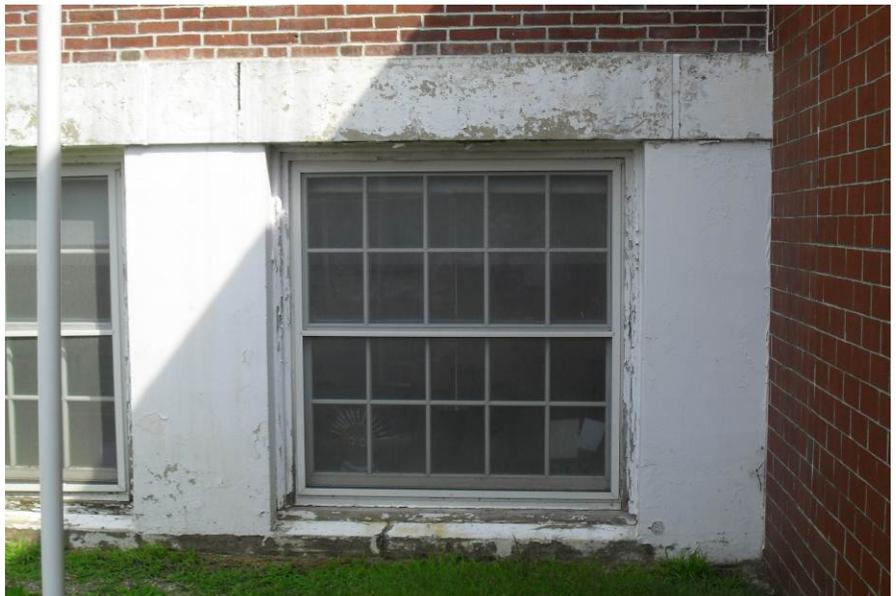
*Concrete and Windows  
Requiring Repair and  
Refinish*

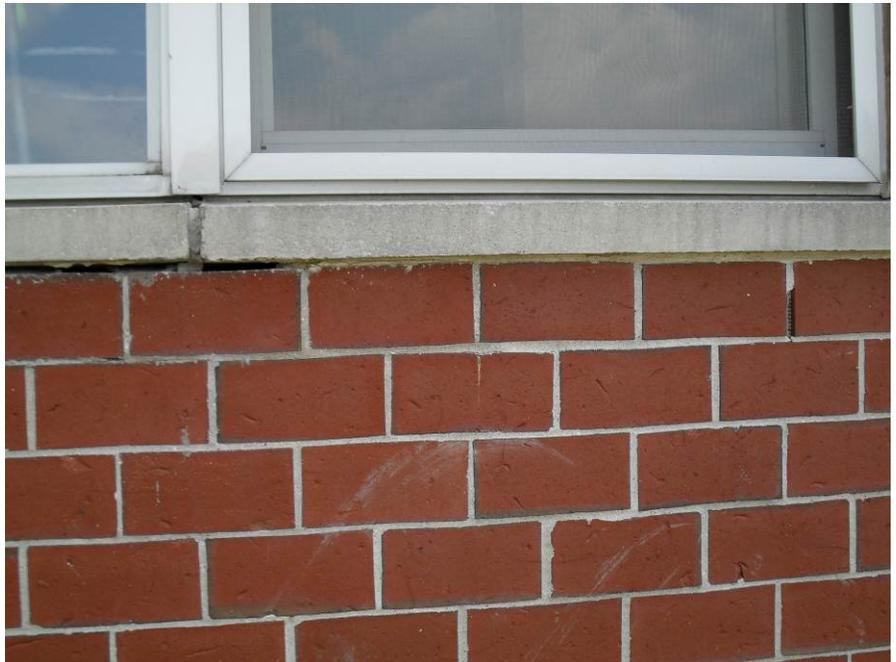
*Window Sill Damage*

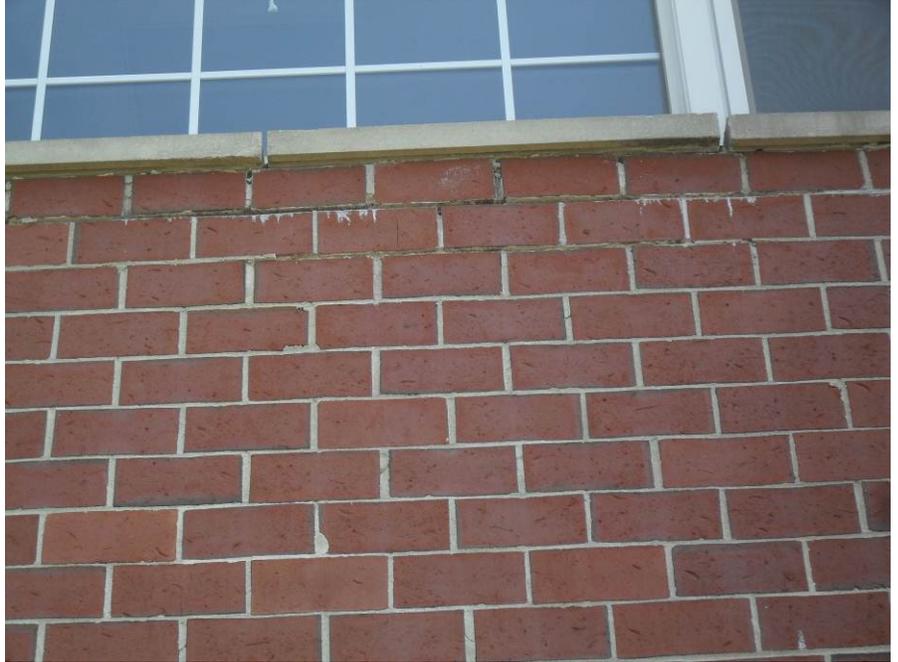
*Butt Joints and Mortar  
Joint Damage*

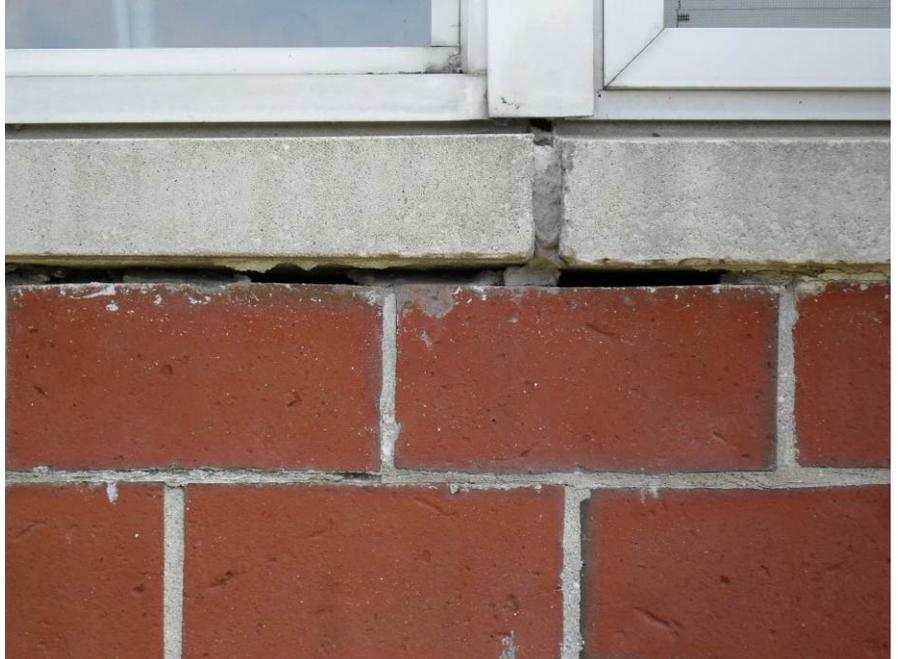
*Consistent Window Sill  
Damage*

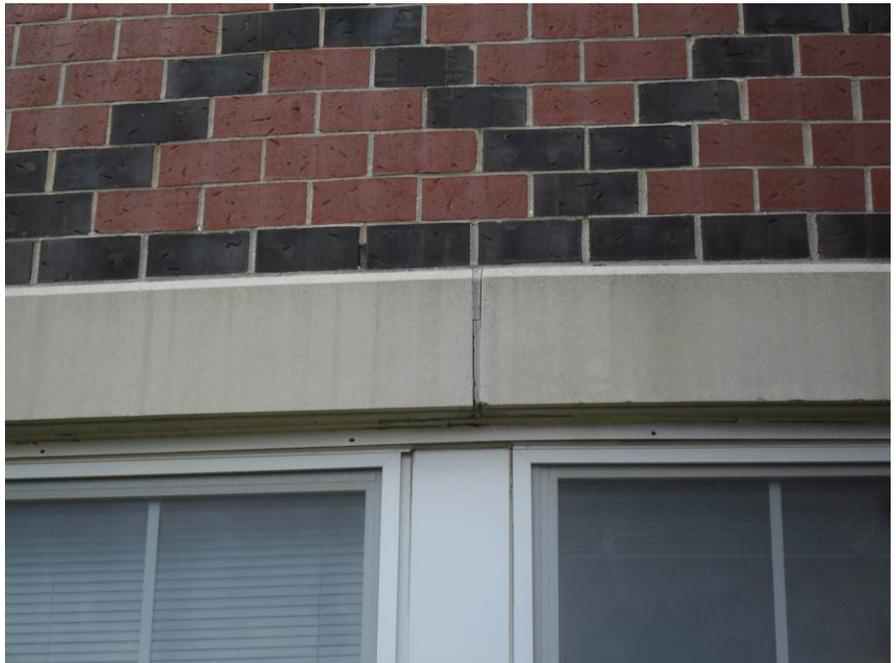
*Broken Joint Between  
Units*

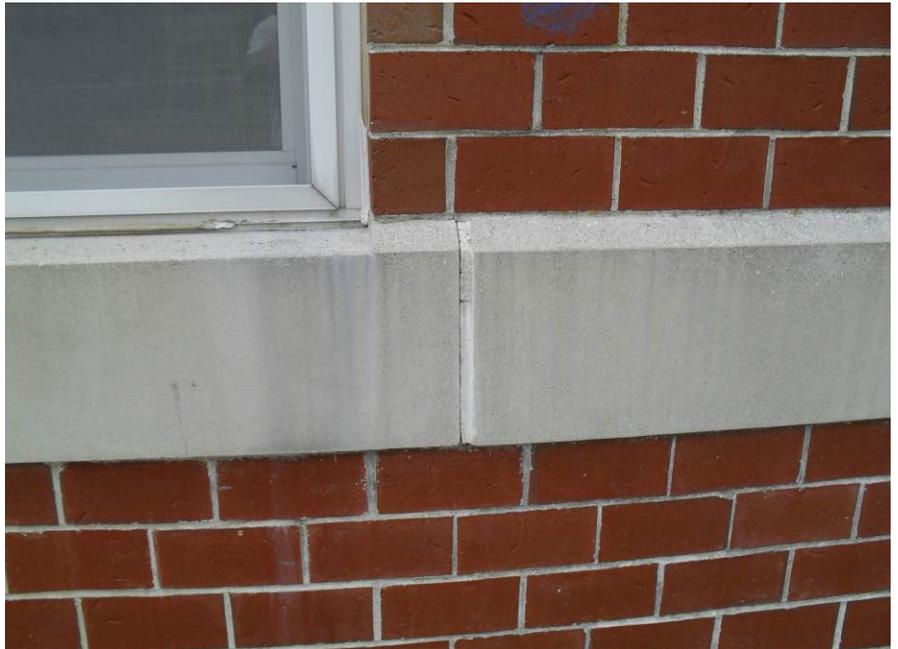
*Mortar Joint Failure*

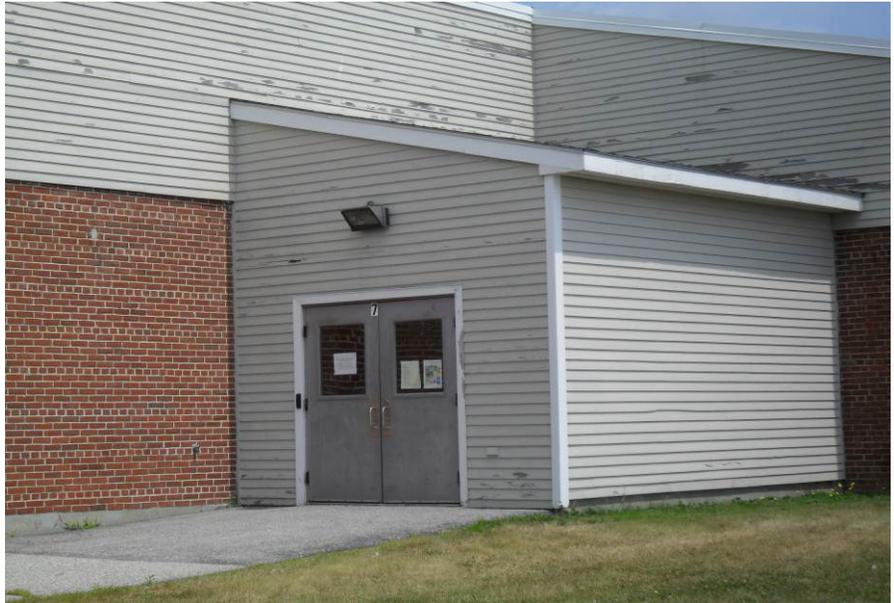
*Wood Clapboard Siding Needs Repainting*

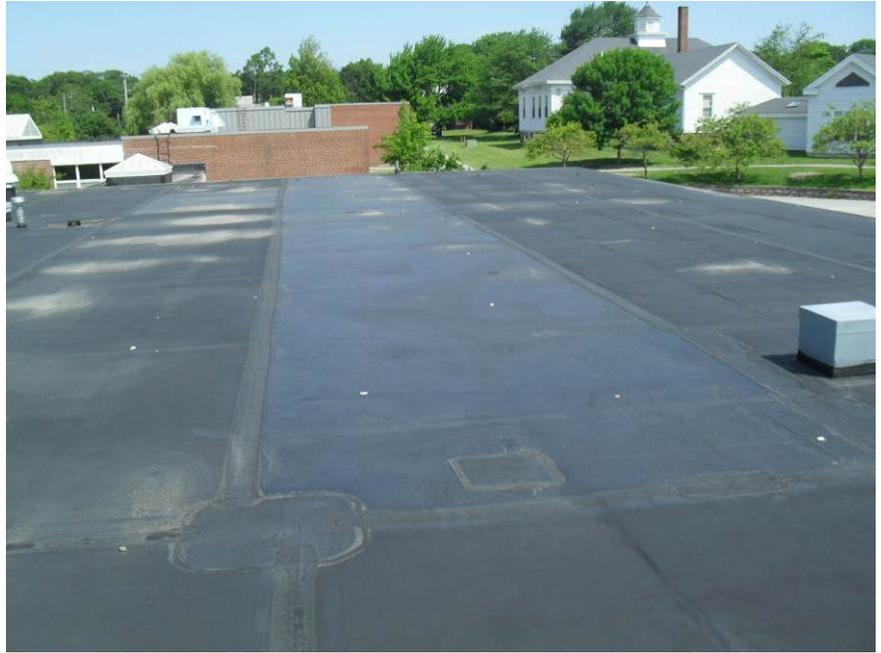
*Elementary School Roof  
with Repair Membrane*

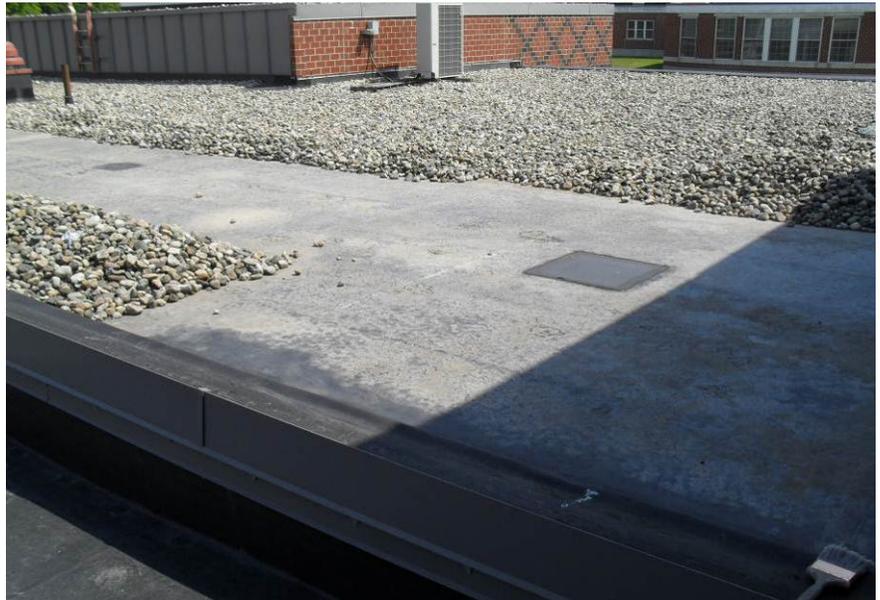
*Roof Membrane Badly  
Worn*

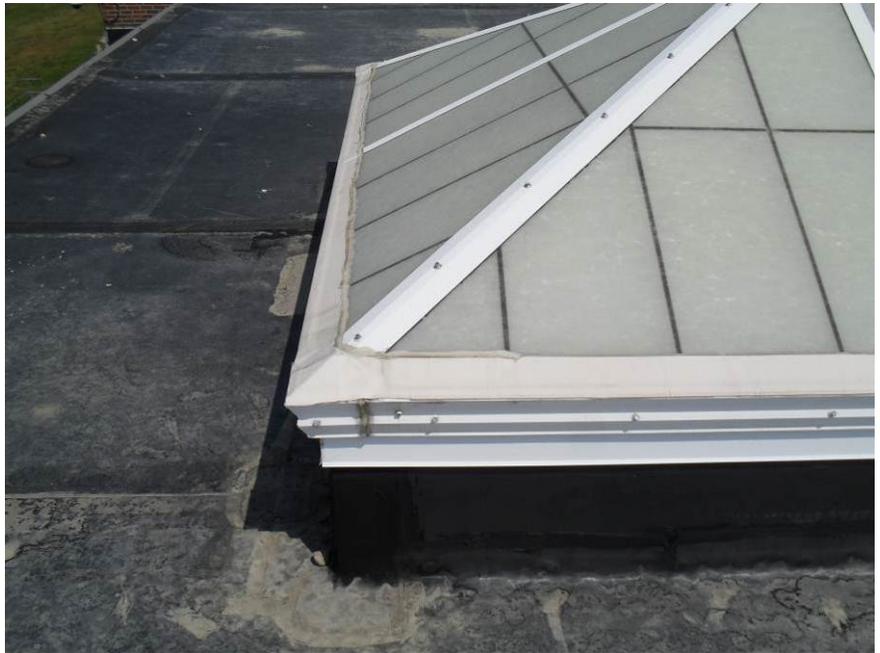
*Skylight Frame With  
Tape Flashing Over  
Frame*

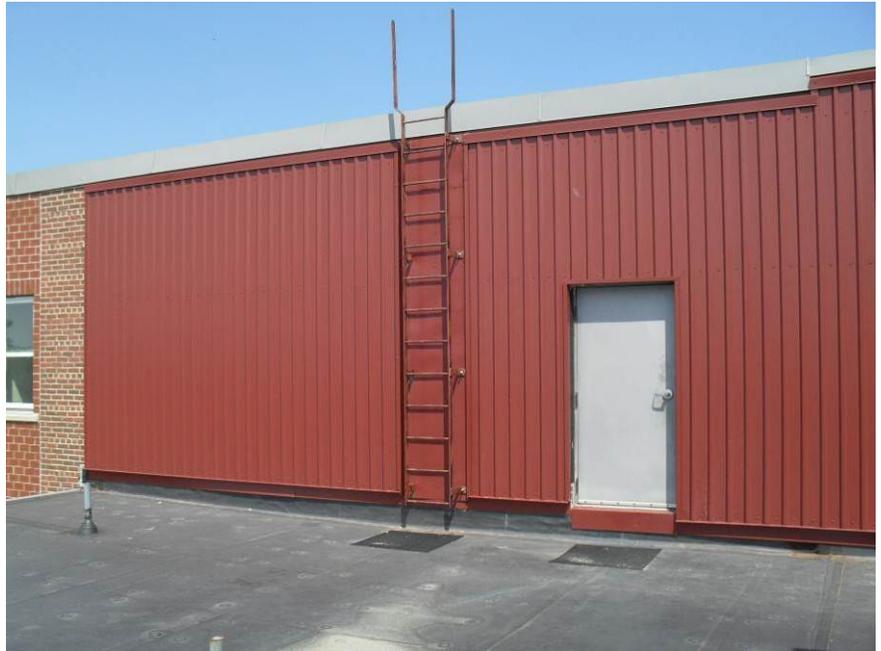
*Vertical Ladder –  
Noncompliant*

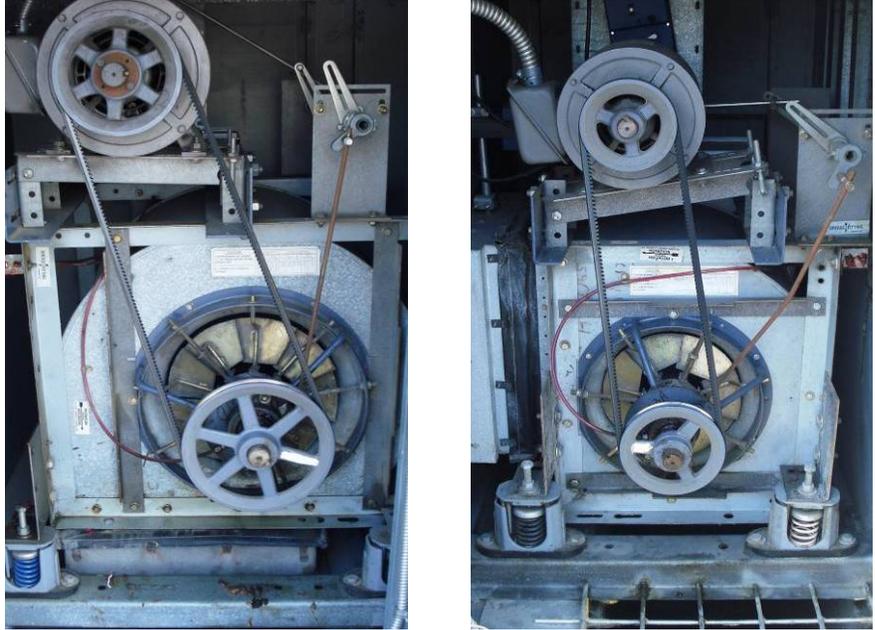
*AHU-1 Supply (Photo Left) and Relief Air Fans with Inlet Vanes*

The outside air portion of the mixed air dampers (shown to the left of the photo above) were not completely closed allowing for a small amount of infiltration of outside air when the unit is off. Recommend adjustment of the damper linkage to allow the dampers to close fully.

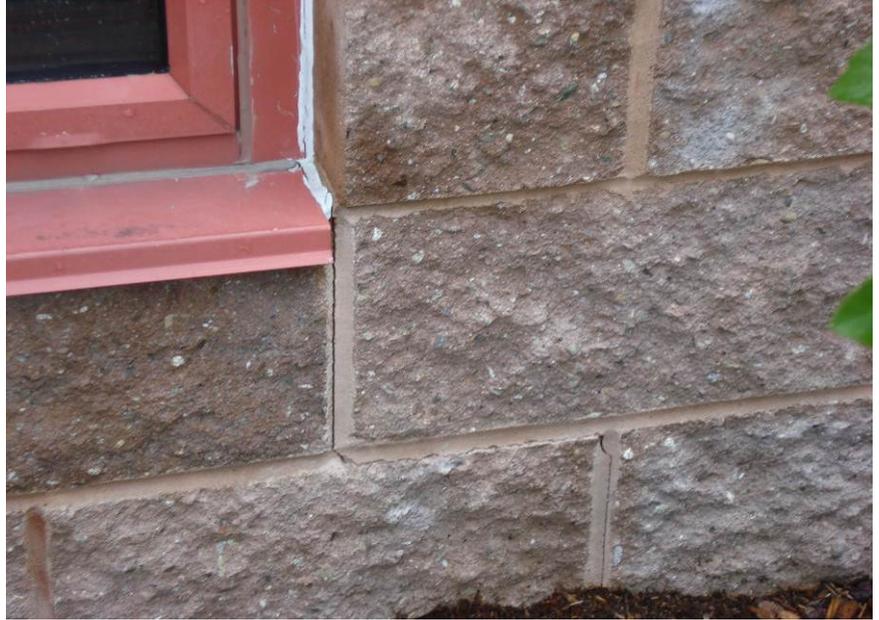
*Stepped Cracked Joint*

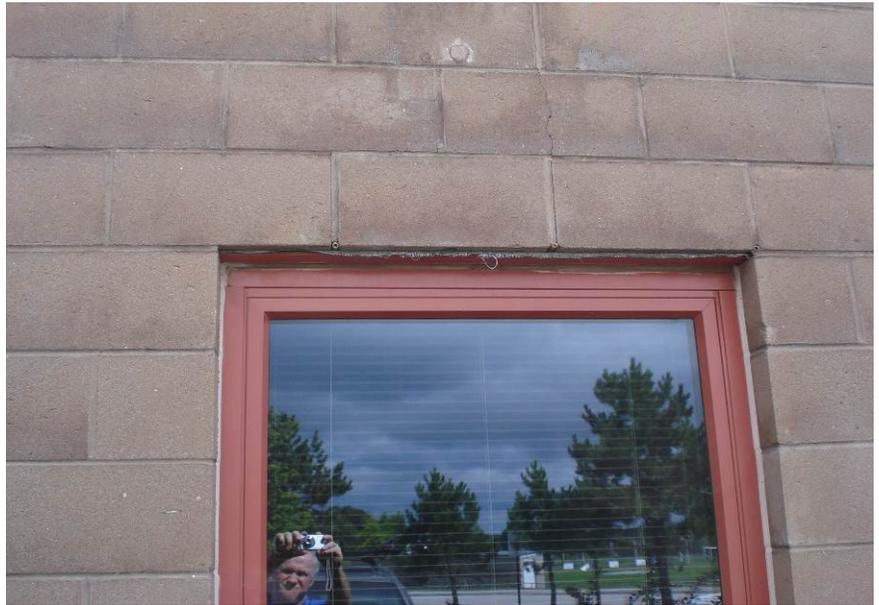
*Window Head – Crack  
Through Joints and  
Block*

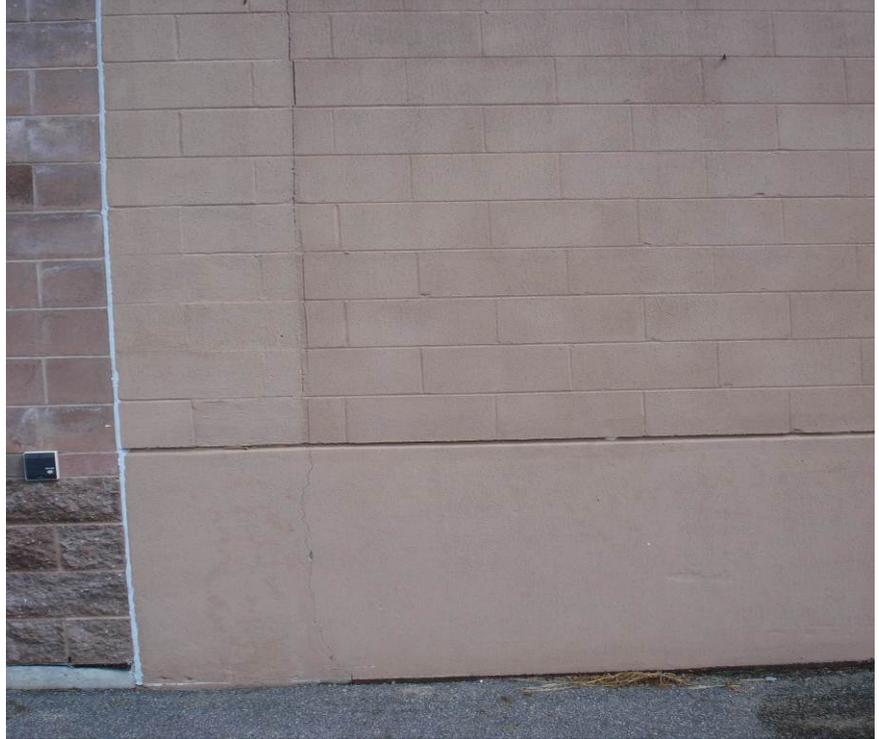
*Crack in Existing Block and Foundation*

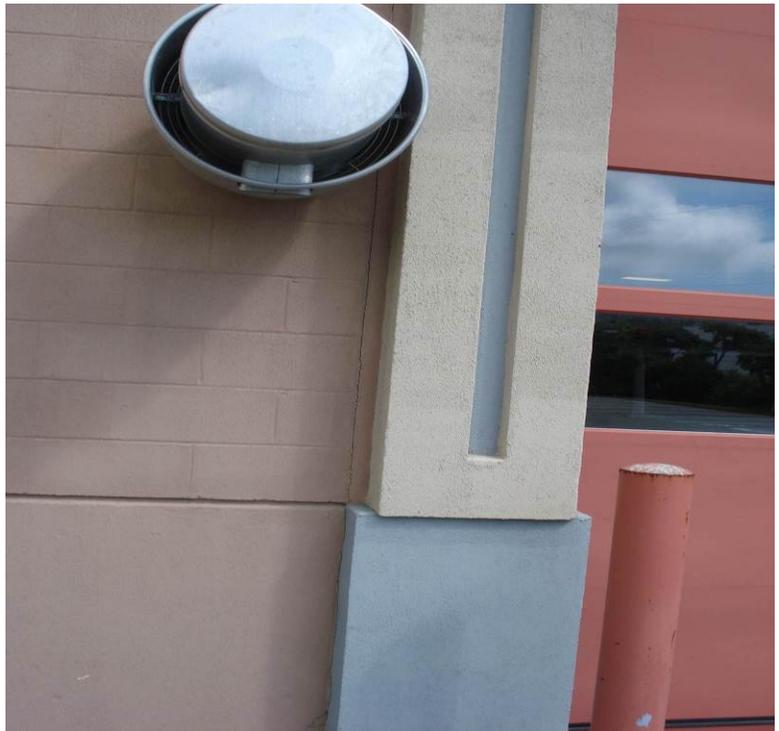
*Control Joint Failure*

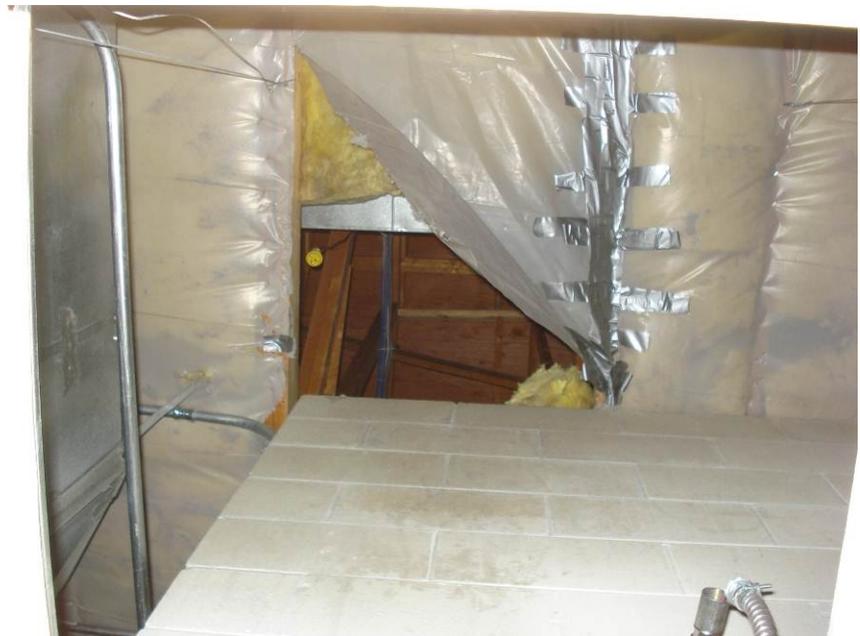
*Major Hole in Insulation  
Barrier*

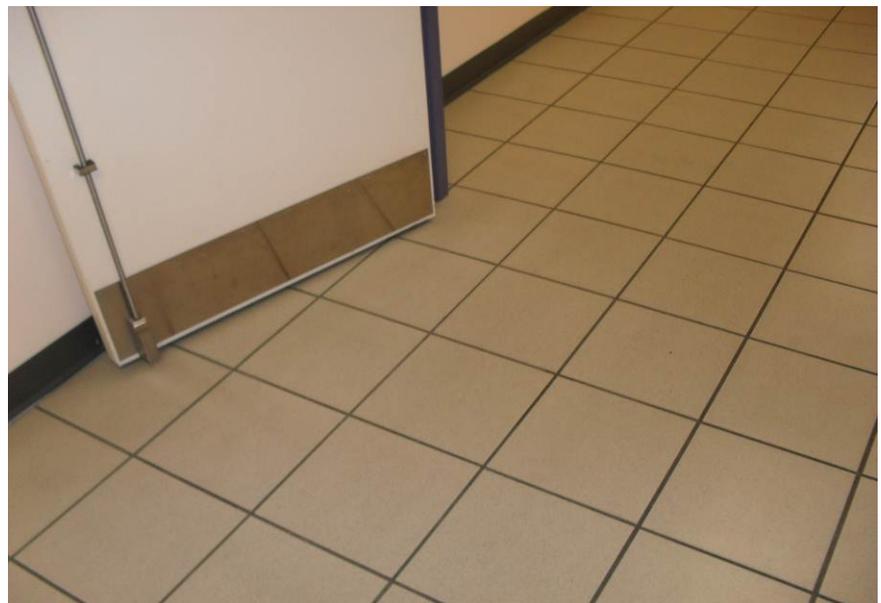
*Floor Strike Plate  
Missing*

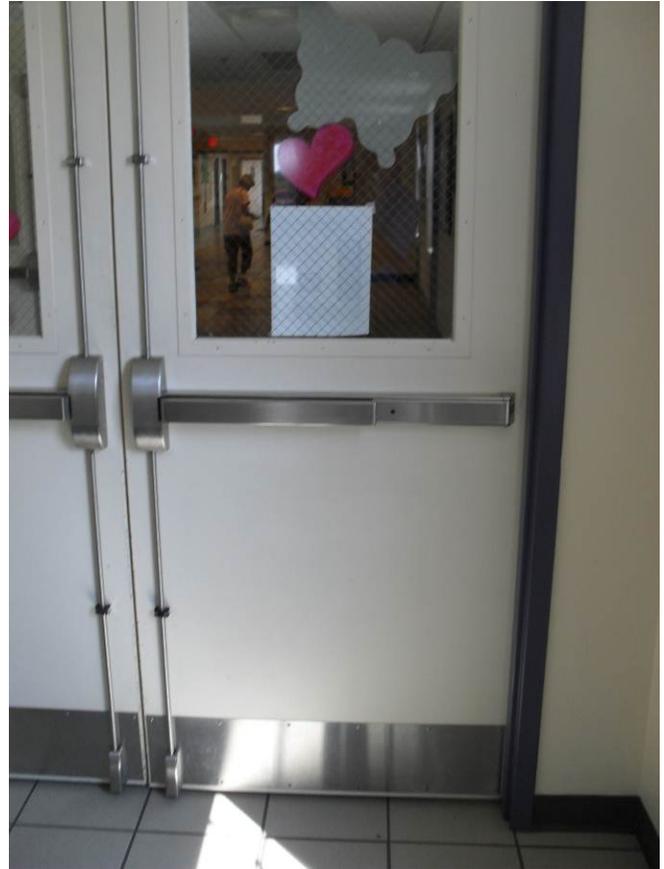
*Wire Glass in Rated  
Doors – Not Allowed  
Per Code*

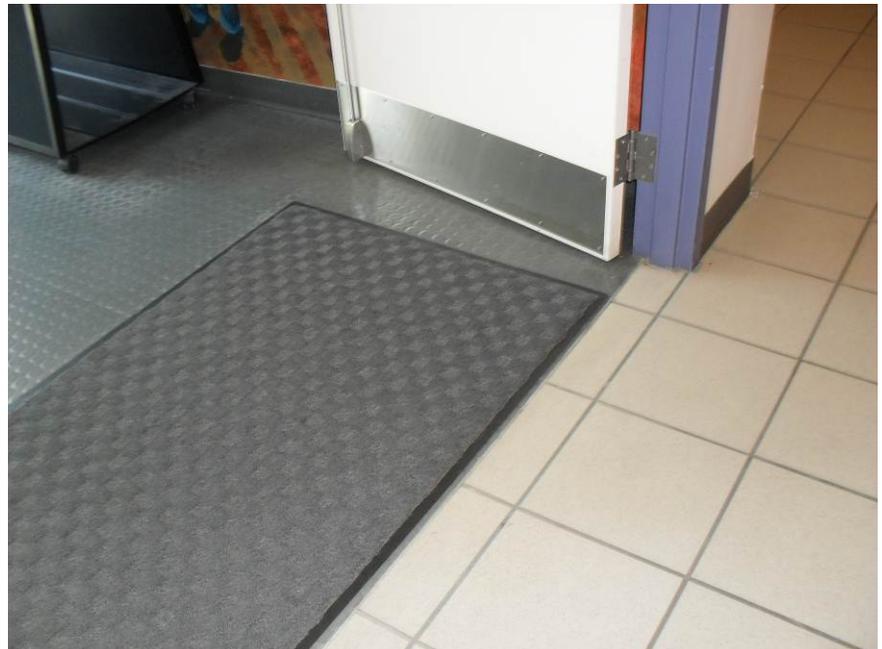
*Floor Strike Plate  
Missing – Doors to  
Main Entrance*

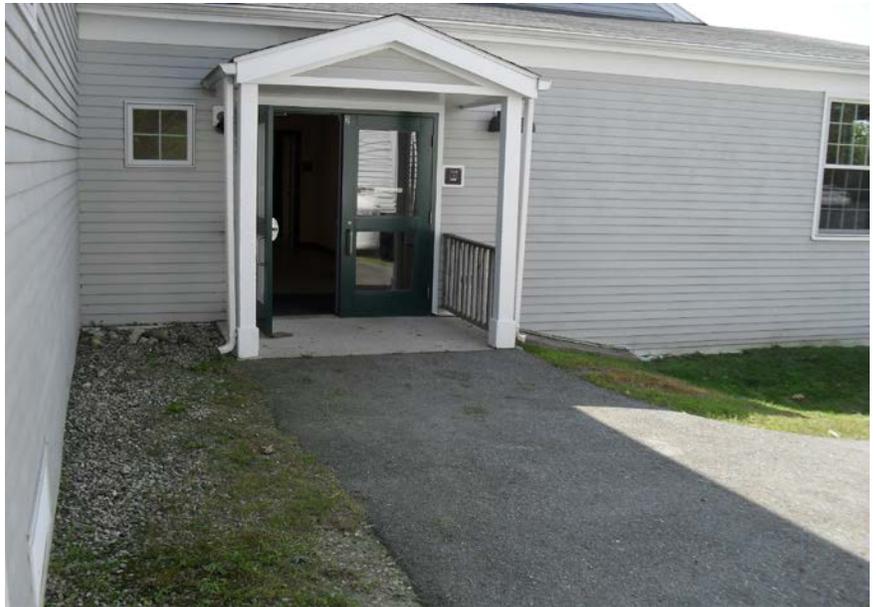
Exit doors at the side entrance cannot be fully open for exiting under freeze conditions. It has been reported that the leading edge of the door becomes stuck in a partially opened position after contacting the concrete entry slab. The entry slab is not a structural slab and is subject to ground freeze when moisture from the roof is introduced into the ground under and heaves the slab upward.

This is a Life Safety code issue that should be repaired immediately. The recommended repair is to remove the canopy and slab and replace with a structural slab and foundation and replace the canopy.

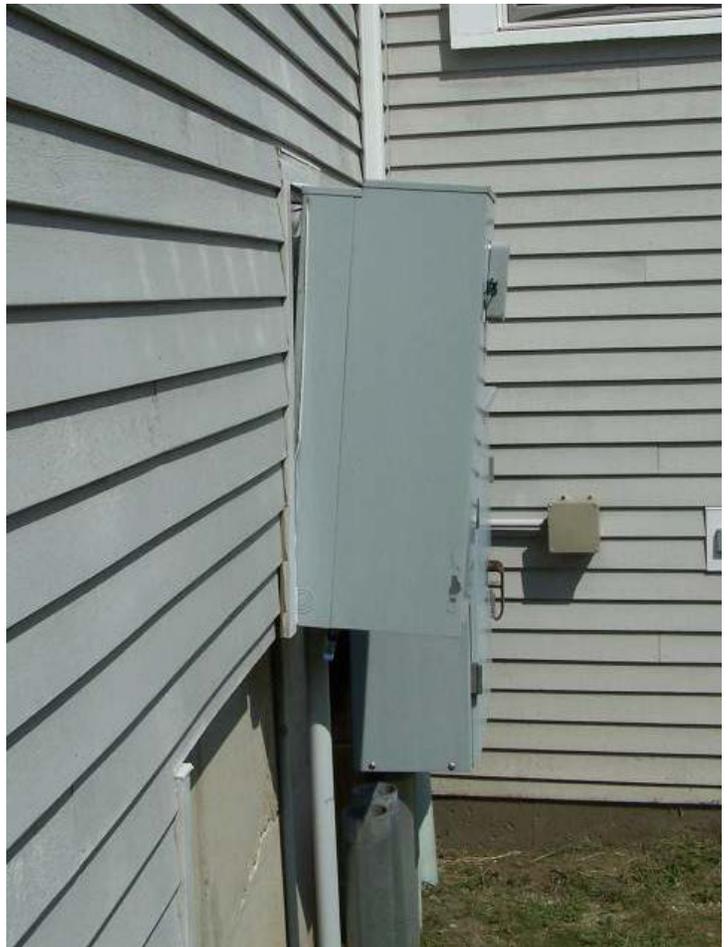
*Meter Enclosure Partially Detached*

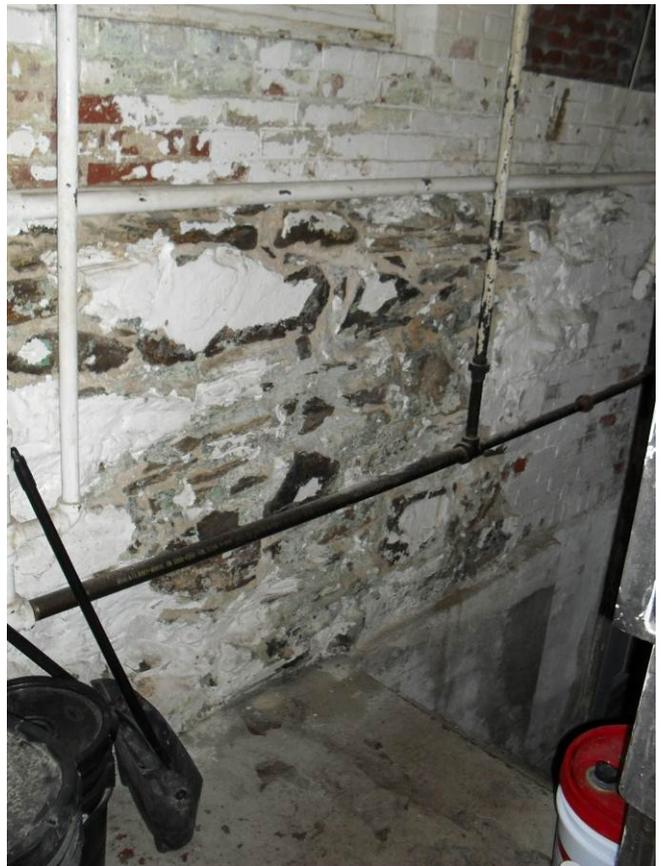
*Stone Wall Foundation  
with Evidence of Water  
Penetration*

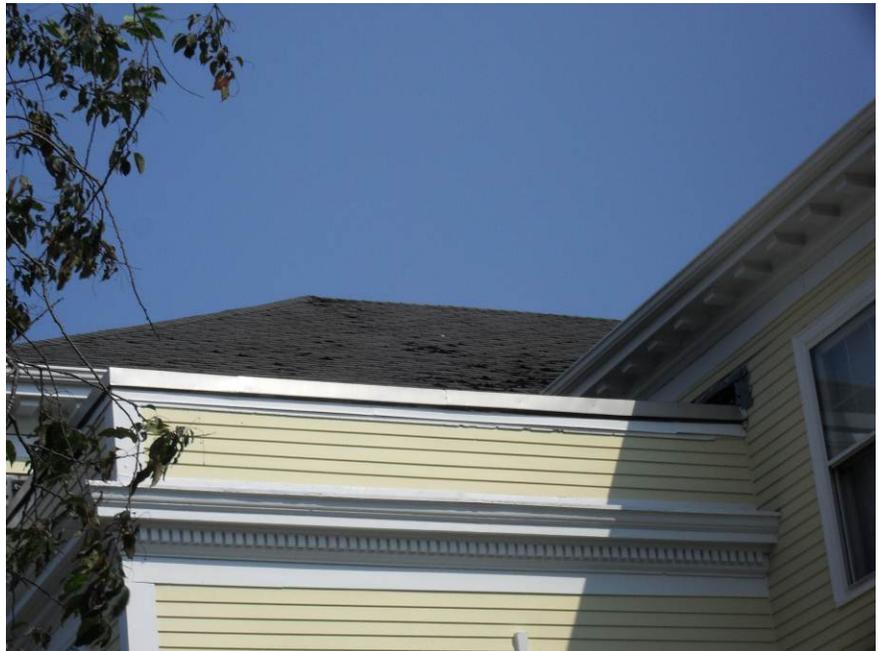
*Partial roof area that has some areas that have been replaced. There are also badly deteriorated shingles that need to be replaced.*
