**Renovation / Demolition Impact Survey
Lead and Asbestos Inspection Services**

(SES Project # 16-06003)

"Former" Spurwink School House
6 Scott Dyer Road
Cape Elizabeth, ME 04107

LEAD INSPECTION REPORT

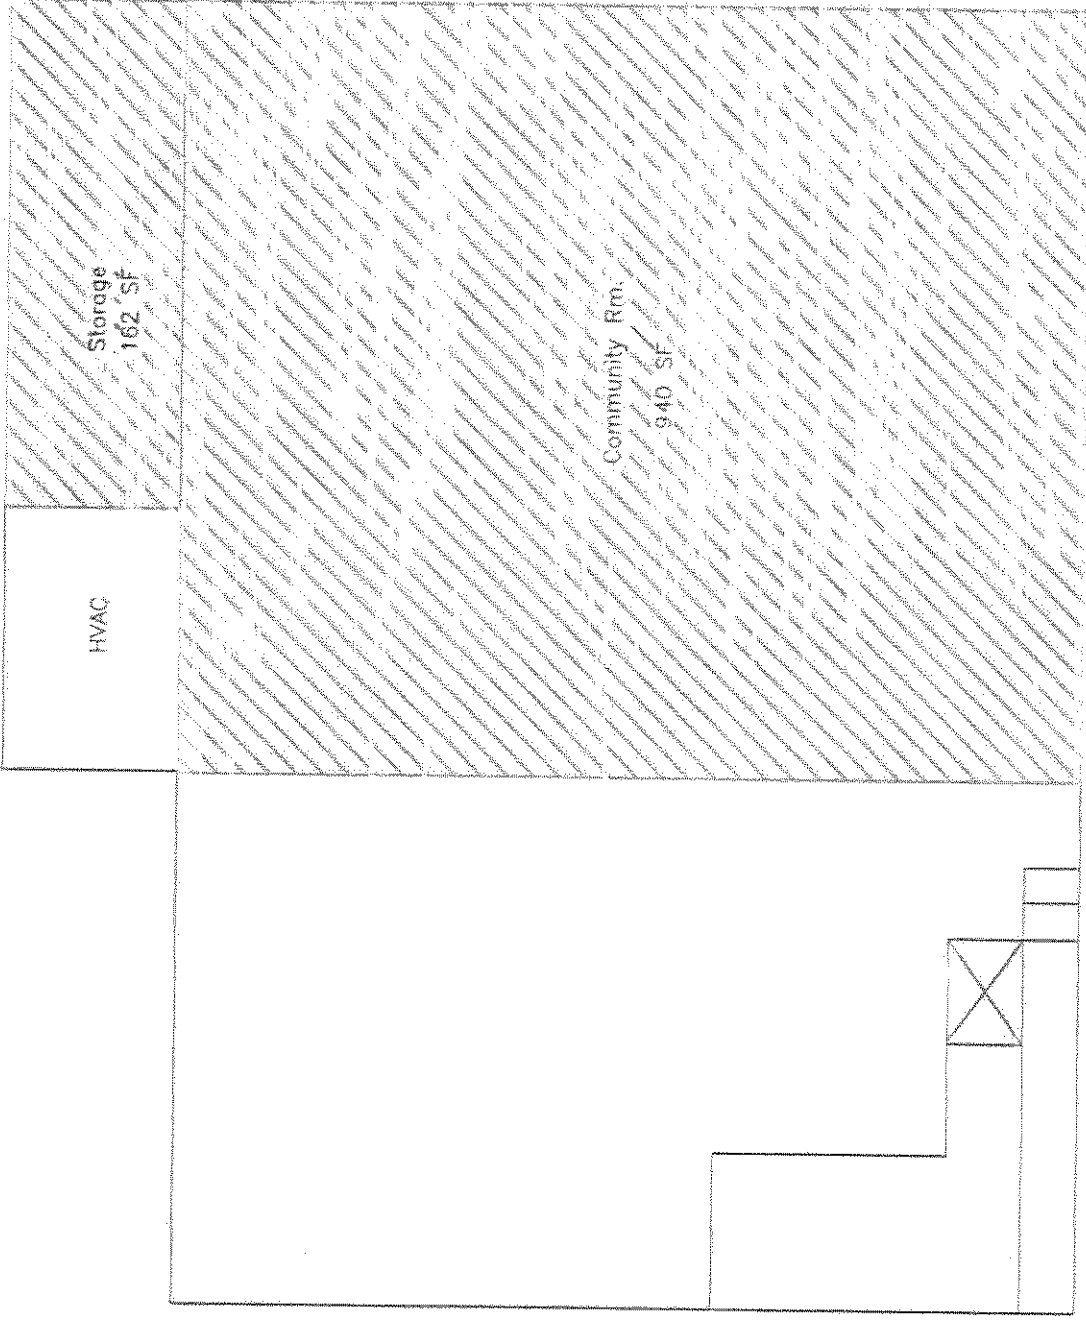
BASEMENT

9'x9" VAT

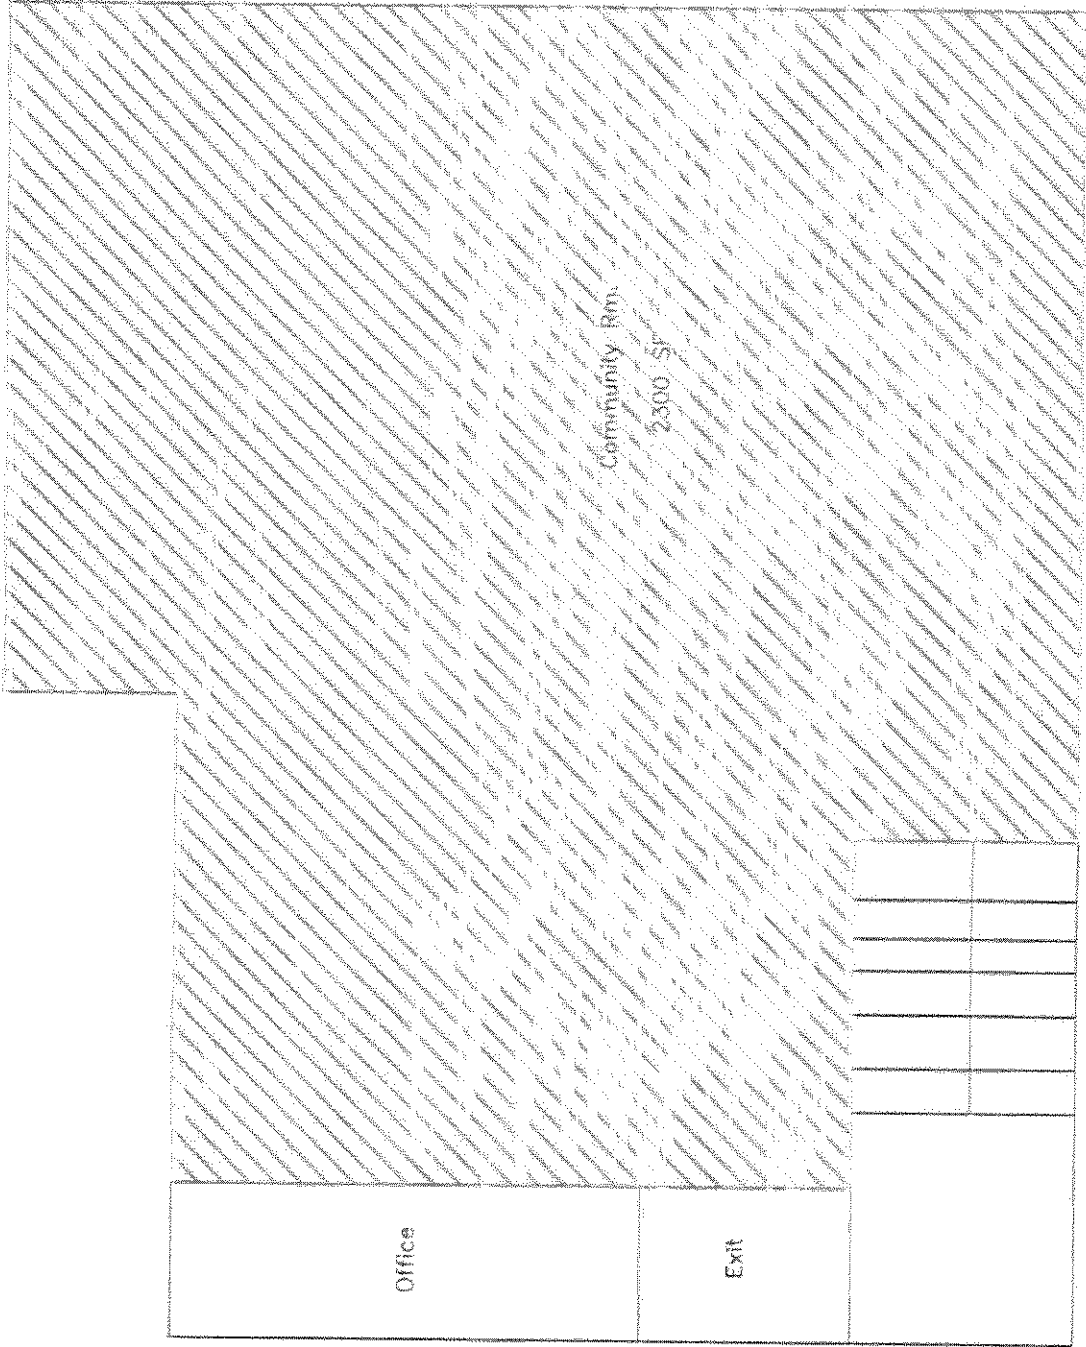
SECOND FLOOR

9"x9" VAT

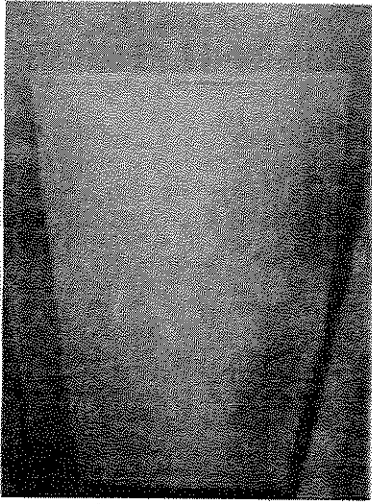
Reading 19- Hall, B Side Wall

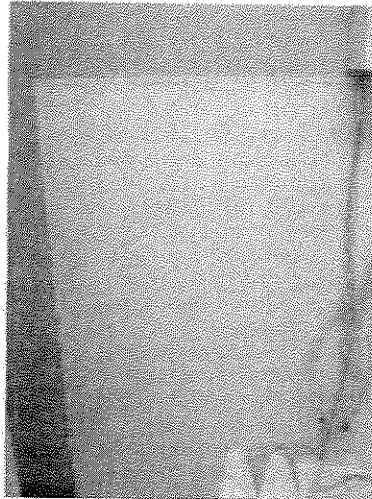
Reading 37- Bathroom, A Side Wall

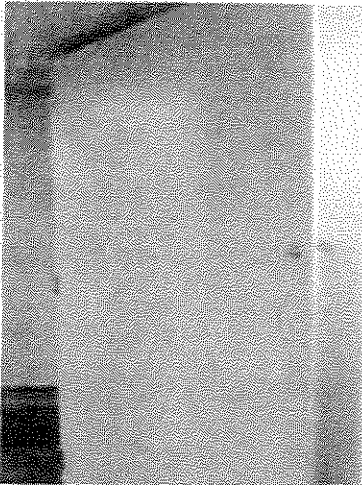
Reading 109- Community Room Door

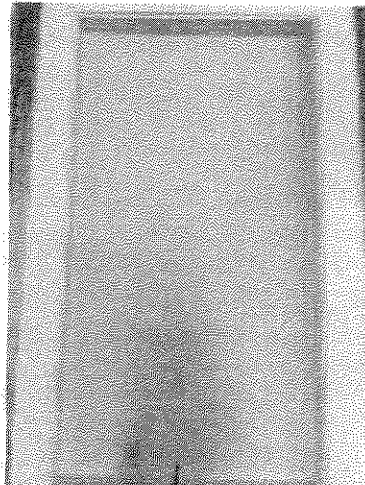
Reading 168- Library Room, D Side Upper Wall

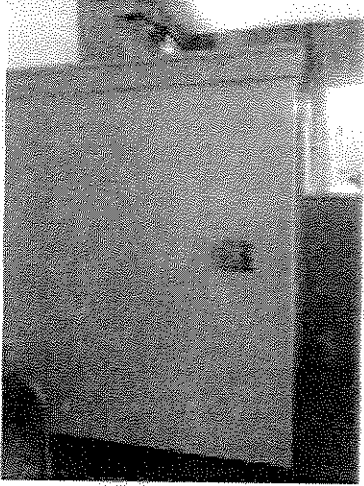
Reading 170- Library Room, Room Ctr. Wall

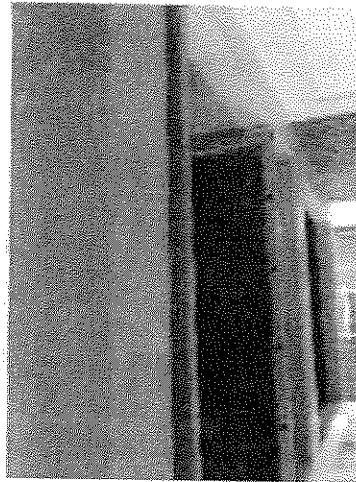
Reading 171- Library Room, Room Ctr. Molding

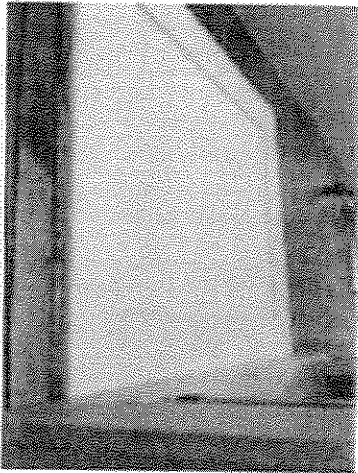
Reading 172- Library Room, D Side Upper Wall

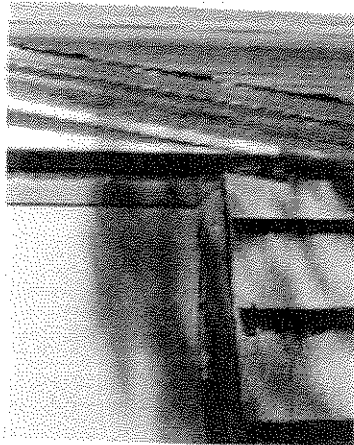
Reading 212- Exterior, C Side Siding (Wood)

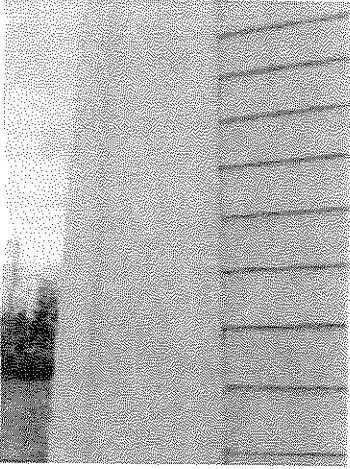
Reading 218- Exterior, A Side Trim

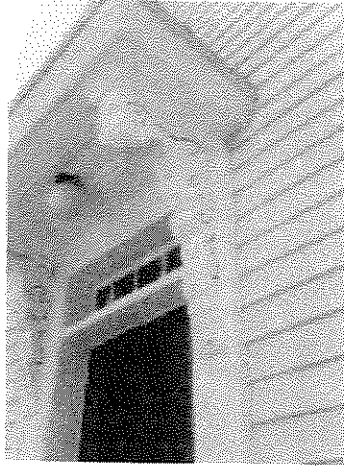
Reading 225- Exterior, A Side Decorative Molding

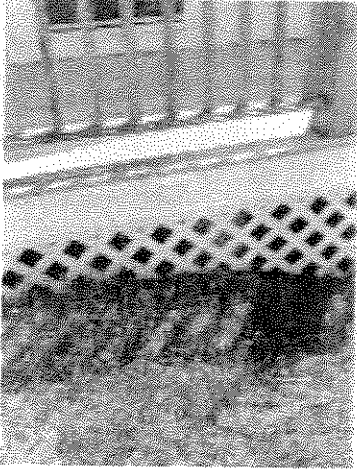
Reading 227- Exterior, A Side Lattice

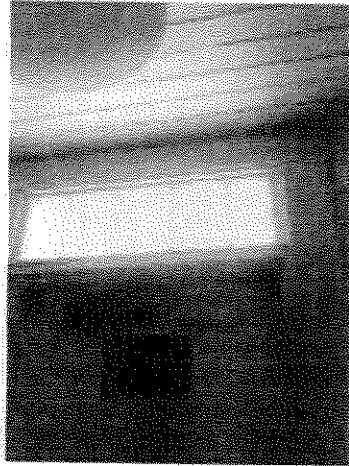
Please note; the Inspector was unable to reach the following areas and therefore the Inspector would assume LBP to be present:

- Exterior Upper Trim/Fascia;
- Window above the A side door in the 2nd Front Entry (see associated picture).

Window above A Side Door in 2nd Front Entry
(Unable to Reach for Reading)
