Fort Williams Park

Town of Cape Elizabeth
Shore Road
Cape Elizabeth, Maine 04107

USERS' GUIDE

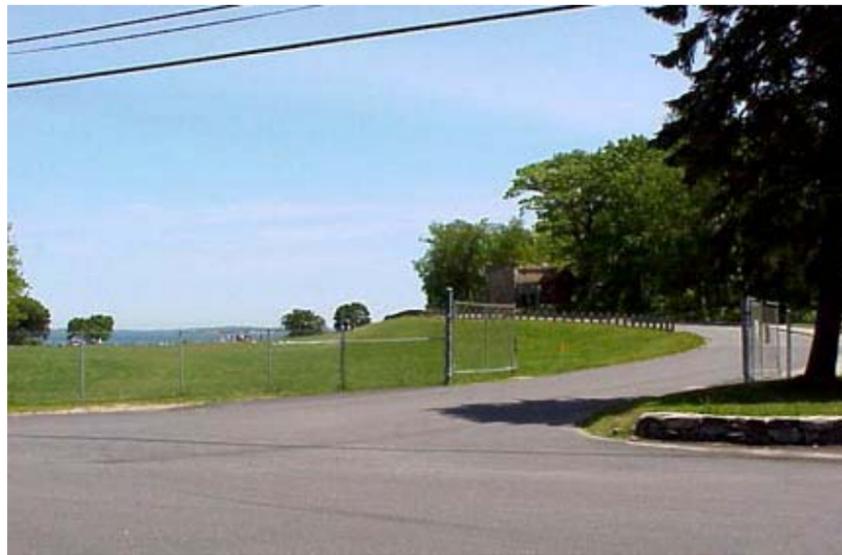
Main Entrance to Fort Williams Park at Shore Road

Issue: The public's view over the Meadow to the Ship Cove Beach area (and the ocean) is interrupted by the sight of cars and play equipment at Ship Cove.

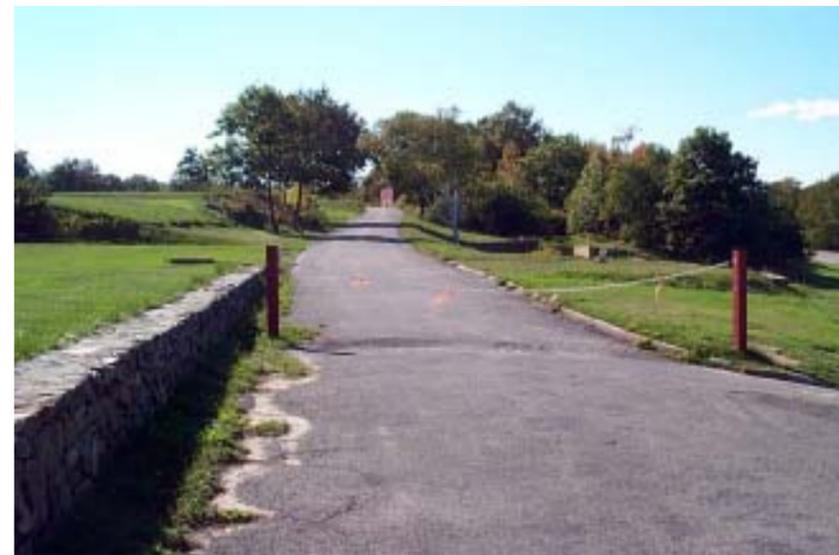
Wheatly Road Entrance from Ocean Road

Issue: The limited width and condition of the access road to the overflow parking area in the Upper Parade Ground Lawn Area reduces its ability to meet the Park's seasonal parking needs.

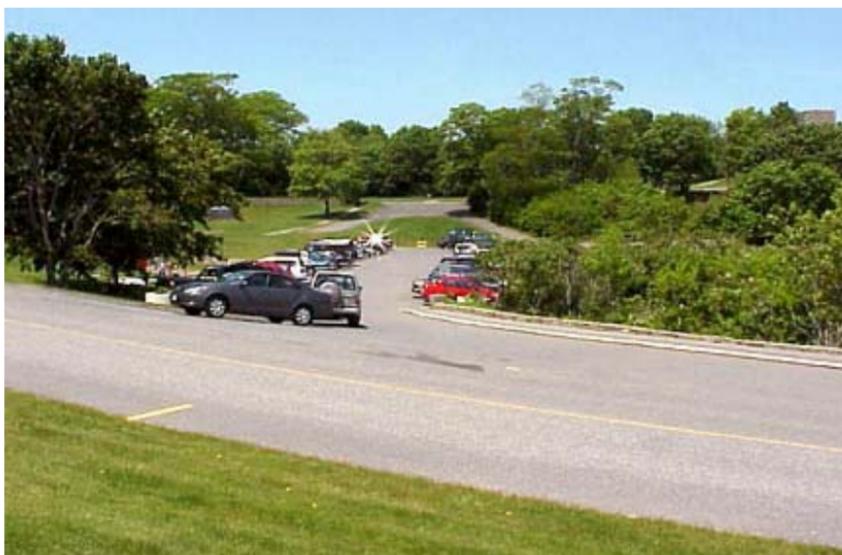
Entrance to Ship Cove Parking Area from Ocean Road

Issue: The current configuration of the parking lot and its entrance reduces its capacity and effectiveness.

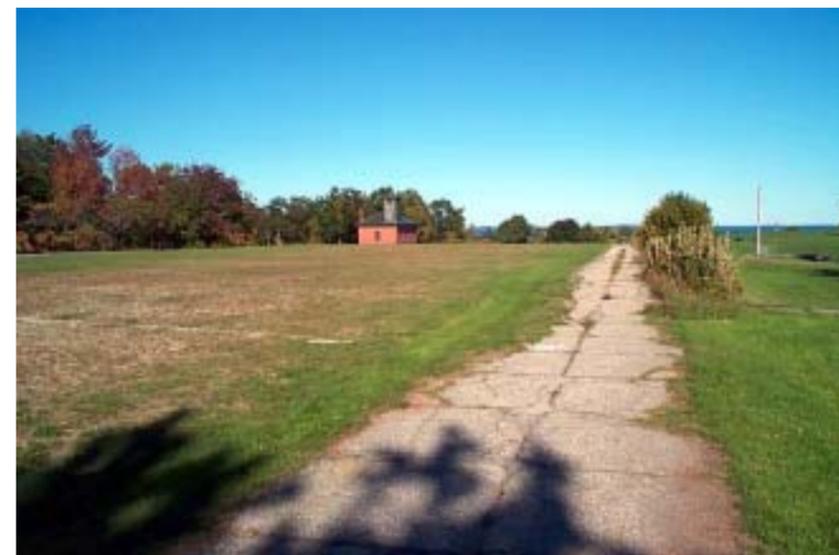
Overflow Parking Area at Upper Parade Ground Area

Issue: Current condition of the access road to the Upper Parade Ground Area reduces its ability to meet overflow parking needs. Possible relocation of the Ship Cove Parking Area to this area raises issues of accessibility and possible impacts on the character of this unique Park area.

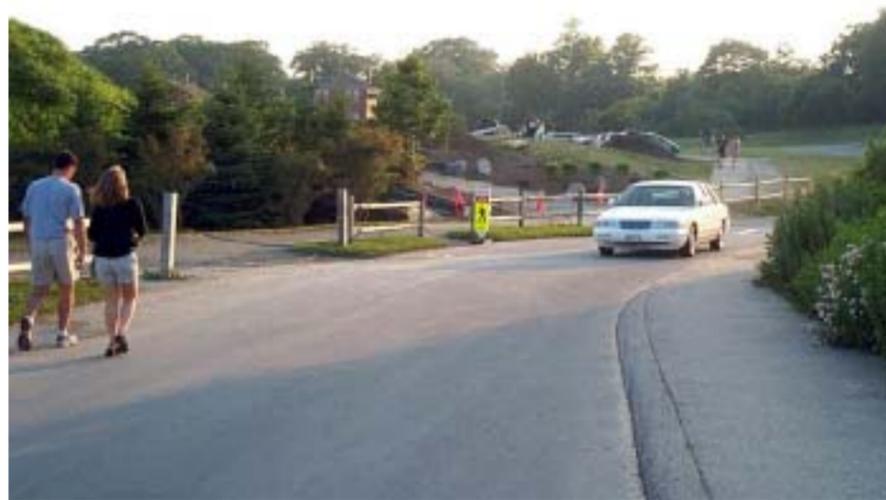
View of road from Head Light Parking Area and Turn Around looking towards Central Parking Area - Photograph illustrates a common occurrence: pedestrians using the access road as a sidewalk. Recent landscape improvements including fencing and a new sidewalk directing people to the Head Light, were specifically intended to enhance visitor safety around the site.

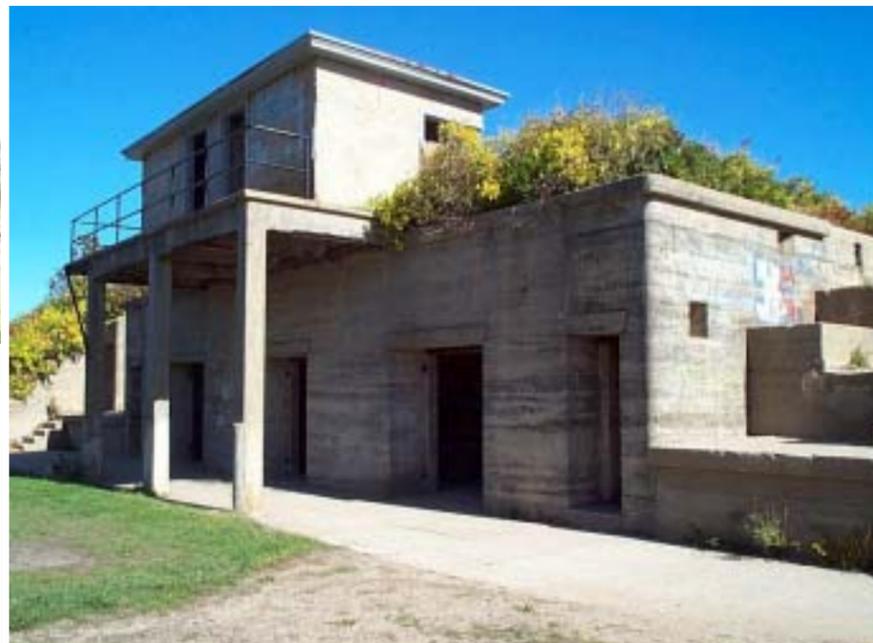
Battery Keys from southwest / shore side.

Significant structural repair required for spalling concrete posts and beams including exposed and corroded reinforcing.

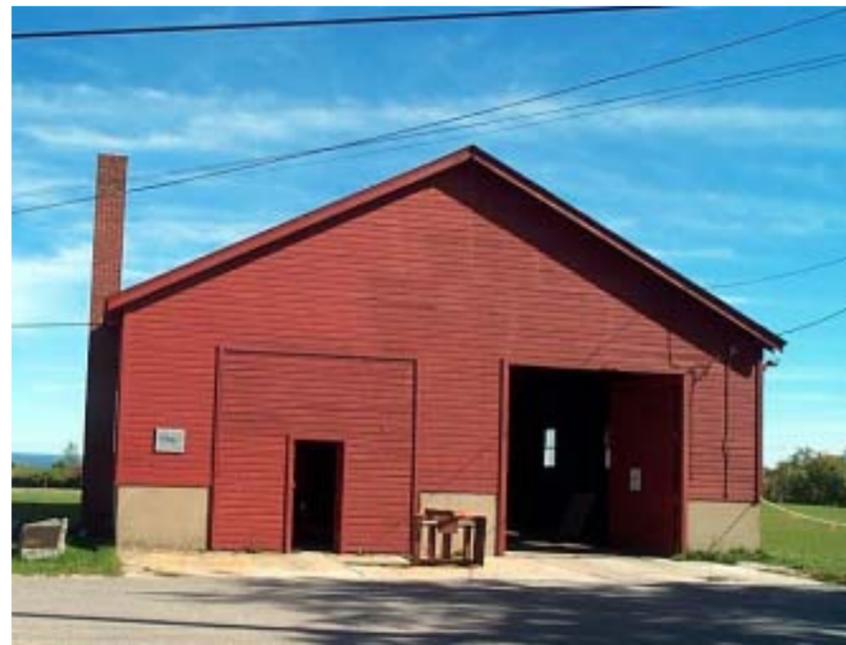
Gun Shed - north elevation.

Comments: General exterior appearance good. Damaged support column. Structural inspection recommended.

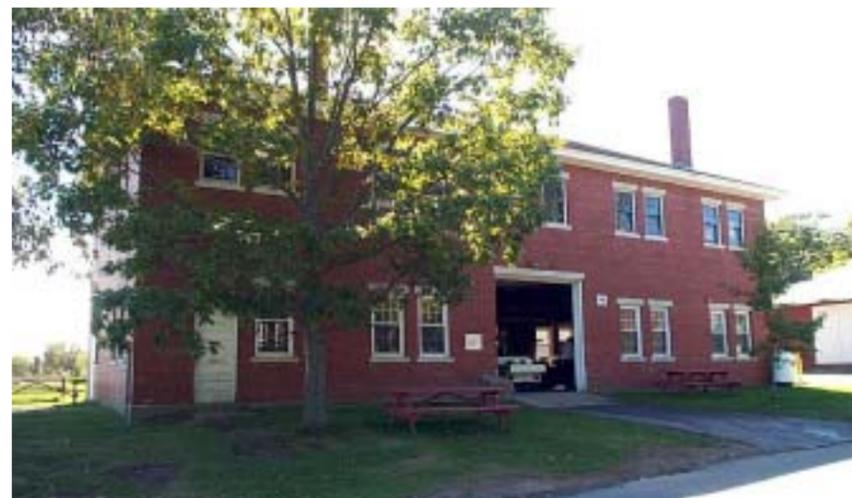
Artillery Engineer Storehouse - north elevation from Humphreys Road.

Comments: Building appearance good. Requires window repair, repainting and structural inspection.

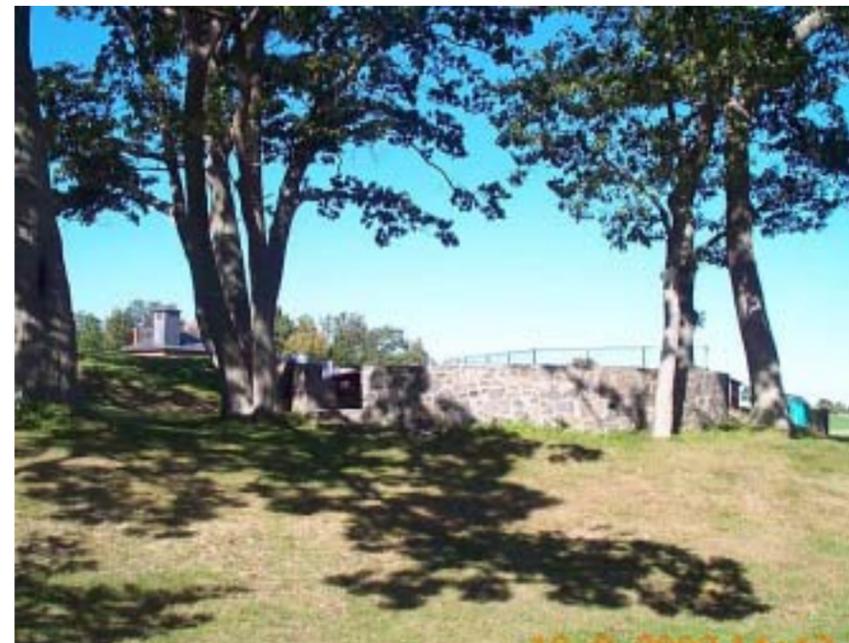
Picnic enclosure from southwest.

Comments:
 Stone work damaged by tree growth. Repair walls to prevent further damage from trees and normal weathering.

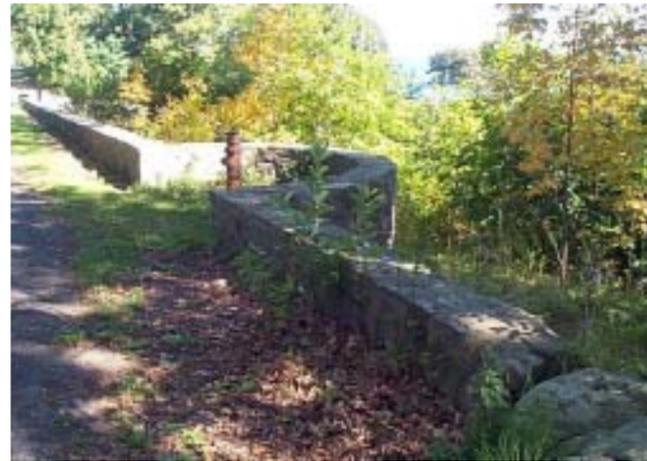
Location **Chapel Road**
Key Reference Number

Fair to poor condition. This stone retaining wall requires structural inspection. Loose and missing stones should be replaced to prevent further damage from weathering.

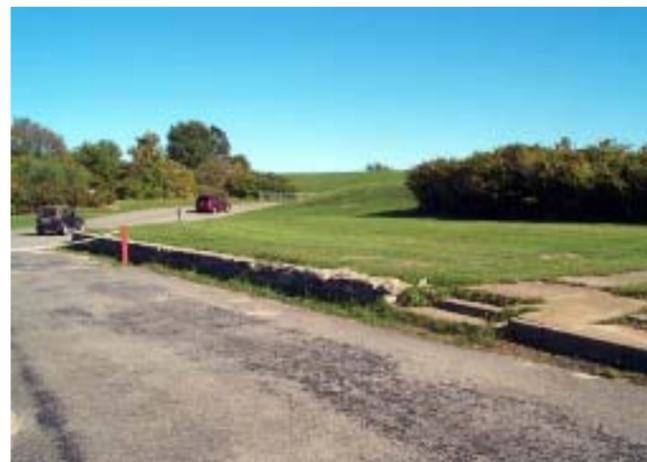
Location **Wheatly Road**
Key Reference Number

Fair. Replace missing stones and repoint.

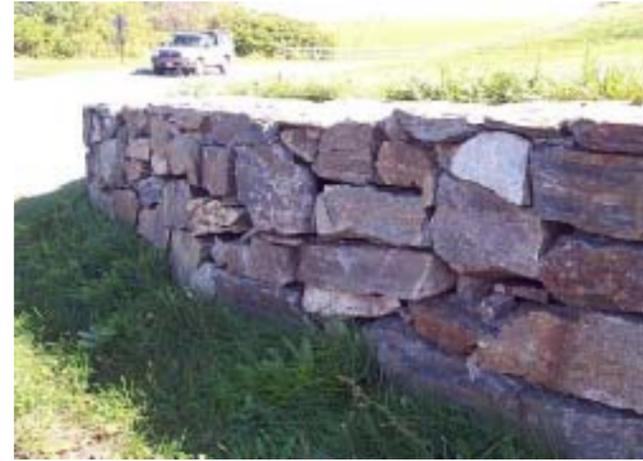
Location **Wheatly Road**
Key Reference Number

Condition Description
Dry-laid large stones good condition. Replace and chink missing stones. Mortar top joints with matching mortar to minimize frost damage.

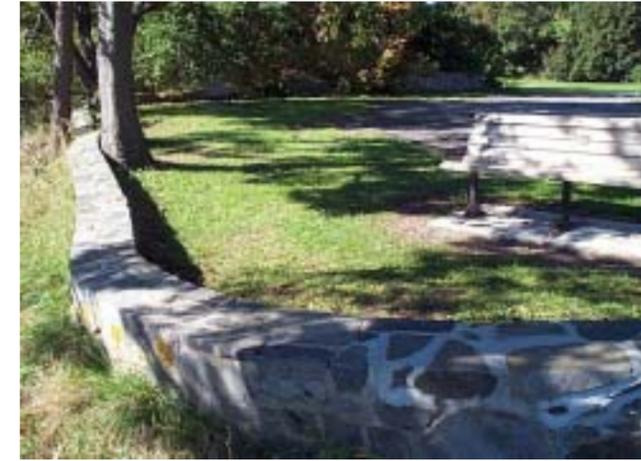
Location **Goddard Mansion**
Key Reference Number

Condition Description
Fair to good. Leaning in some areas. Where serving as a retaining wall inspect for structural damage. Repoint wall as needed with matching mortar. Encloses the overlook above Ship Cove

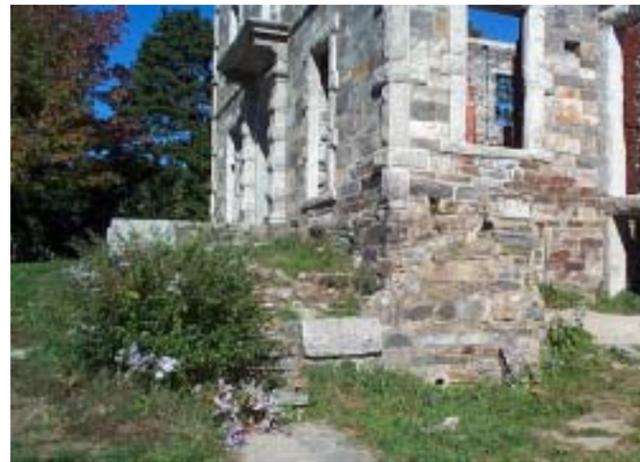
Location **Goddard Mansion**
Key Reference Number

Condition Description
Old Garden terrace retaining walls in very poor condition. Reconstruct/ repair for partial garden restoration.

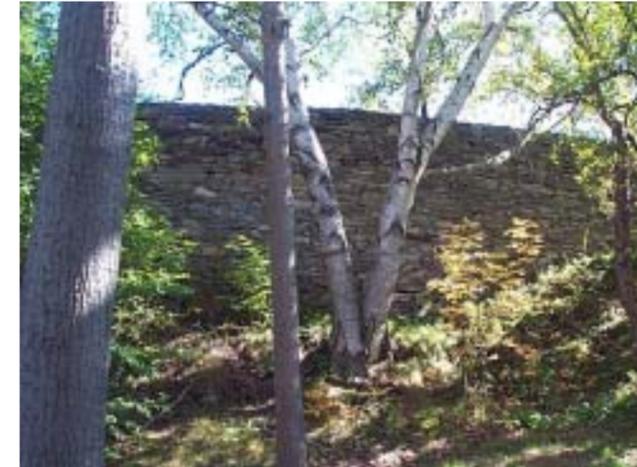
Location **Wheatly Road (west end)**
Key Reference Number

Condition Description
Inspect for loose and missing stones. Provide timely repair. (See 7.1)

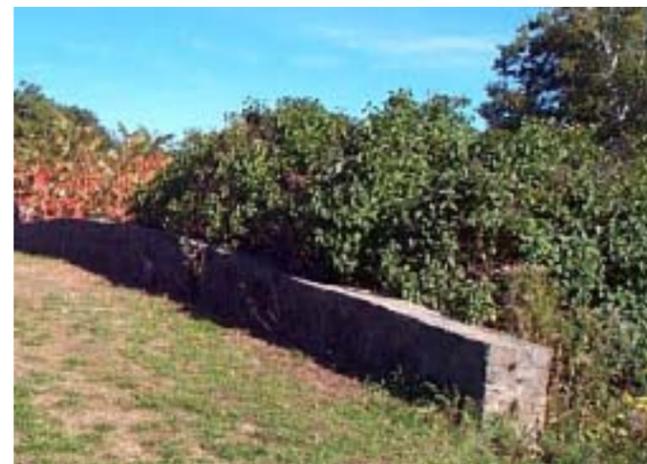
Location **Barrette Road**
(Officers' Row)
Key Reference Number

This wall extends from Picnic Shelter driveway along old Barrette Road. Fair condition but leaning.

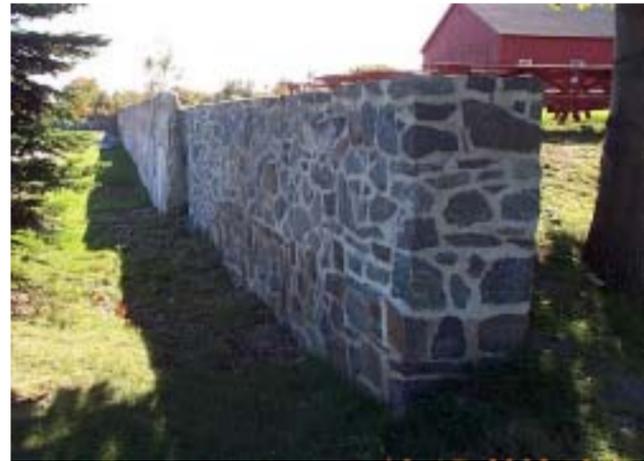
Location **Central Parking Lot**
Key Reference Number **9.1**

Condition Description
Existing wall in good condition as pictured. Wall on south side of parking requires extensive repair.

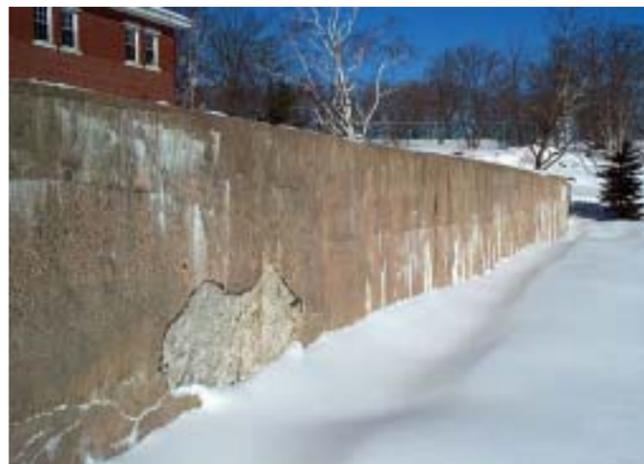
Location **Central Parking Lot**
Key Reference Number **9.4**

Condition Description
Concrete and stone wall sealed with parging. Resurface wall in SW end of parking lot.

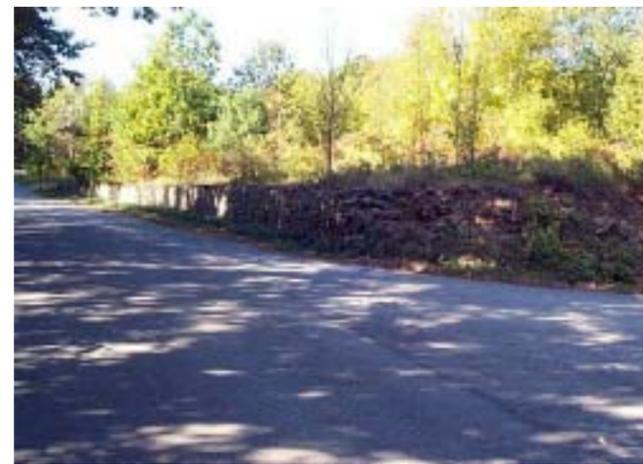
Location **Merriman Road @ Blake Road**
Key Reference Number **101**

Condition Description
NW corner intersection wall is rubble. Clean up and landscape. Repair remaining walls beyond intersection.

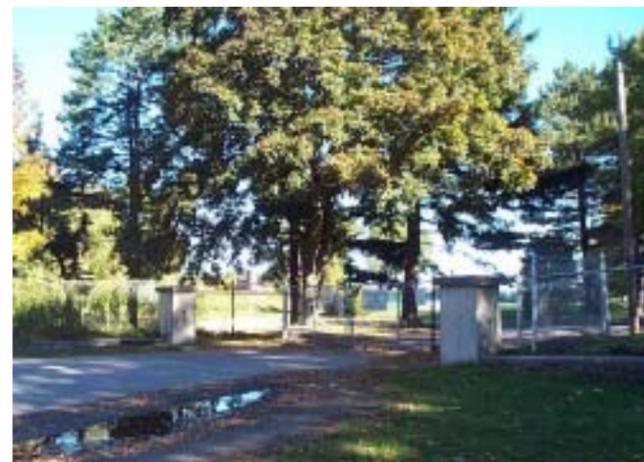
Location **Farnsworth Road Entry**
Key Reference Number

Condition Description
Distinct pillars and flanking walls in fair condition.

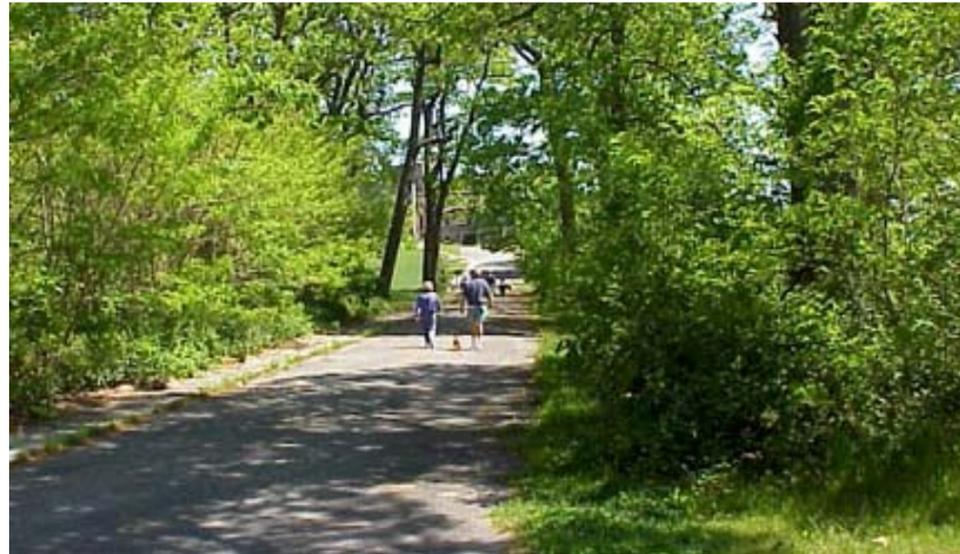
View of Chapel Road entry to Park looking towards Goddard Mansion. (Note the overgrown with understory vegetation on either side of the road.)

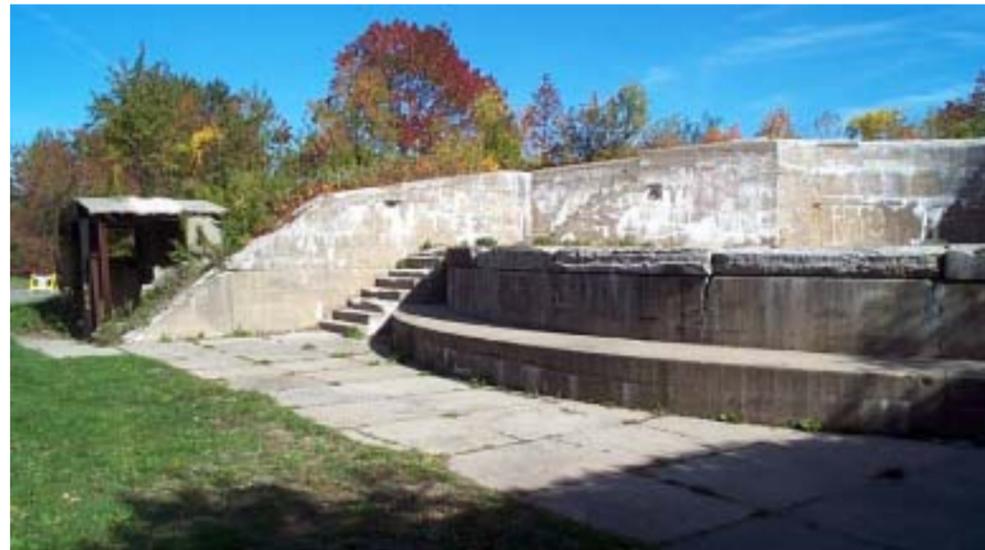
View of northern gun mount in Battery Garesche as viewed from Merriman Road. Note dense vegetation beyond which screens views of the Battery from “The Green”. Greater visibility of the Battery may help to discourage vandalism.

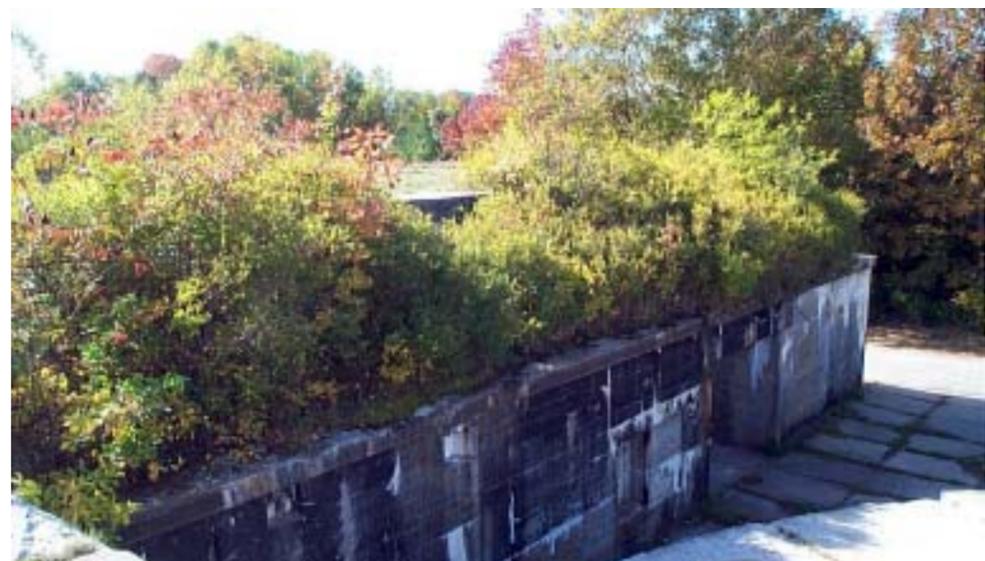
Top view of Battery Garesche. Note deteriorating condition of concrete, walls and impact of roof top vegetation.

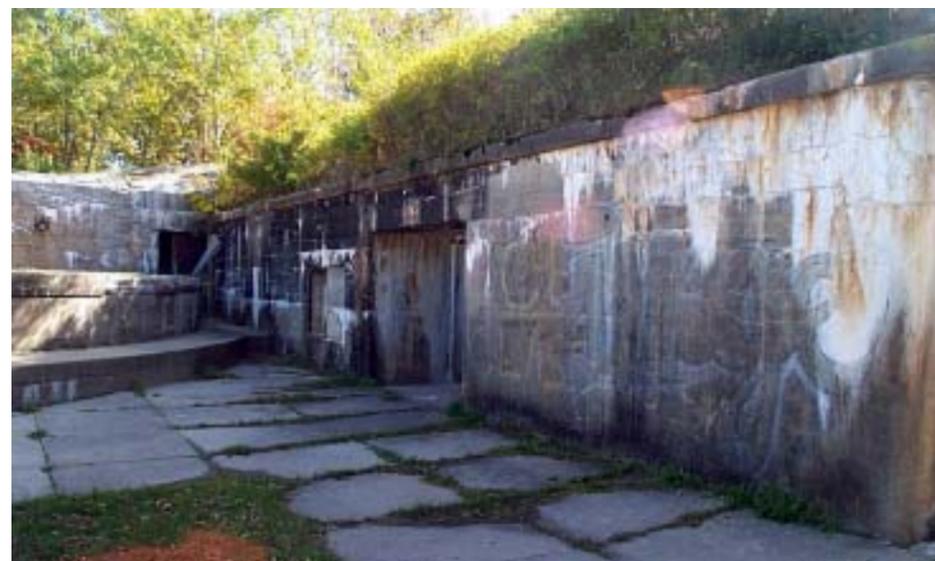
View of Battery Garesche exterior wall from ground level. Note overhanging rooftop vegetation, spalling concrete, vandalized entrance gate, and graffiti painted wall. The concrete square surfacing paving pattern is the same found in front of Battery Blair.
