THOMAS MEMORIAL LIBRARY Facility Assessment and Improvement Scenarios

Cape Elizabeth, Maine
March 2, 2009

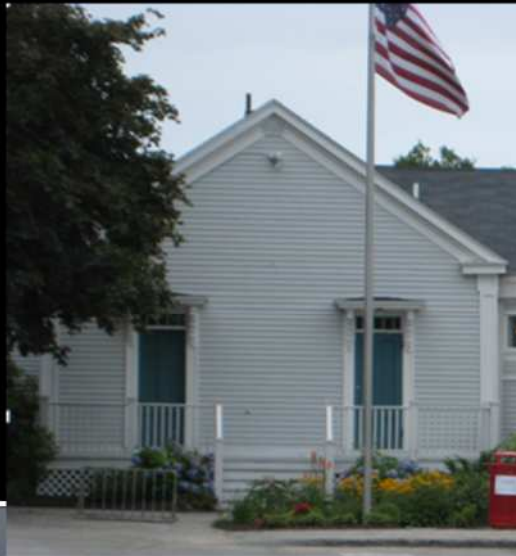
Another historic portion of the Library is the upper level of the “Spurwink School.” What stands today is a remnant of the original building that William Widgery Thomas Jr. donated to the Town in 1919 to serve as a library. The school was built in 1849 as a one-room school house on Bowery Beach Road, about a quarter mile from the intersection of Fowler Road. Thomas was a teacher at the school in 1857. This section of the building houses the Library’s materials for young children and a very crowded staff office. The front façade and one side of the building are the primary remnants of the original school. The rear wall was removed when the annex portion was added and the wall adjacent to the connector was significantly modified and the mechanical lift was added at the time the connector was built. The upper level (the original school) sits on a foundation that was built in the 1940s. This section of the building has quite a history.

The building has been on no fewer than five sites and has traveled somewhere in the neighborhood of 3 – 4 miles during its history.

The foundation and basement of the Spurwink School dates from 1944 when the school was moved to the present site. This area of the facility houses one office, the staff break room, the parenting collection, and the only restroom at this end of the Library.
