Fort Williams Park

Town of Cape Elizabeth
Shore Road
Cape Elizabeth, Maine 04107

USERS' GUIDE

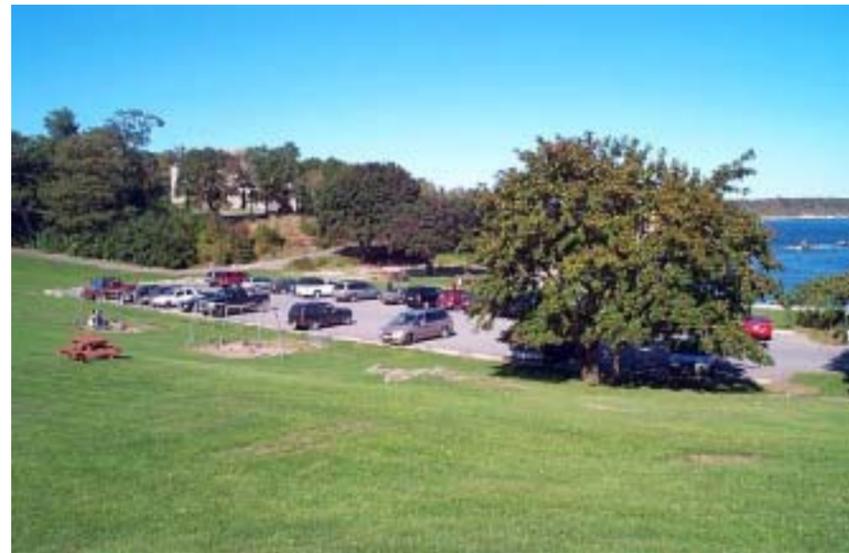
Ship Cove Parking and Beach Area.

Issue: Access to picnic area and Keyes Road for visitors with physical disabilities is limited due to lack of sidewalks and uneven terrain.

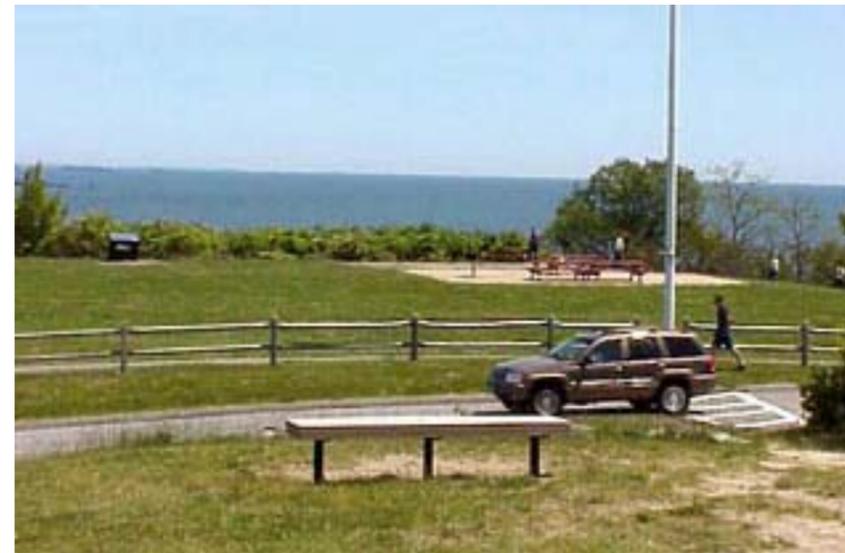
Pedestrian crossing at crest of Ocean Road. (between Kitty's Point and Battery Knoll flagpole)

Issue: The crossing is not clearly signed which increases possible conflicts between pedestrians and cars.

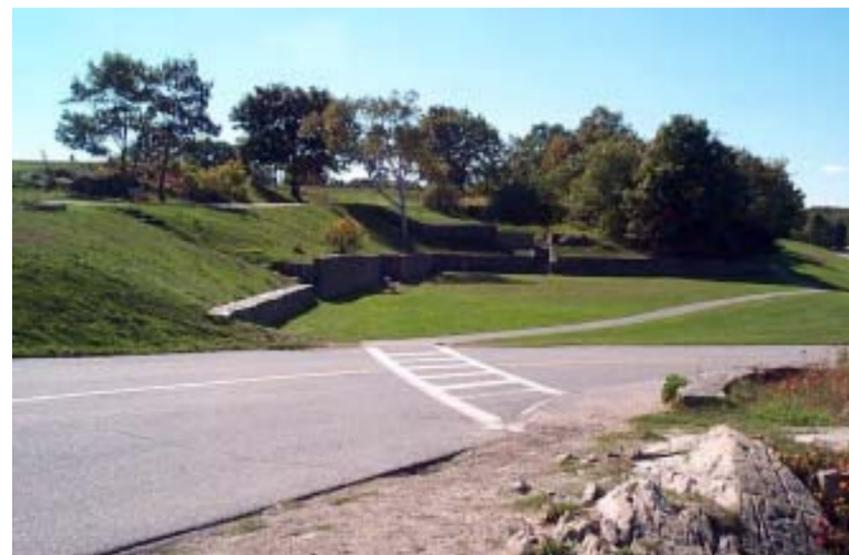
Alternative access to Ship Cove Beach from upper Parade Ground lot area.

Issue: Pedestrian route follows Wheatly Rd. (upper left in photo) down stone steps, across existing lawn area to painted cross walk in foreground. Accessible route would follow length of Wheatly Rd. (see photo of Wheatly Rd. entrance, page 13.)

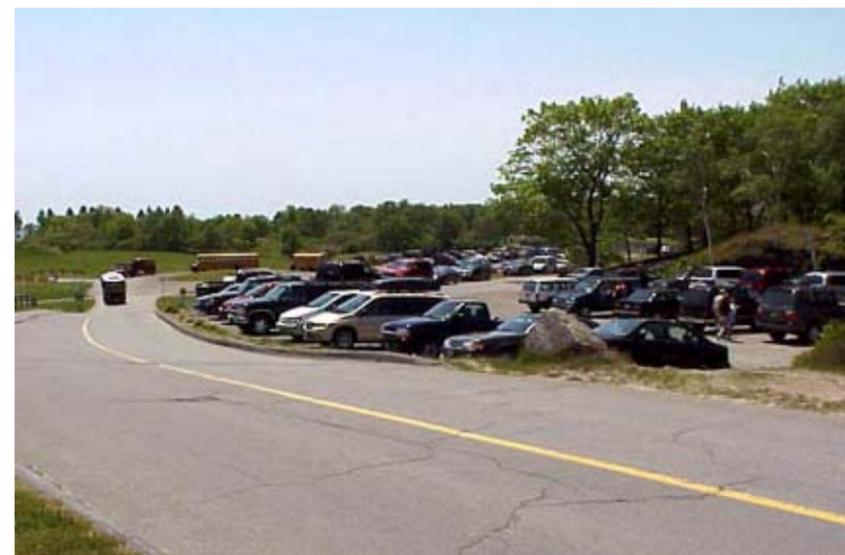
Esplanade between Ocean Road and Picnic Shelter Parking Area. (looking towards Central Parking Area)

Issue: The lack of effective separation between cars and pedestrians crossing from the parking lot towards Battery Knoll and the Portland Head Light Grounds reduces pedestrian safety.

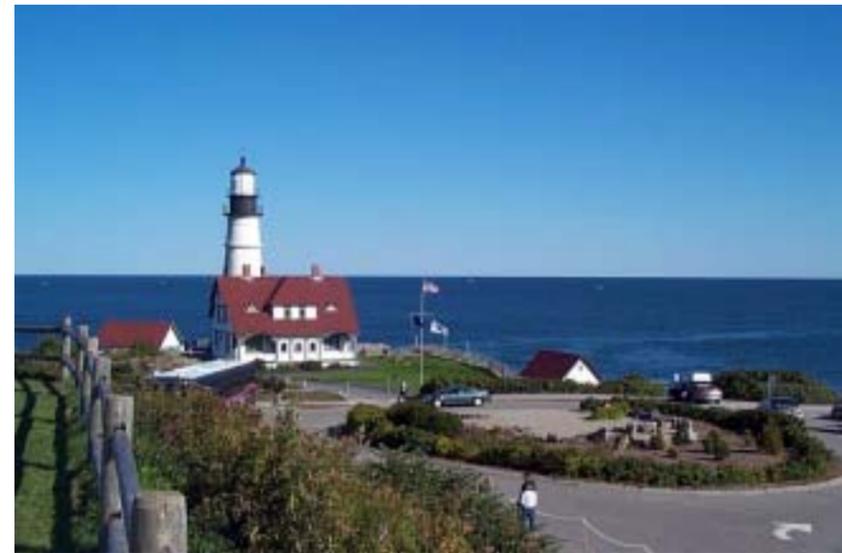
Head Light Parking Area and Turn Around - Efforts to effectively separate people and cars in this very active area are intended to reduce the possibility of conflicts and to increase safety.

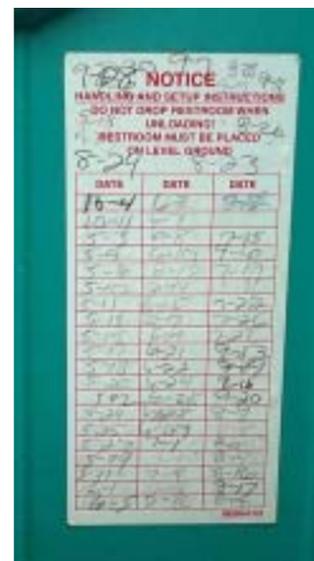
Existing Porto-lets at Ship Cove and Chapel Road Maintenance log and “overuse” of facility in spite of cleaning every other day.

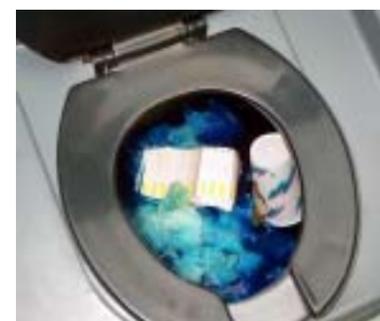
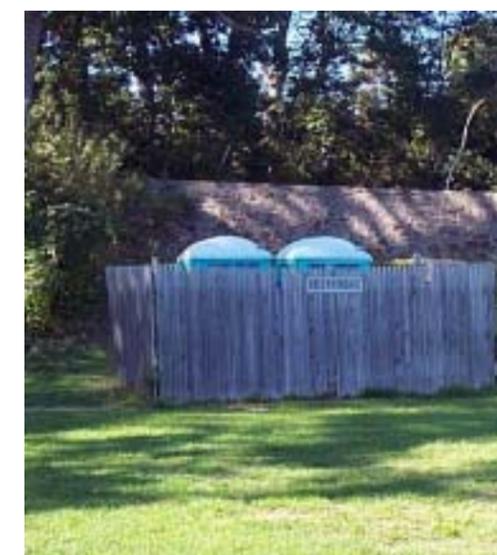
View of Existing Porto-lets at Ship Cove Parking Area with cedar stockade fence enclosure. Diapers often left in and around these facilities.

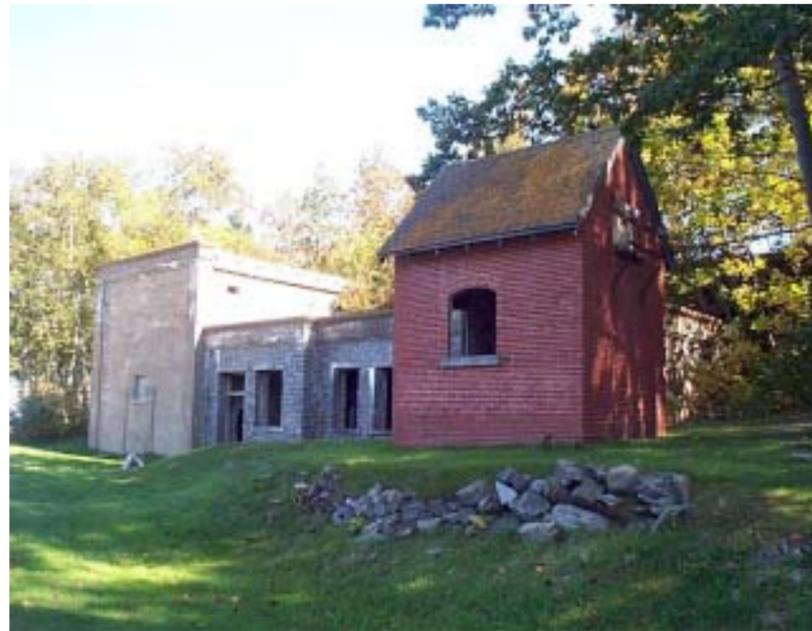
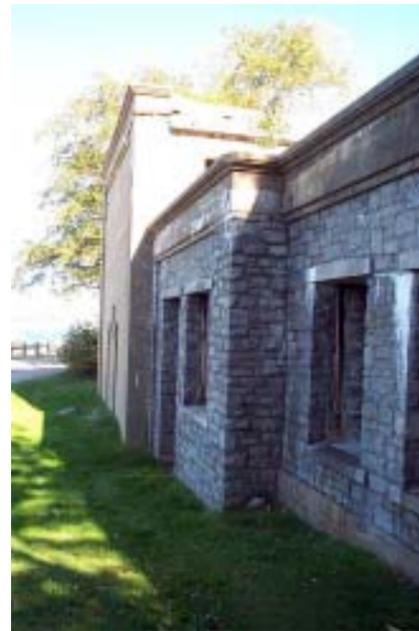
Central Powerhouse - north elevation

General appearance fair to good, however structure prone to water damage and loading from landscaped roof above. Structural review recommended. Focal point at Park main entrance.

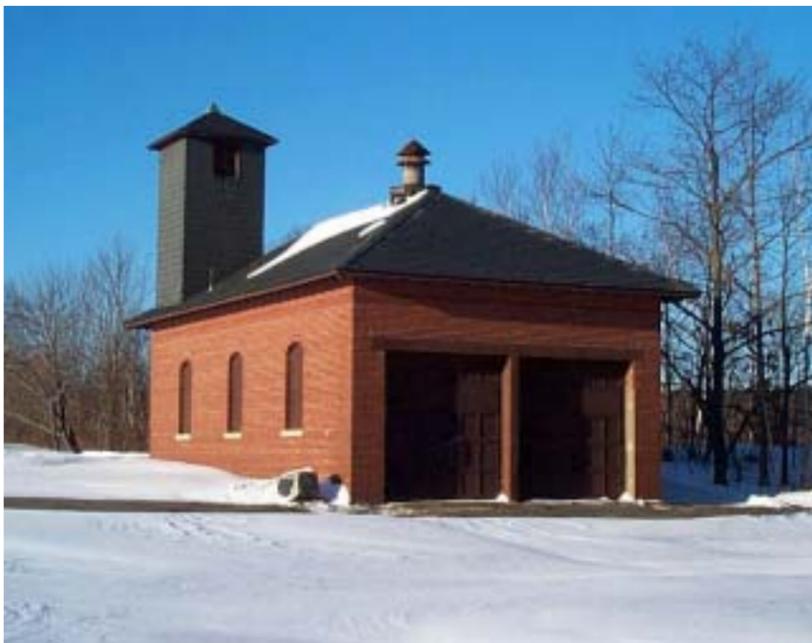
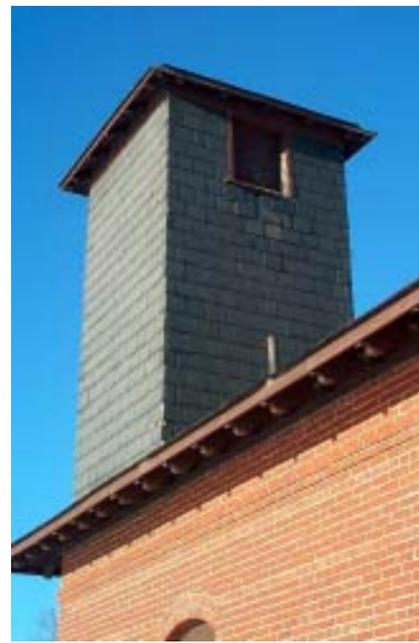
Wheatly Road - Old Fire House from west

General appearance fair to good. Slate roof and slate covered hose tower require inspection and repair.

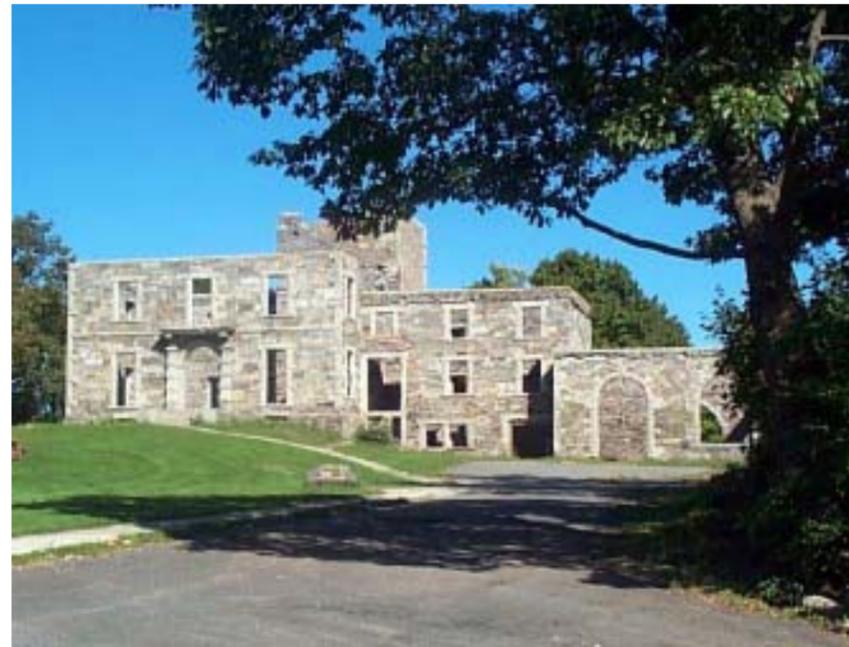
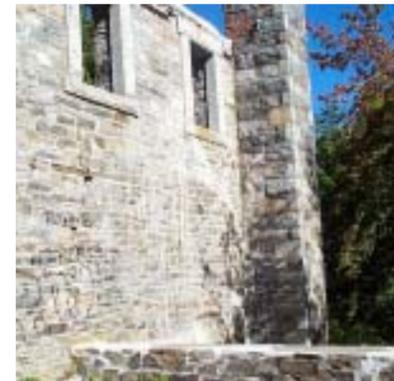
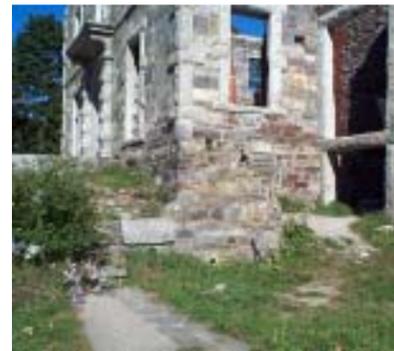
Goddard Mansion from west on Chapel Road.

Interior was burned out in 1981 as a controlled burn. Exterior stone work, lintels periodically repaired. Review structure for stability and safety.

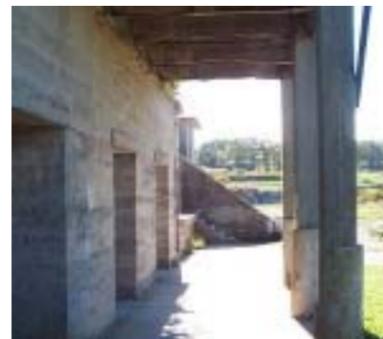
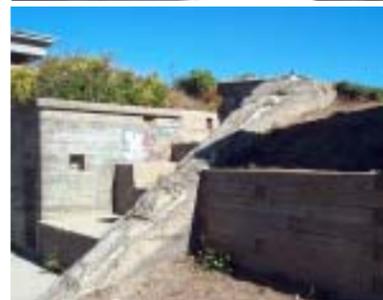
Battery Keys - details of conditions of concrete structure.

Significant structural repair required for spalling concrete posts and beams including exposed and corroded reinforcing.

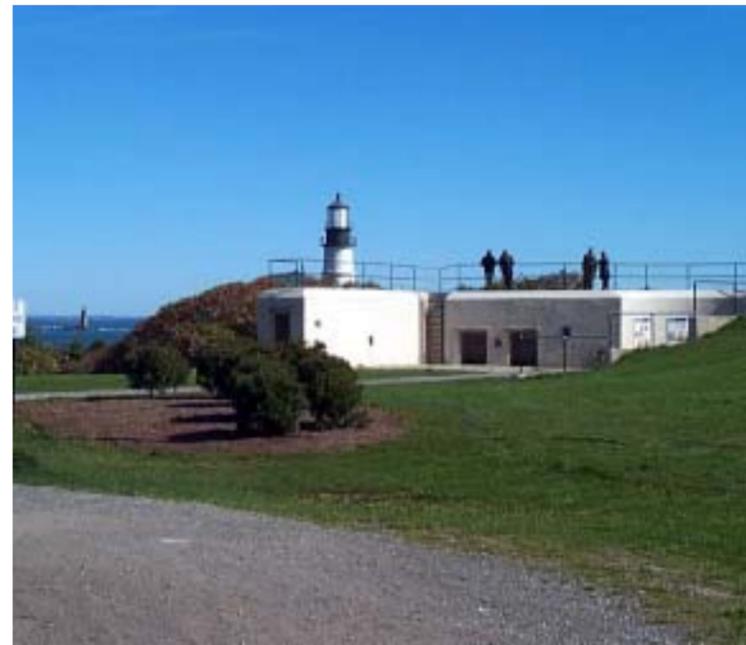
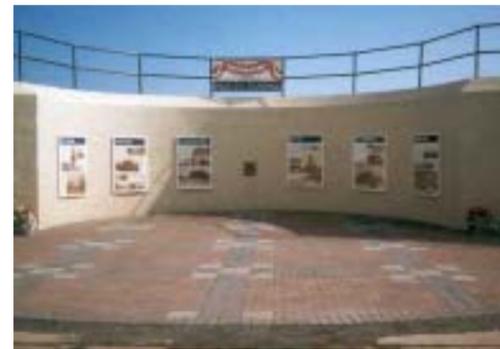
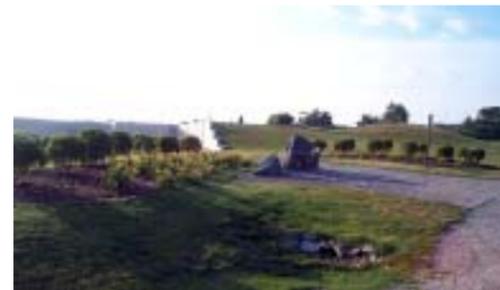
Battery Blair Memorial (above) and entrance to Memorial from Central Parking Area (below).

Old concrete pavement requires replacement. Battery's concrete surface treatment needs to be monitored for ongoing maintenance and painting. Space is available for additional displays.

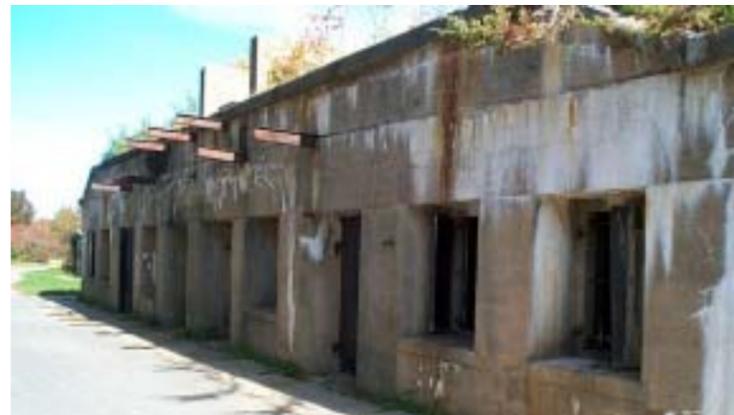
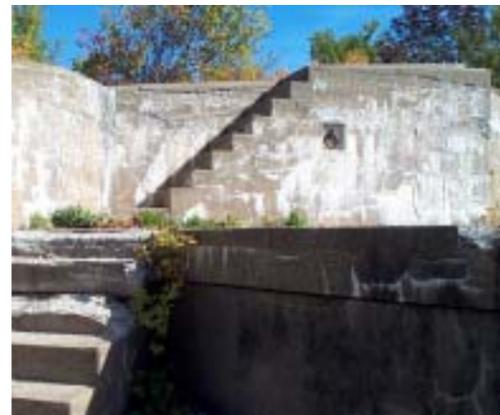
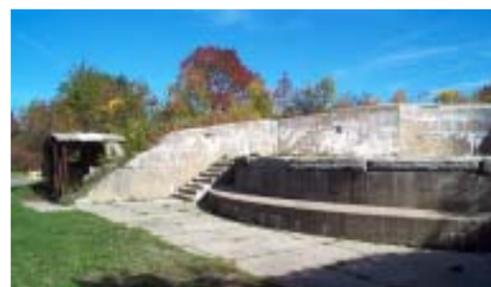
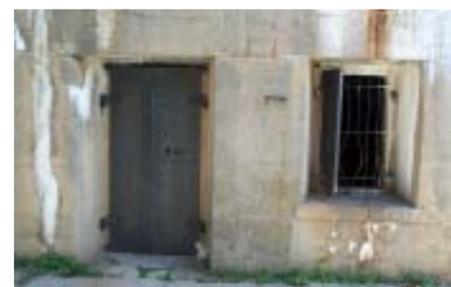
Battery Garesche is a large complex with both interior and exterior spaces.

Concrete structure in need of inspection and repair. Main roof is loaded with soil and plantings. Interior in fair condition but subject to vandalism.

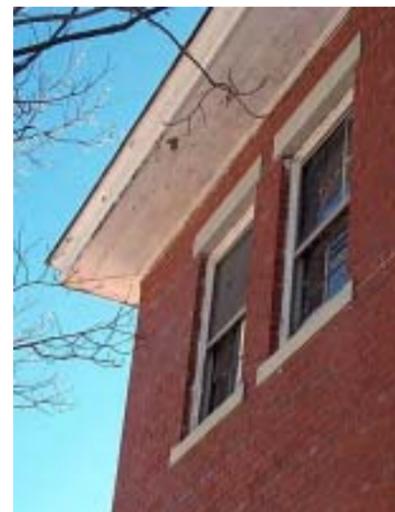
Upper story window in Artillery Engineer Storehouse.

Comments: Building appearance good. Requires window repair, repainting and structural inspection.

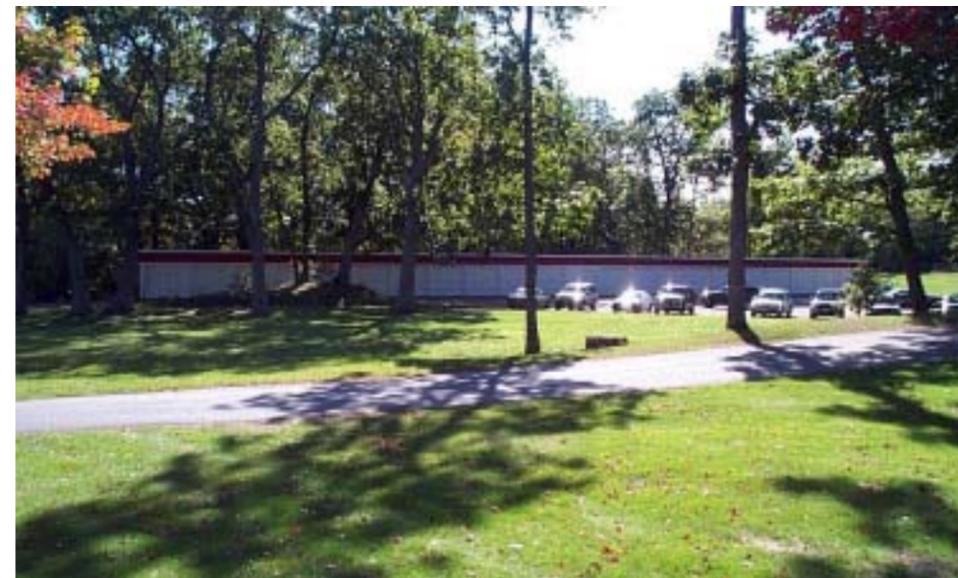
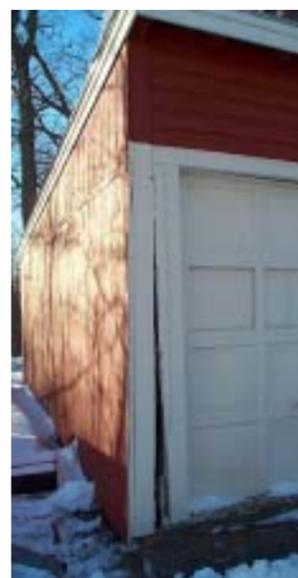
North elevation. Future proposed playground site in the foreground.

Northeast corner of garage building.

Comments: Good to fair condition. East end has damaged and splayed wall.

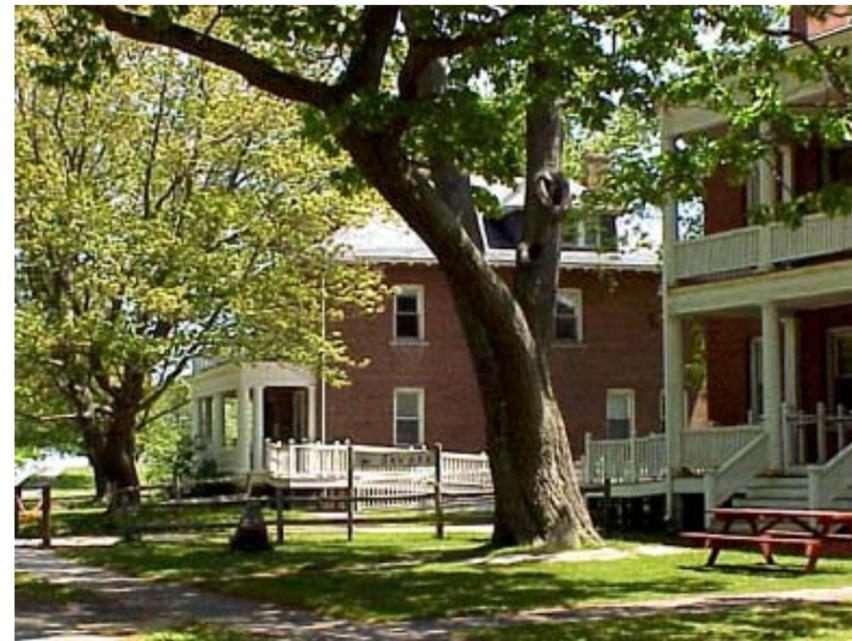
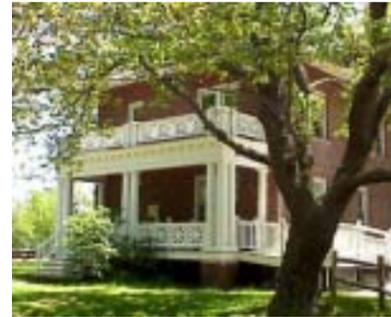
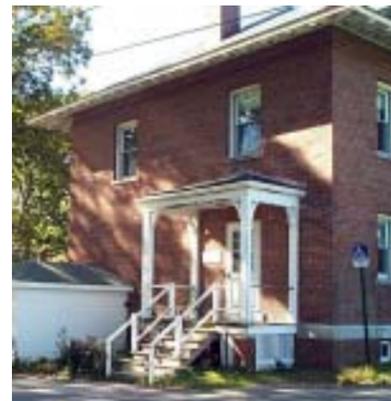
Name: **Field Officers' Quarters Building**
 Master Plan Key / 13
 Area: 8 / Officers' Row
 Date of construction: 1911

Looking southeast from Harrison Road. (above)

View / East entrance and elevation. (right)

Comments:
 Ongoing maintenance required. Reconstruct rear porch and steps. Repair and paint porches, steps, rails, and lattice.

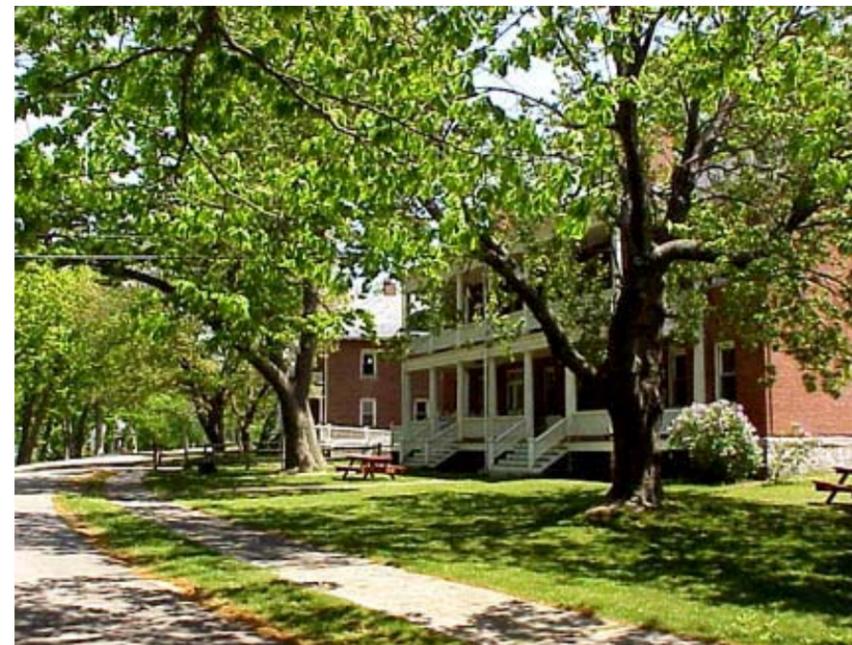
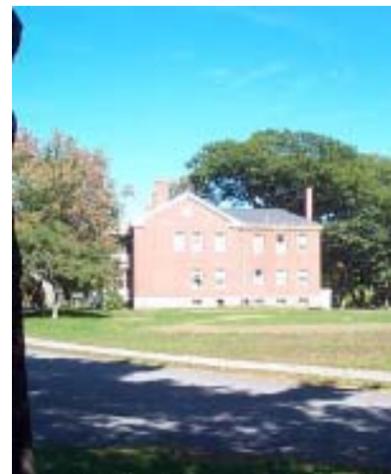
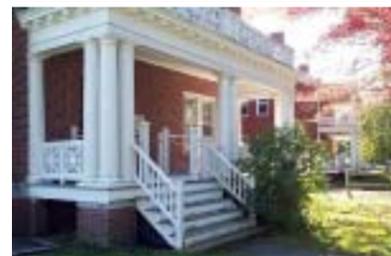
Name: **Bachelor Officers' Quarters Building**
 Master Plan Key / 14
 Area: 8 / Officers' Row
 Date of construction: 1909

North elevation view. (facing Harrison Road)

West elevation and porch detail. (right)

Comments:
 Ongoing maintenance required. Repair and paint porches, steps, rails, and lattice.

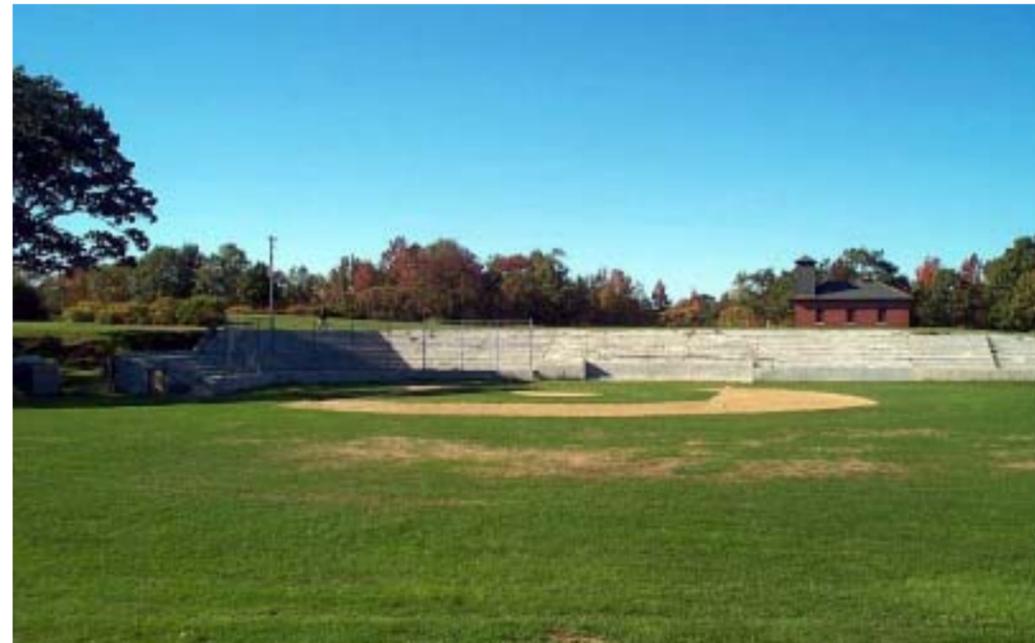
Concrete bleachers from southeast.

Comments:
 Surfaces refinished in 1990 but not withstanding normal wear and weathering. Explore long term repair or reconstruction.

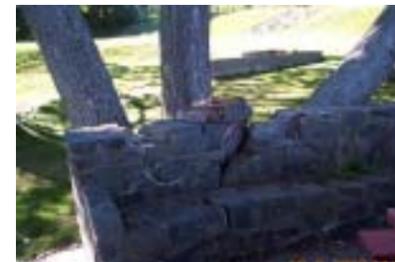
Detail stone wall and tree trunks.

Comments:
 Stone work damaged by tree growth. Repair walls to prevent further damage from trees and normal weathering.

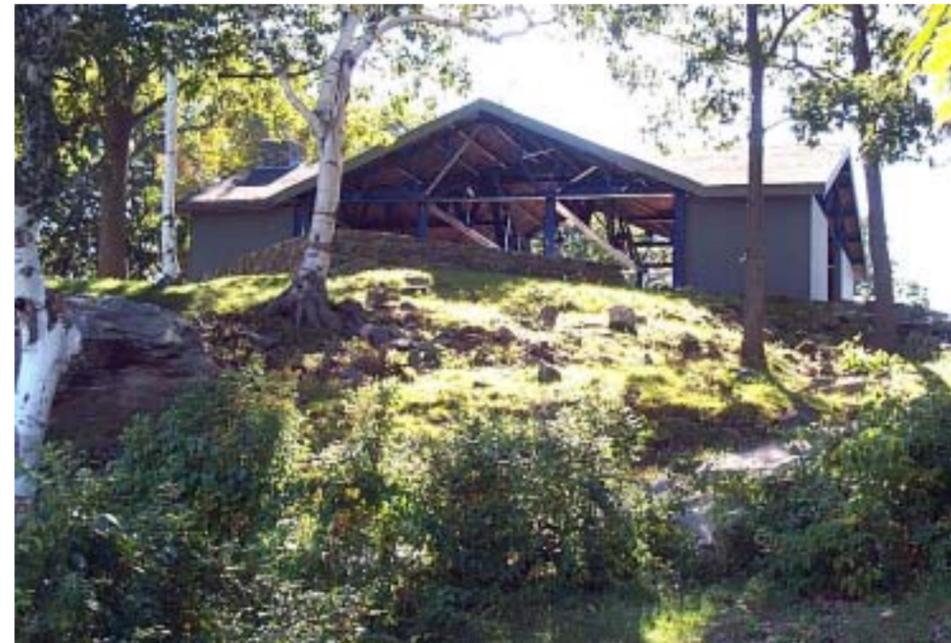
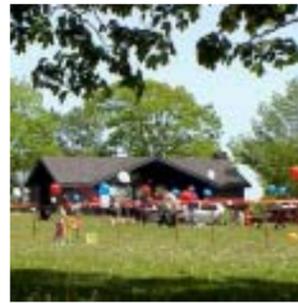
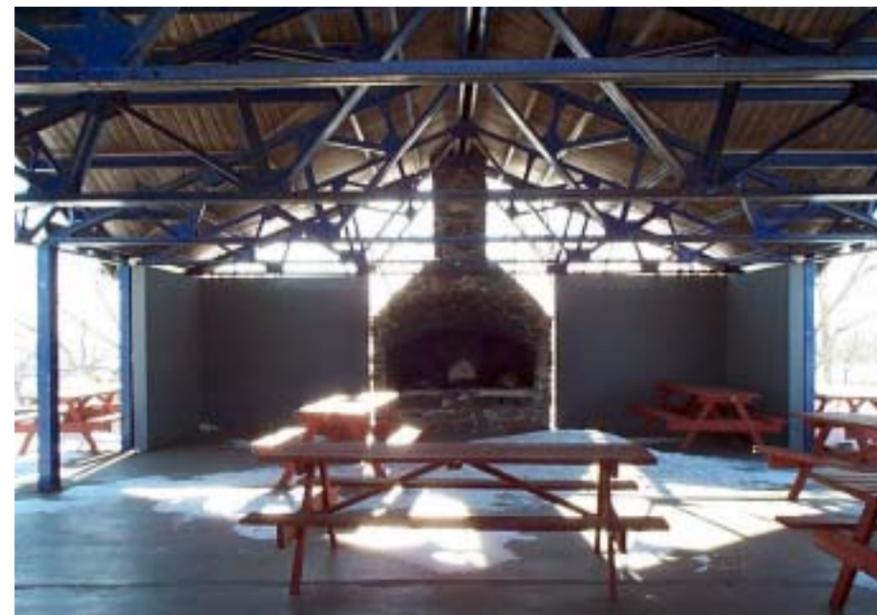
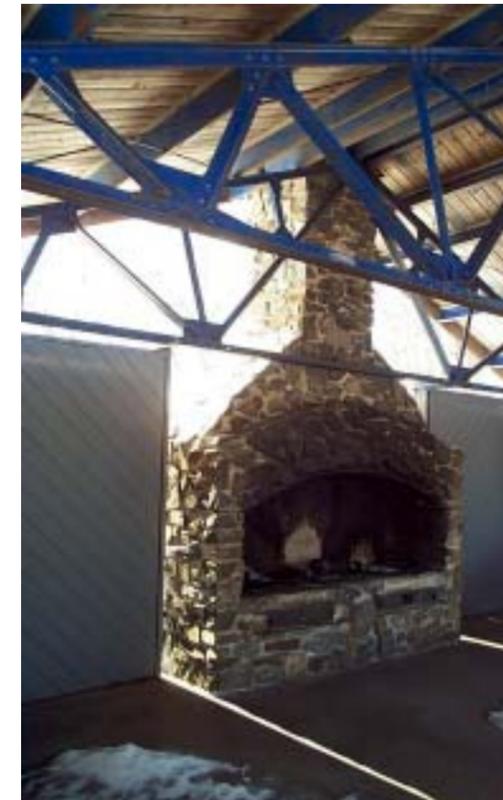
Name: **Picnic Shelter**
Master Plan Key / 18
Area: 8 / Officers' Row
Date of construction: 1985

Picnic Shelter from east - looking up from parking lot.

Comments:
Generally in good condition. Inspect chimney and stone work for scheduled maintenance and cleaning. Access and slope stabilization improvements ongoing. Painted in 1995 and in good condition.

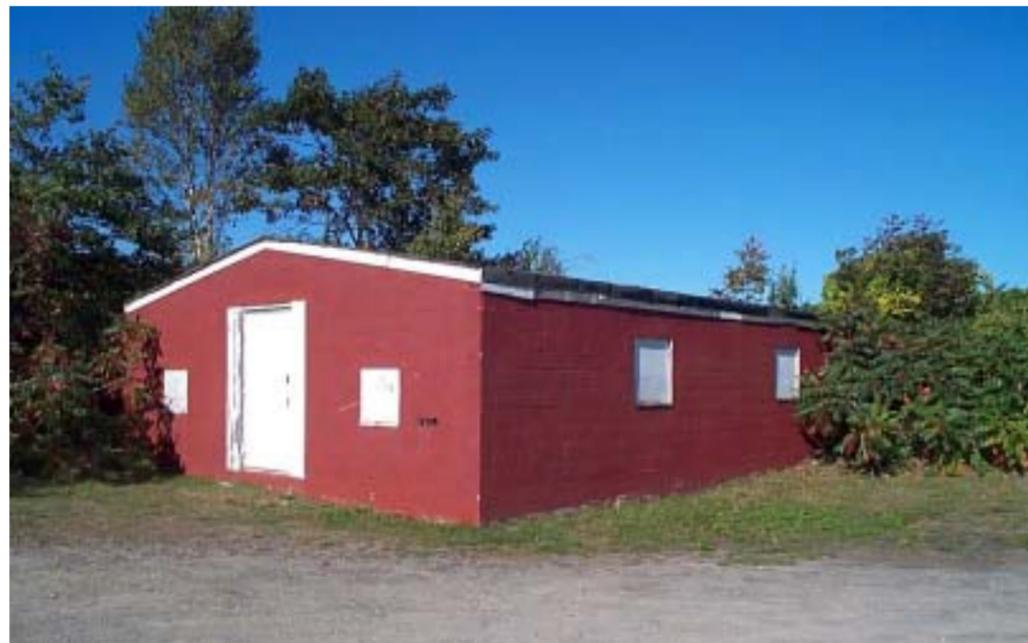
Concrete Block Storage Building from South.

Fair to poor condition. This structure included in 1995 study as possible conversion into a rest facility.

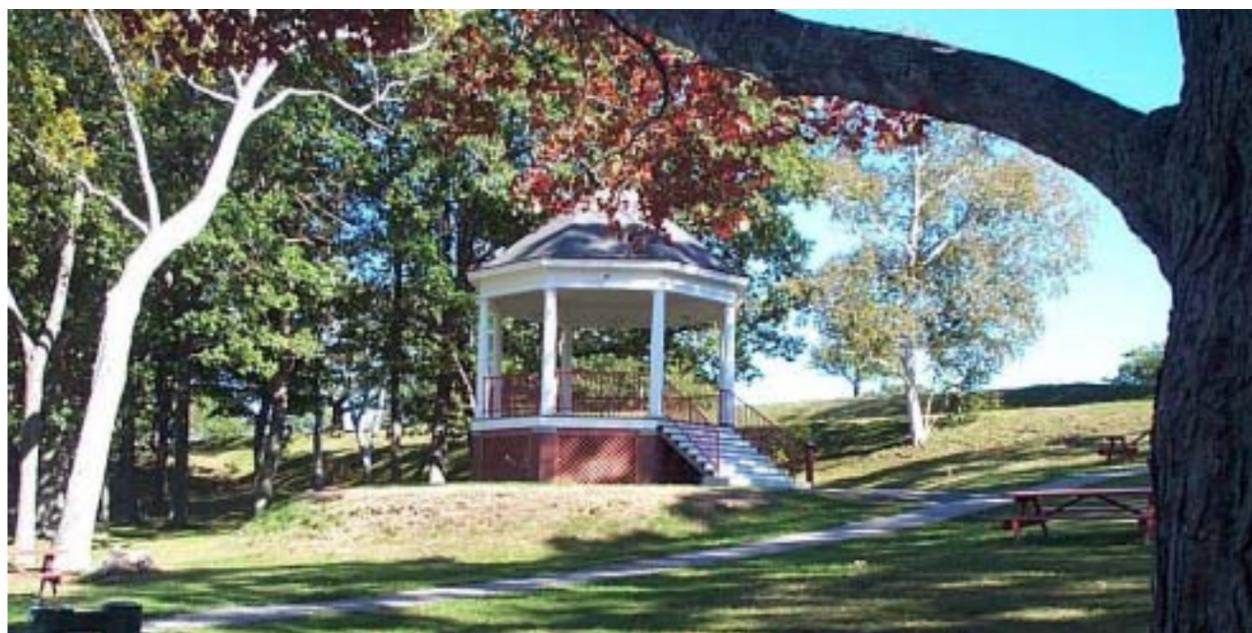
Bandstand from Northwest looking through the Officers' Row Preserve towards Harrison Road.

Good condition. Underwent structural and cosmetic renovation in 1999. Provide ongoing maintenance and painting.

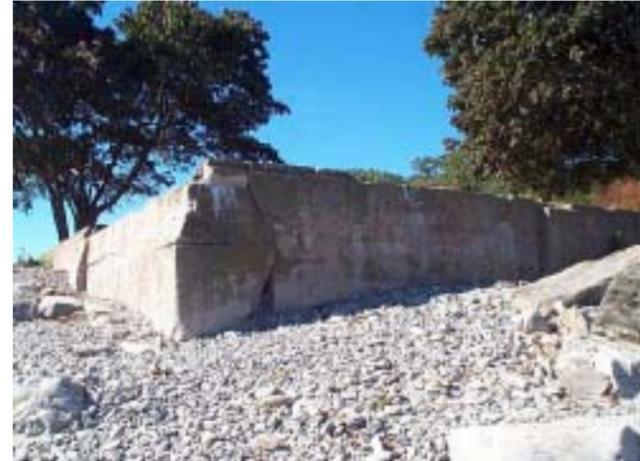
1.2

Location **Ship Cove Beach**
Key Reference Number

Poor condition. This old foundation wall will provide the base for possible future picnic site above. Confirm regulatory constraints regarding repair/ reuse.

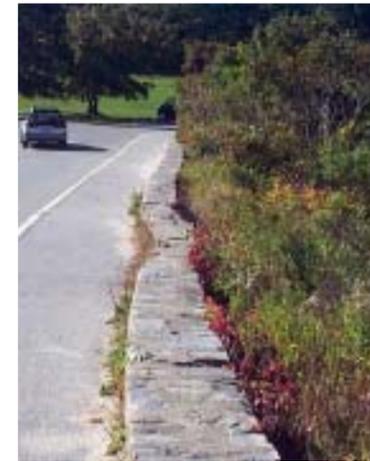
1.3

Location **Ship Cove/ Ocean Road**
Key Reference Number

Fair to poor condition. This stone retaining wall requires structural inspection. Loose and missing stones should be replaced to prevent further damage from weathering.

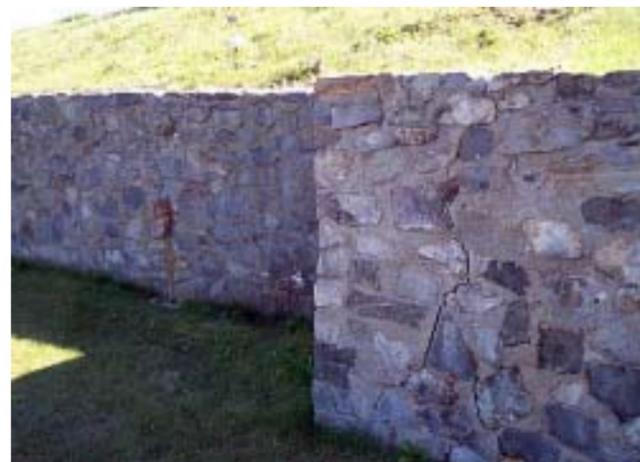
1.5

Location **Below Wheatly Road**
Key Reference Number

Good to Fair. Some repairs undertaken. Repoint with matching mortar color. Stair repair within this section of stone wall.

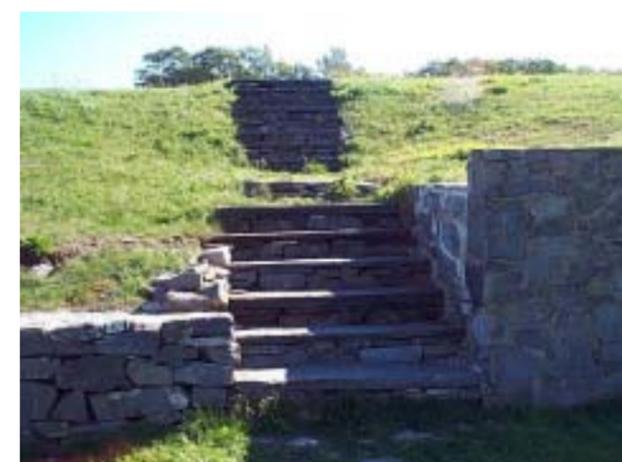
1.5

Location **Below Wheatly Road**
Key Reference Number

Fair to poor condition. Steps have been repaired. Require further repair and matching stones w/ appropriate sizes.

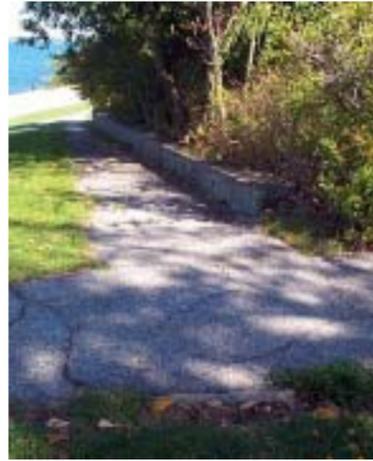
1.5

Location **Above Powers Road**
Key Reference Numbers

Condition Description
Fair to poor missing stones. Wall also hidden in brush beyond to south.

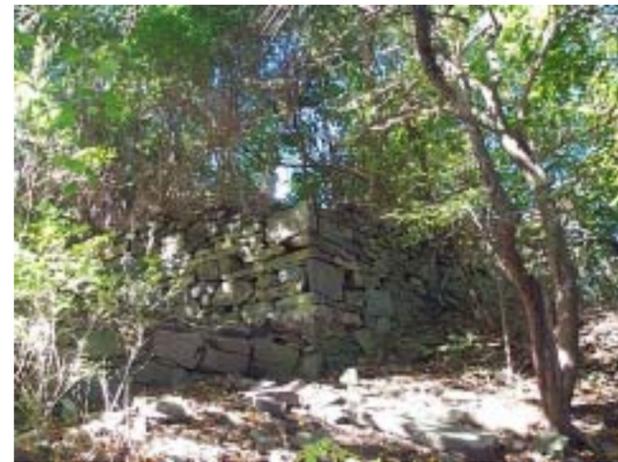
2.3

Location **Goddard Mansion**
Key Reference Number

Condition Description
Old Garden terrace retaining walls in very poor condition. Reconstruct/ repair for partial garden restoration.

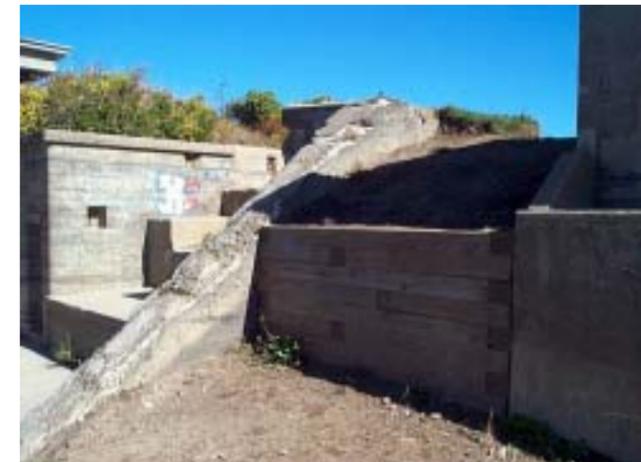
2.4

Location **Battery Keys**
Key Reference Number

Condition Description
Retaining wall repair using pressure treated lumber rather than stone or masonry. Endeavor to use materials consistent with environment and original construction.

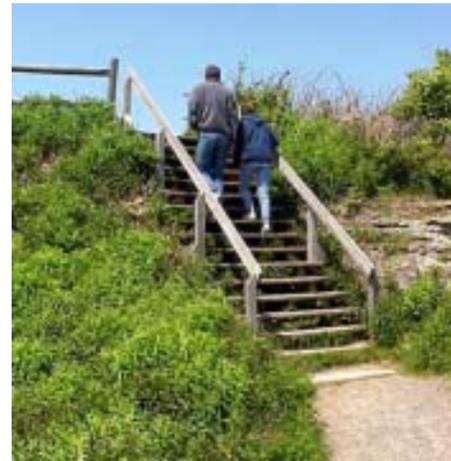
3.2

Wooden steps and handrail. Provide ongoing maintenance. Although a possible budget extravagance, consider stone steps and landscape similar to approach to Battery Blair from below. Key transition point from hill top to Cliff Walk and Head Light

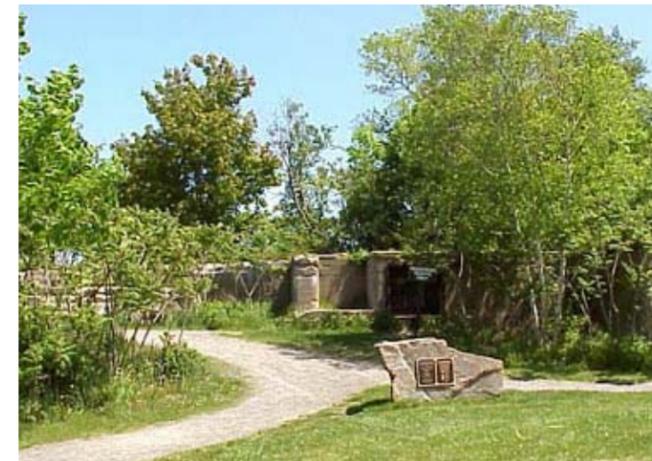
4.1

Continue repair of concrete wall and steps at Battery Hobart.

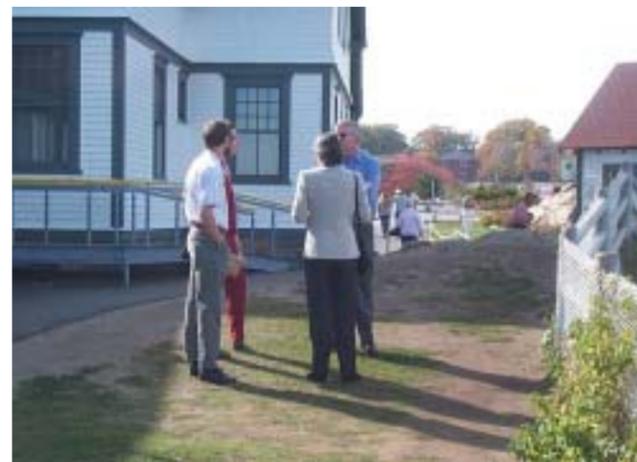
5.1

Preliminary design has been completed by LUC. Awaiting budgeting for final design.

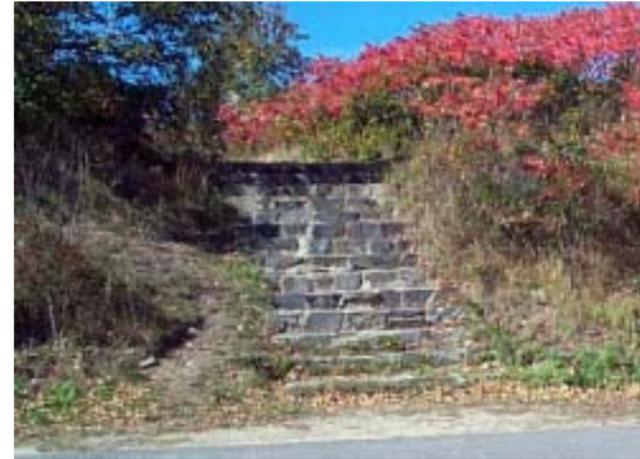
6.2

Condition Description
Old stone steps built into slope. Risers irregular. Repair as required. A key link from "The Green" to MP Field and Battery Blair/ Central Parking.

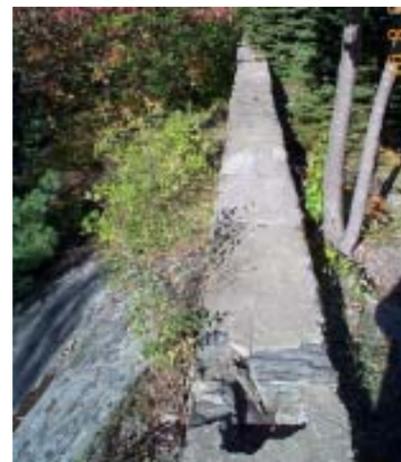
7.2

Condition Description
Inspect for loose and missing stones. Provide timely repair. (See 7.1)

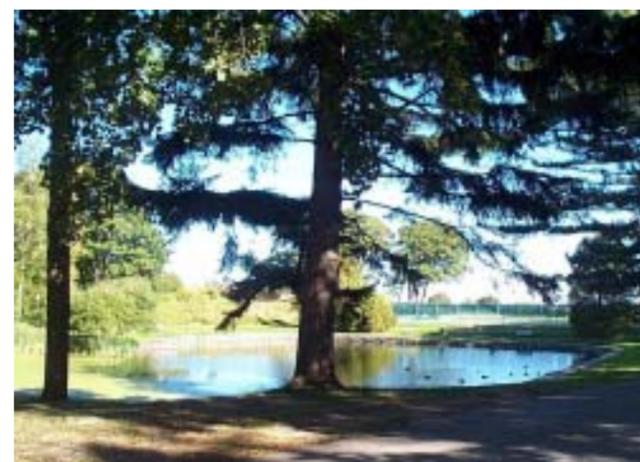
7.3

Condition Description
Lower wall has been reconstructed in 1998. Upper wall is scheduled for reconstruction. The adjacent tennis courts (in photo beyond the pond) were repaved in 1998.

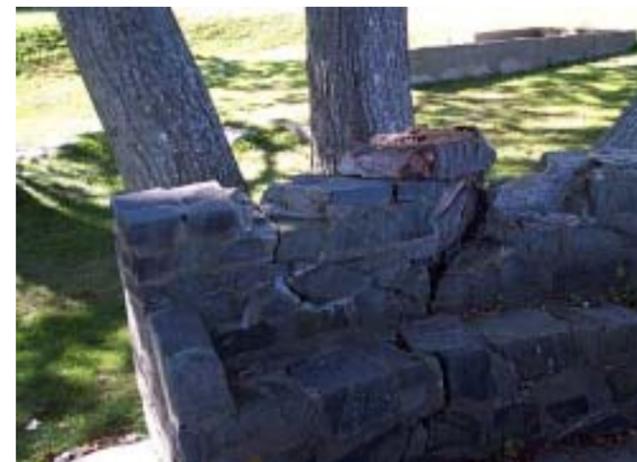
7.4

Condition Description
Circular stone gazebo remnant (picnic area). Fair condition. Stones being dislodged by trees. Repair and prune trees.

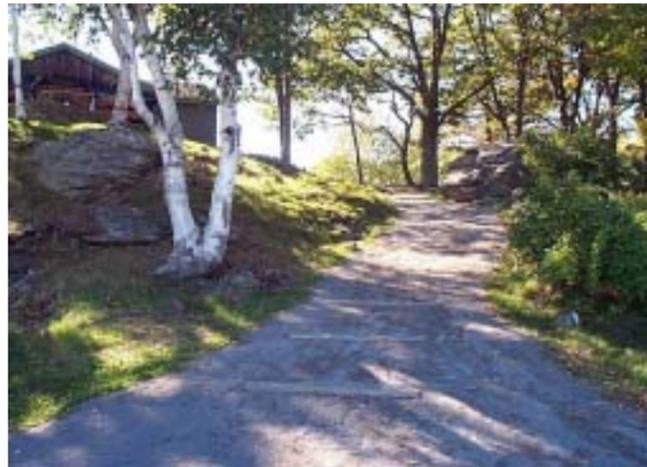
8.1

Ongoing construction at ramped steps including new drainage and slope stabilization work. Provided edge containment and additional landscaping.

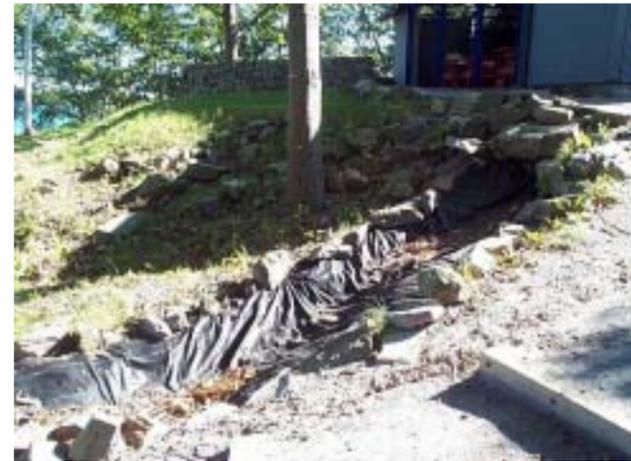
8.1

Ramped steps, new drainage and slope stabilization work. Note patio wall in background.

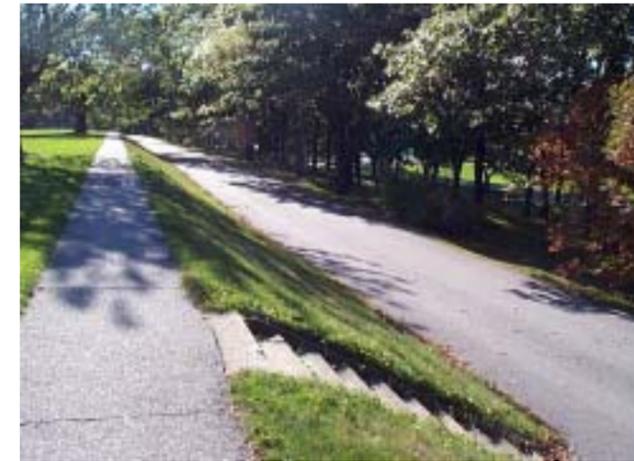
8.2

Old concrete steps once provided access to sidewalk leading to buildings on Officers' Row. Condition varies. Concrete sidewalk overlaid with asphalt. Heaving at joints.

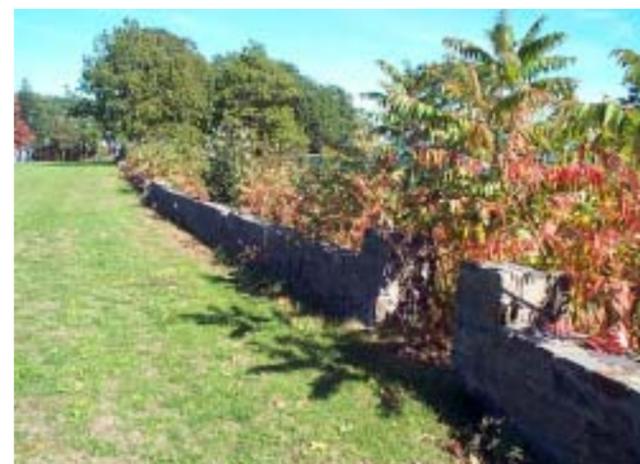
8.4

This wall extends from Picnic Shelter driveway along old Barrette Road. Fair condition but leaning.

See item "8.3". Note breaks in wall accented with pilasters.

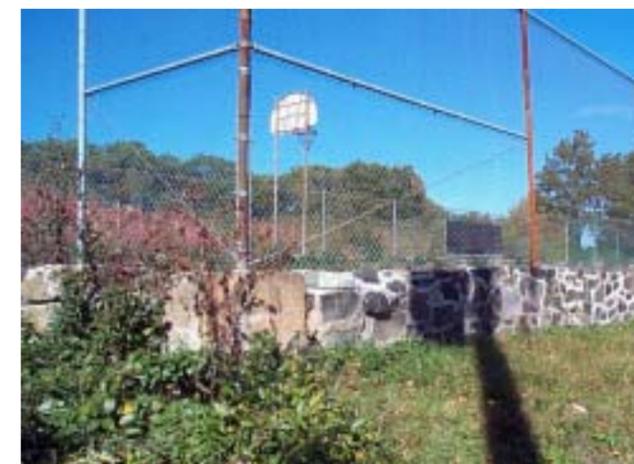
8.5

Low stone retaining wall supports portions of basketball court that also includes a tennis court. Wall in fair condition.

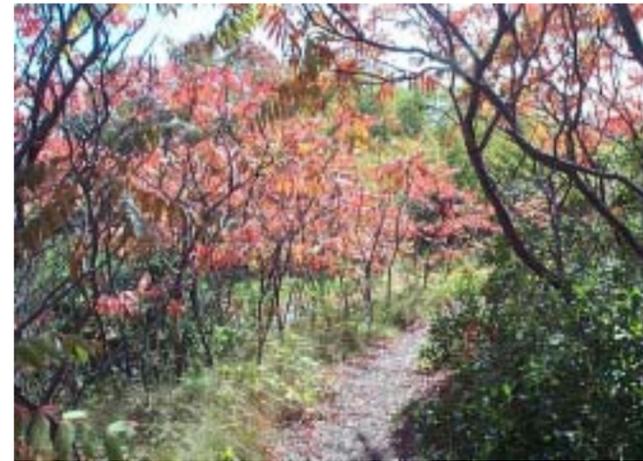
Location **Battery Blair-south**
Key Reference Number **9.2**

Condition Description
"Sumac walk" link from Battery Blair to Battery Garesche. Hidden surprise. Repair walk and selectively prune to preserve enclosure.

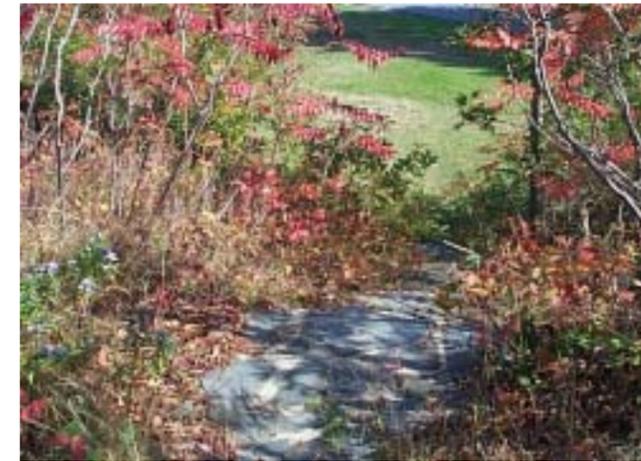
Location **Merriman Road to Battery Blair**
Key Reference Number **9.3**

Condition Description
Narrow stone steps. Repair loose stones.

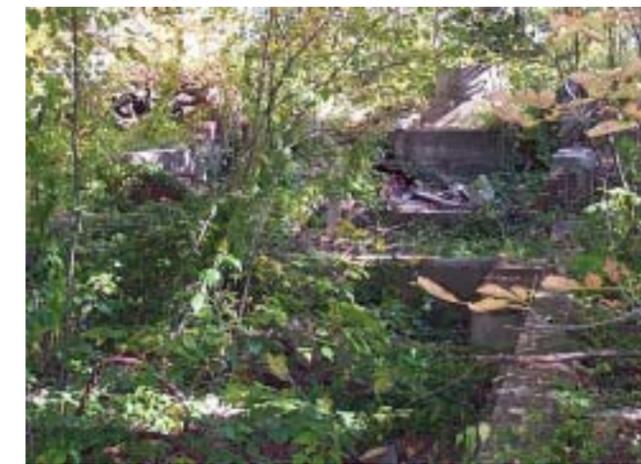
Location **Southwest Preserve**
Key Reference Number **102**

Condition Description
"Disappearing Search Light" remnant foundation. Clear brush and repair remaining concrete and stone for historic reference.

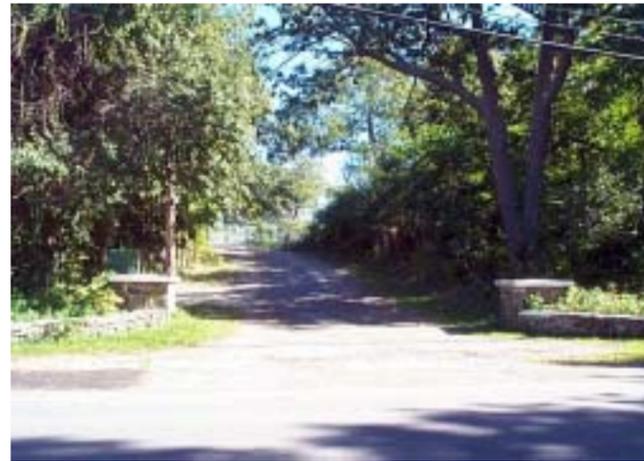
SR1

Condition Description
Wall in fair condition. Recent repairs completed in 2002. Repointing and wall capping treatment should be compatible with existing wall construction. This entry is for pedestrian, service and emergency access only.

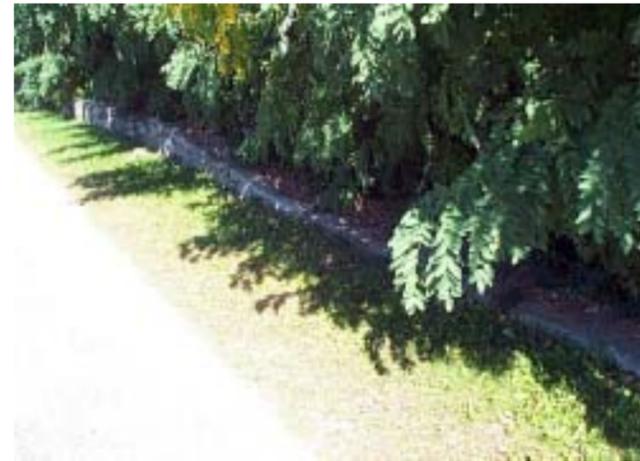
SR2

Condition Description
Wall in fair condition. Varies in height and eventually disappears into grade.

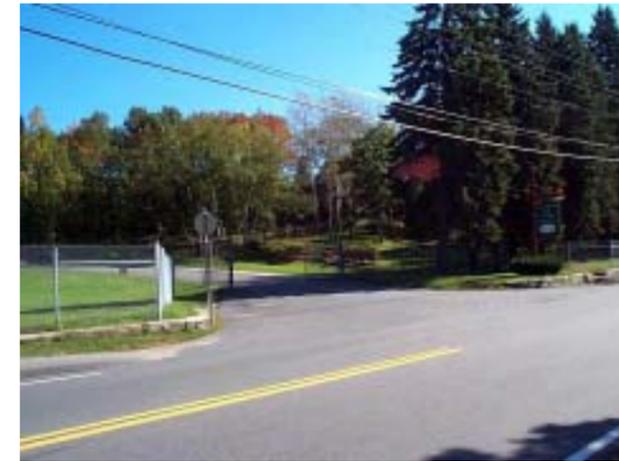
SR3

Condition Description
Low flanking walls each side of Powers Road. Fair condition. Replace missing stones and repoint with matching mortar.
