Fort Williams Park

Town of Cape Elizabeth
Shore Road
Cape Elizabeth, Maine 04107

USERS' GUIDE

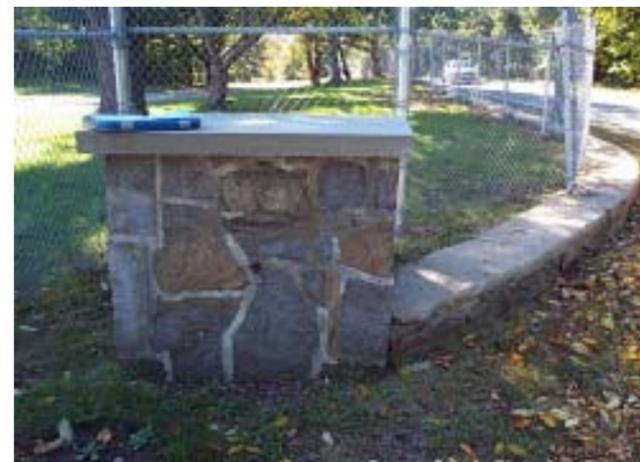
SR5

Condition Description
Pillars in good condition. Wall in fair condition. Use matching mortar and consistent wall capping typical.

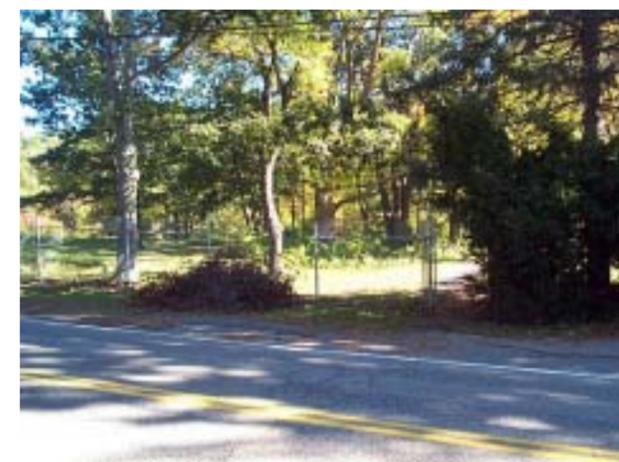
SR6

Condition Description
Service and emergency access only. Wall ends 100 ft. north of gate. Wall at top of hill in poor condition.

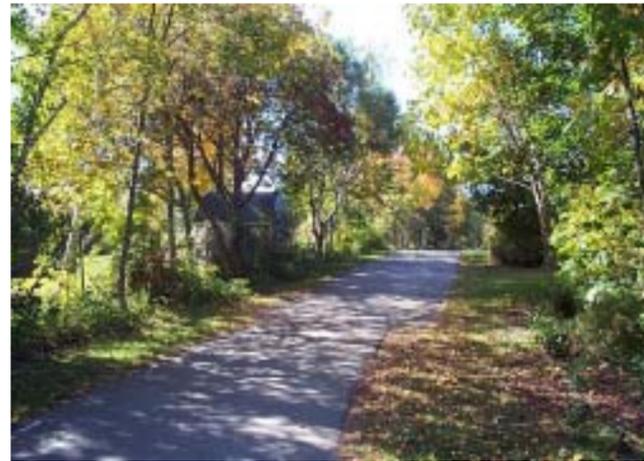
B

Existing narrow buffer along Merriman Road. Infill with evergreen, naturalized plantings. Coordinate with abutters to assess view preservation and buffer impact.

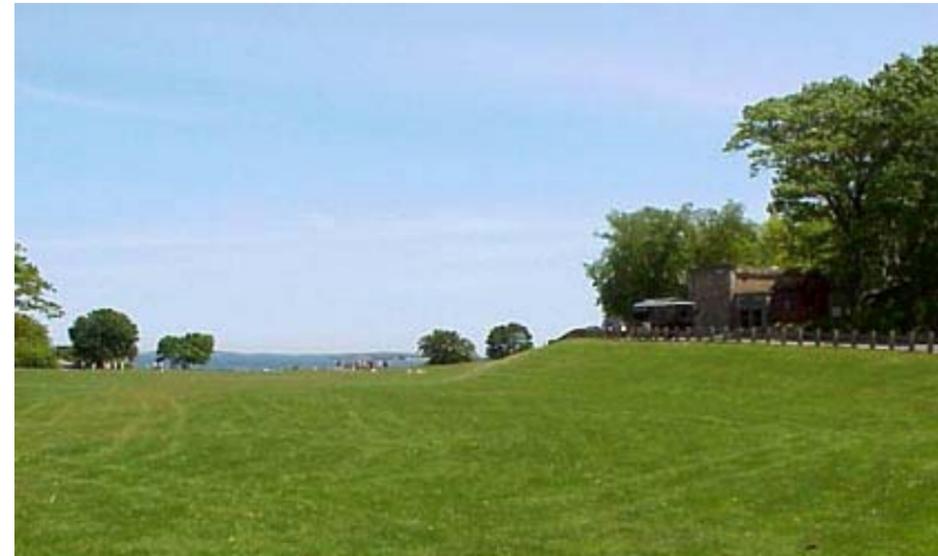
View of The Meadow from immediately inside the Park's entry gate on Shore Road.

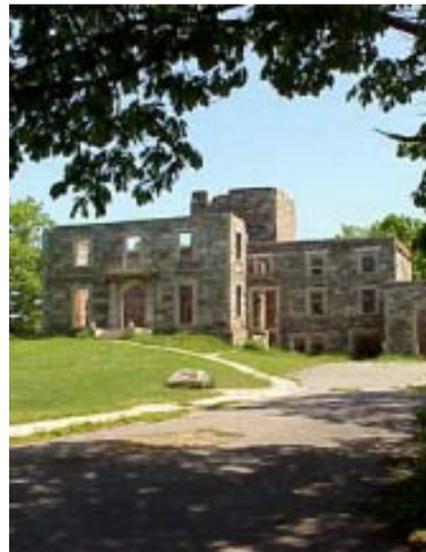
View of Goddard Mansion from the eastern end of Chapel Road. (Note the large lawn area in the foreground.)

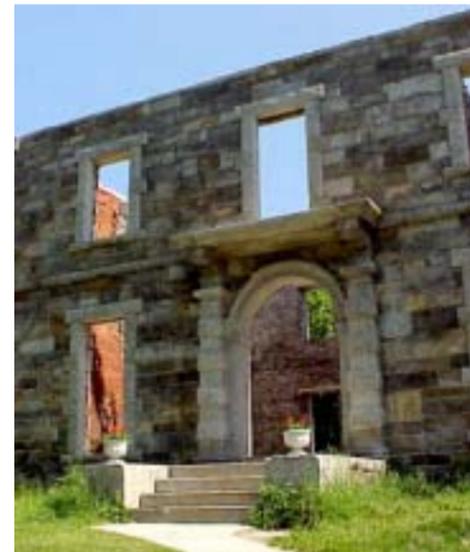
View of front entry to Goddard Mansion.

- Goddard Mansion is in stable, though deteriorated, condition. Areas within the structure/shell represent safety hazards.
- Pedestrian access to Goddard Mansion is in poor condition and represents a limitation to safe pedestrian circulation.
- Severe grade changes and uneven surface conditions restrict accessibility to the Mansion for disabled visitors.
- Goddard Mansion garden to east of Mansion is overgrown limiting access and obscuring desired scenic views to Casco Bay.
- Steep and unstable slopes along Keyes Road limits access to garden area.
- Social paths over steeply sloping grades damage vegetation and promote soil erosion.

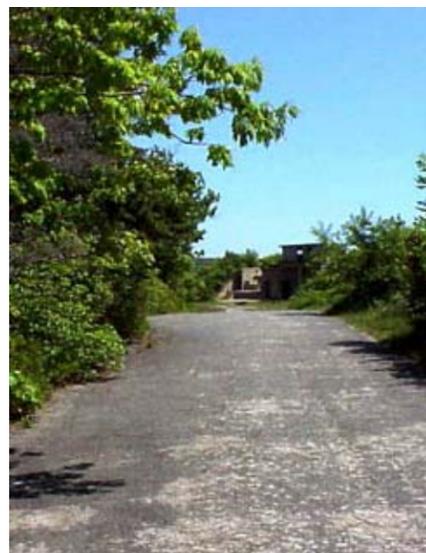
View down Keyes Road looking east. (Note the overgrown vegetation on both sides of the road.)

- Keyes Road is in fair condition and needs maintenance.
- Battery Keyes is deteriorating. Sections of concrete are spalling and exposed reinforcing bars are becoming weaker and pose a public hazard. The structure is the target of vandalism and graffiti. Its isolated location makes it an attractive location for unsupervised activities.

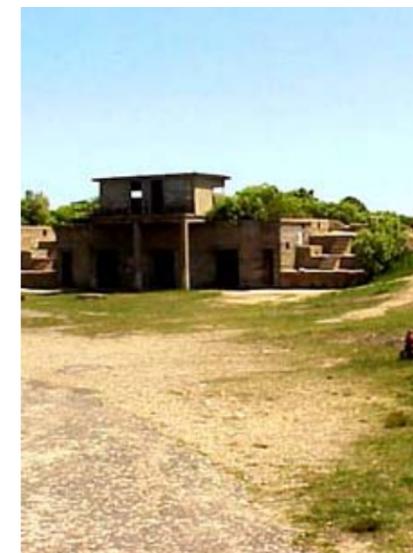
Battery Keyes as viewed from the eastern end of Keyes Road.

- Pedestrian access to Battery Keyes is limited and restricted by uneven terrain, eroding slopes and steep grades.
- Large amounts of litter and broken glass are found throughout the Battery.

- Social paths around the upper areas of the Battery have compacted the ground and have damaged vegetation. Exposed soils are vulnerable to erosion.
- The absence of fences along the seaward side of the Battery allows unrestricted access to steep and potentially dangerous grades.

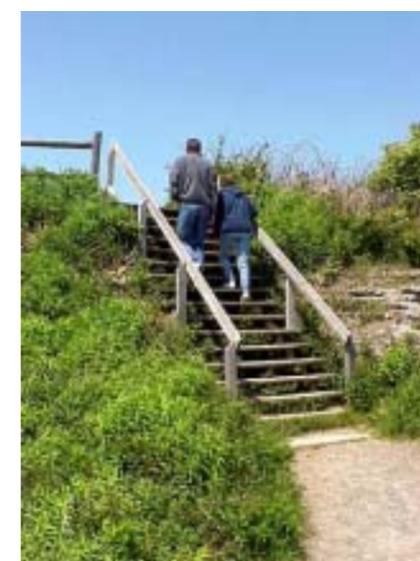
Wooden steps at the southeastern edge of Battery Knoll provides the primary means of access between the knoll and the southern end of the Cliff Walk and Portland Head Light.

- Battery Hobart is becoming obscured by undergrowth. The concrete work of the Battery is deteriorating. Careful pruning will expand view of the Battery and concrete repair will enhance its historic significance as well as provide a focal point at the north entrance to the Cliff Walk.
- The wooden display case and map of Casco Bay by the flagpole is extremely weathered and is in need of repair or, possibly, replacement.
- Vegetation along the seaward side of Battery Knoll is overgrown and threatens to hide desired scenic views to the bay, the islands and the sea beyond.
- Existing wooden stairs at the south end of Battery Knoll to the Portland Head Light are in need of repair or, possibly, replacement. Current design limits and restricts access.

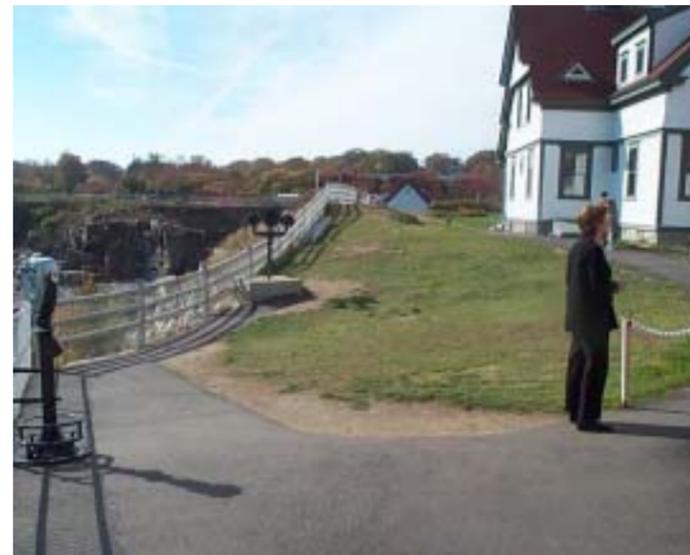
View of south side of Head Light. (Note erosion in lawns and at overlook areas due to heavy pedestrian use.)

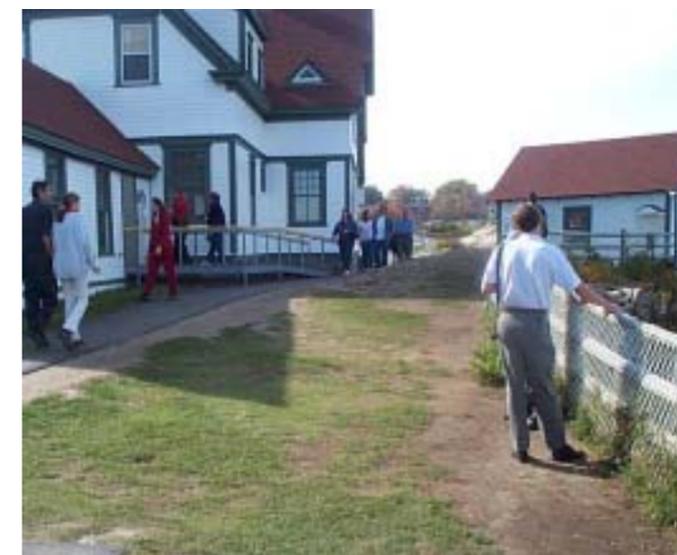
Overlook area on north side of Head Light. (Note extensive compaction and erosion of lawn areas due to heavy pedestrian use.)

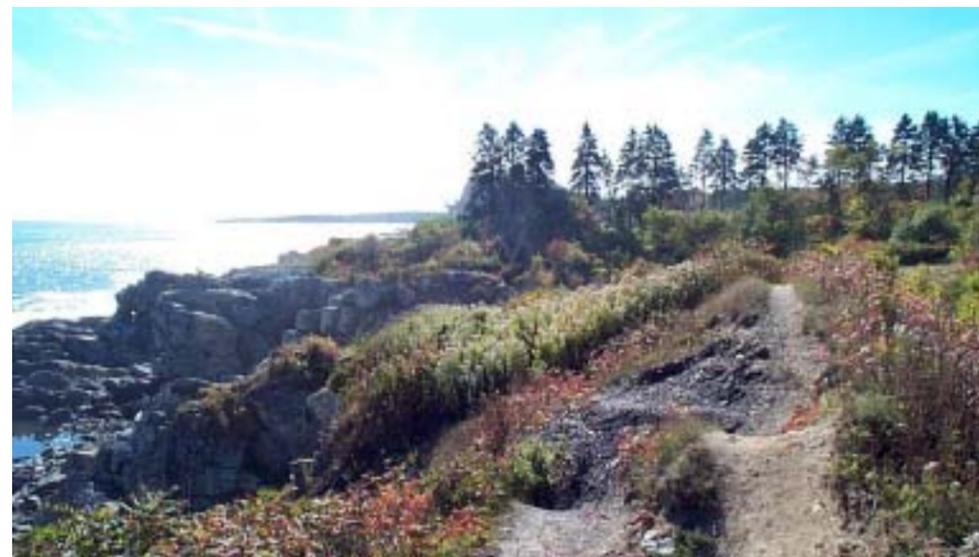
View of the shoreline from atop The Mounds. (Note eroded pathway demonstrating use of area for access to the Beach Area at the south eastern edge of Park.)

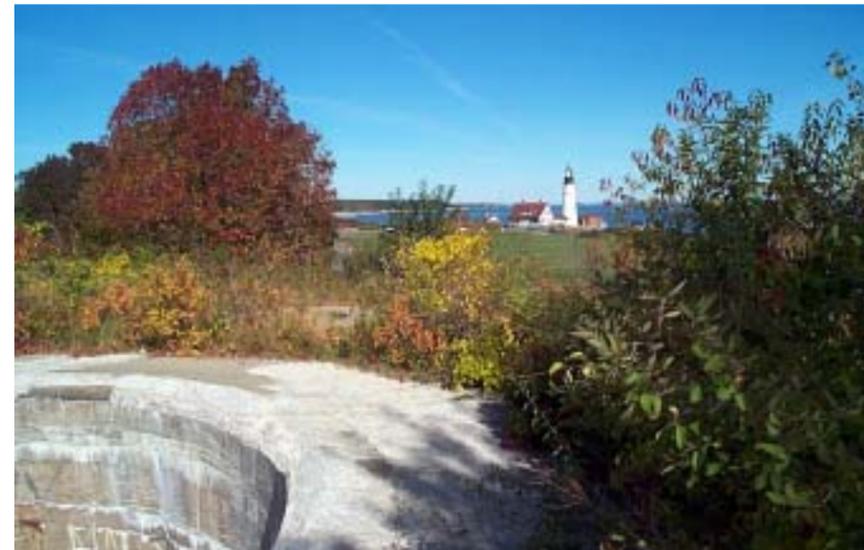
View from Battery Garesche to Portland Head Light. Note density of rooftop landscape and volunteer shrub growth.

- Overgrowth of vegetation on top of Battery Garesche and to the north has both exacerbating the condition of the deteriorating structure, and further lead to the sense of isolation for this unique military landmark located in the far southeast corner of the Park.

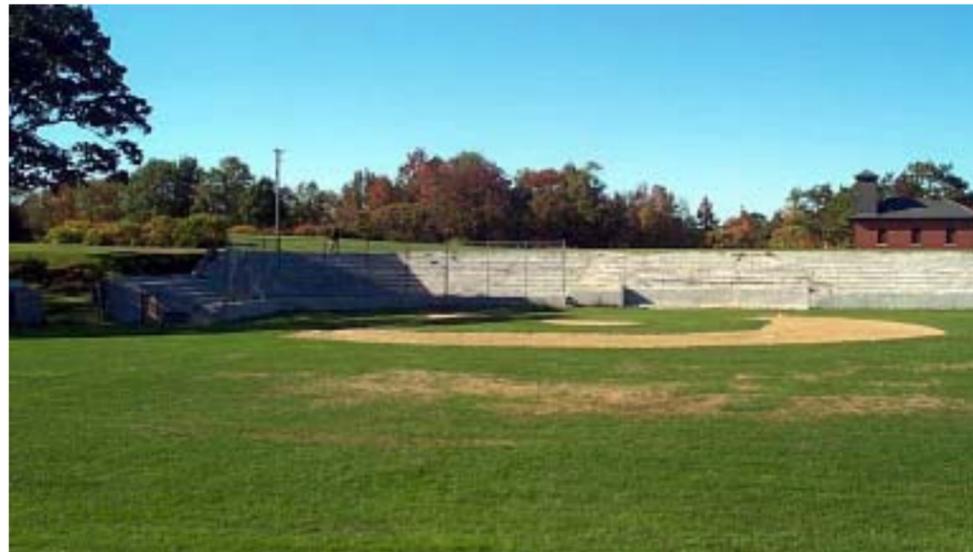
View of ball field located in the northwestern corner of the Parade Grounds with the concrete bleachers behind and the Fire Station beyond.

- Condition of existing concrete bleacher indicates the need for extensive maintenance or possible alternative treatments.
- The northerly hillside and areas adjacent to the Pond areas designated for “Formalized” or ornamental landscape.

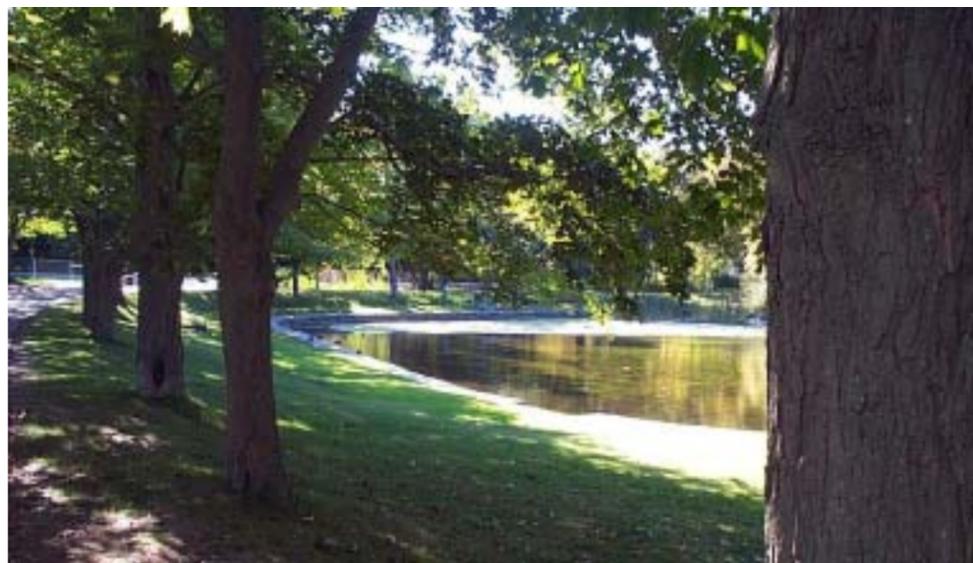
View of the Pond from Farnsworth Road. Most recent renovations to wall completed in 1998.

- The Pond water is susceptible to algae growth.
- Upper garden wall needs to be repaired.
- The condition of the existing bandstand is stable and good.
- The condition of the circular stone picnic enclosure is poor. Loose stones in the stonewalls and cracks in the walls and floors indicate the need for extensive repairs and maintenance.

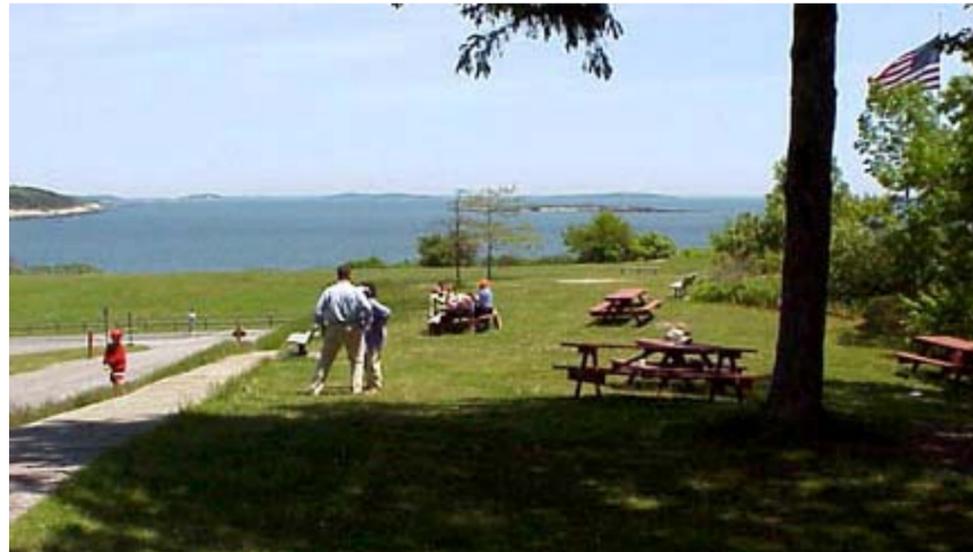
View of Kitty's Point from northeast corner of Officers' Row area.

- Condition of Kitty Point area and landmark is fair. The area's vegetation is overgrown and in need of maintenance.
- The pavement in the existing parking area below the Picnic Shelter is in need of repair and maintenance.

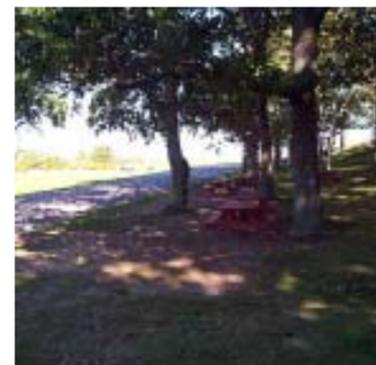
Evidence of erosion and possible root compaction within the Officers' Row Preserve

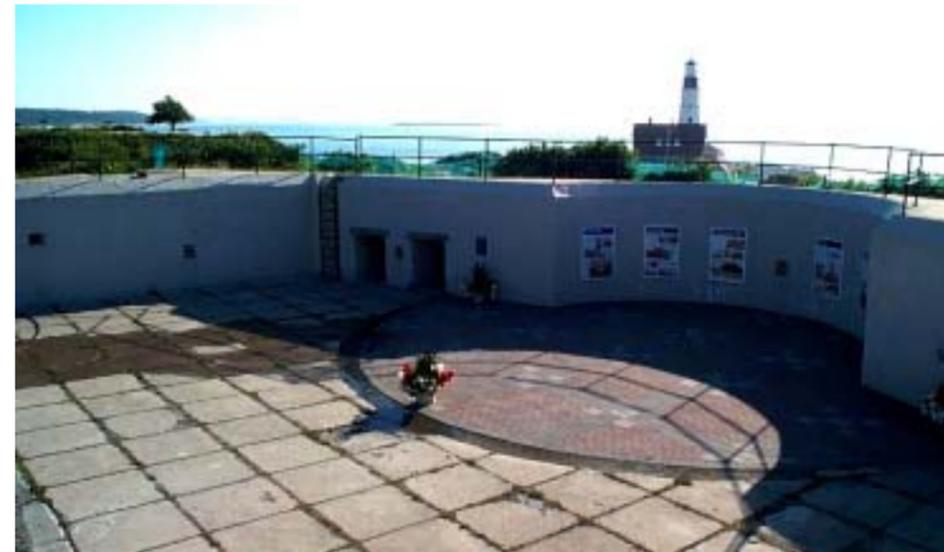
Overview of Battery Blair Memorial with the Portland Head Light in the background. (Note gridded areas of original concrete pavement surrounding more recently installed decorative concrete pavers provided by naming donors.)

- Areas of concrete continue to spall from the walls around Battery Blair.
- The pavement within Battery Blair Memorial collects and retains storm water and run off when it rains or snows. This situation creates a public hazard.

- Portions of the pavement (concrete squares) within Battery Blair are uneven and promote the growth of weeds. This situation presents a safety hazard and maintenance costs and needs to be addressed.

- Correcting the drainage of the paved area within Battery Blair.
- Treatment of the concrete squares at the outer portions of Battery Blair Memorial to improve safe pedestrian movement and reduced maintenance.
- Installing additional trees in the Central Parking Area. Design plans for this area have been prepared previously and should be consulted. Poor soil conditions in the area prevented original tree plantings from thriving.
- Definition and resurfacing of the parking areas in the vicinity of the public maintenance buildings.

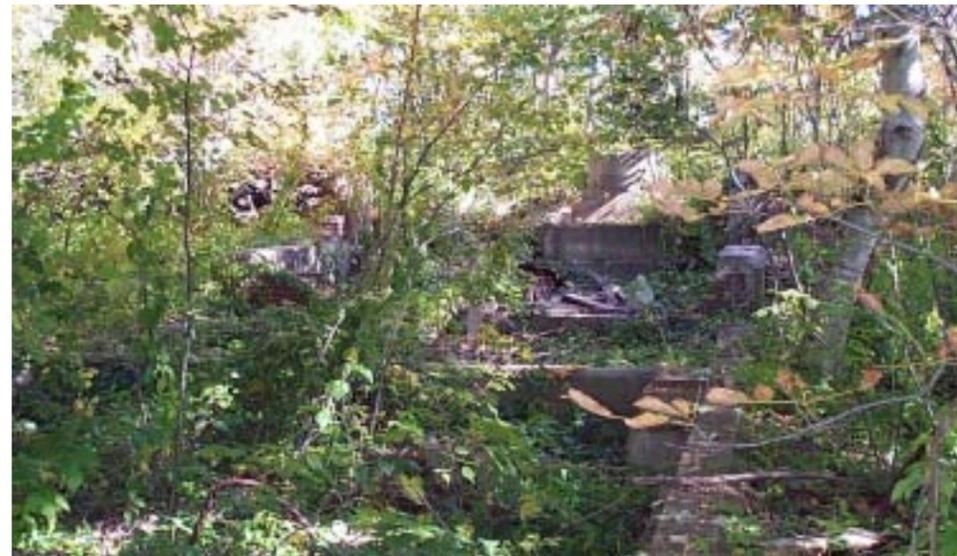
Overgrown vegetation hiding remains of concrete foundations of the "Disappearing Search Light" reported to have been located in the central area of the current Preserve.

- The condition of the existing vegetation in the Southwest Preserve is overgrown and its maintenance needs should be assessed.
- Existing vegetation provides a valuable buffer between the Park and the adjacent private residences. This vegetation should be protected and maintained.
- The general location and condition of the “Disappearing Search Light” is overgrown and poorly documented.
- Pedestrian access into and through the Southwest Preserve is restricted by overgrown conditions and uneven terrain.
- The Southwest Preserve lies within a subarea of the Fort Williams Park zoning district called “Southern Section of Fort Williams Park.” Permitted uses are severely restricted within the Southern Section boundary. Playgrounds are not a permitted use.
