**Town of Cape Elizabeth**  
Seven Building Facility Study  
*Cape Elizabeth, Maine*

**Introduction****Town of Cape Elizabeth Facilities Study**

*Facility Study Process*

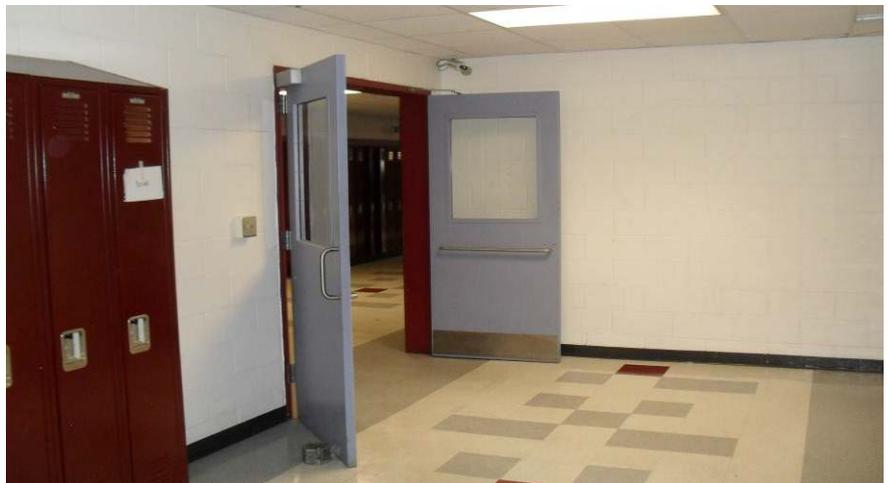
*Cross Corridor Doors*

On the second and third floor corridors at the midpoint of the floor there is a set of cross corridor doors that swing in one direction. As they are constructed they constitute a dead corridor from one direction and violate the Life Safety Code for egress in a northerly direction. Recommend removal of the doors and leave frame to eliminate code violation.

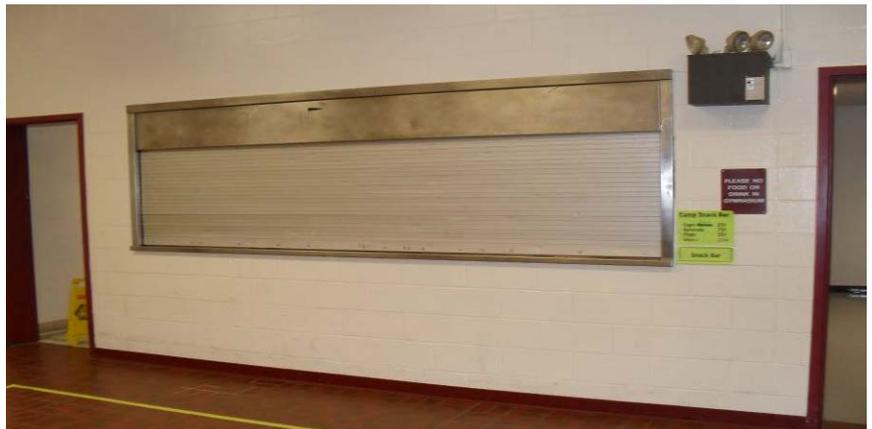
*Concession Serving Window*

Concessions serving window is not ADA compliant, existing is too high. Maximum height to counter line should be 34". Recommend lowering existing unit in place or install a new unit at a lower height.

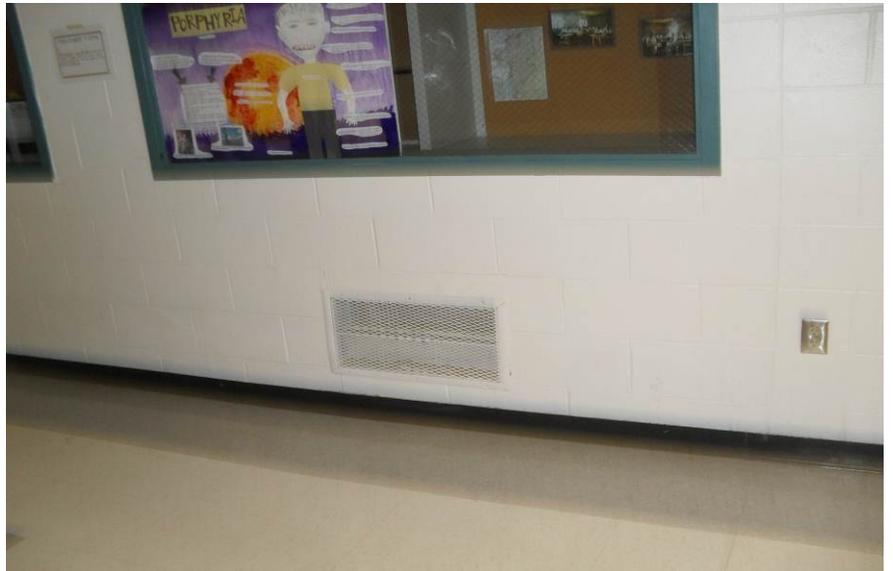
*Wall Transfer Grille*

Transfer grilles through walls and doors. Transfer of make-up air for exhaust through this type of grille installation is no longer allowed by Life Safety Code from a means of egress corridor. The through wall grille has a fire damper with a fusible link on it. We would recommend the installation of a smoke damper tied to the fire alarm system as a correction method. The grille in the door would have to be blocked up and a new transfer installed overhead with a smoke damper.

The Life Safety Code puts a lot of emphasis on protecting the exit access corridors from smoke penetration.

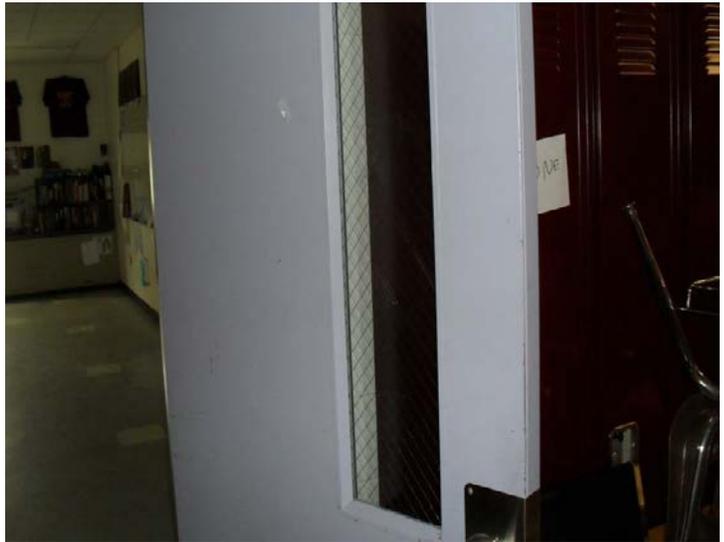
*Doors – Glazed Panels  
of Wire Glass*

Most of the existing glazed panels in the doors have a polished wire glass panel. This type of wire glass in doors and or borrowed lite panels is not allowed per current IBC Building Code. At the time of replacement, new glazing should be laminated glass tempered as required by current code.

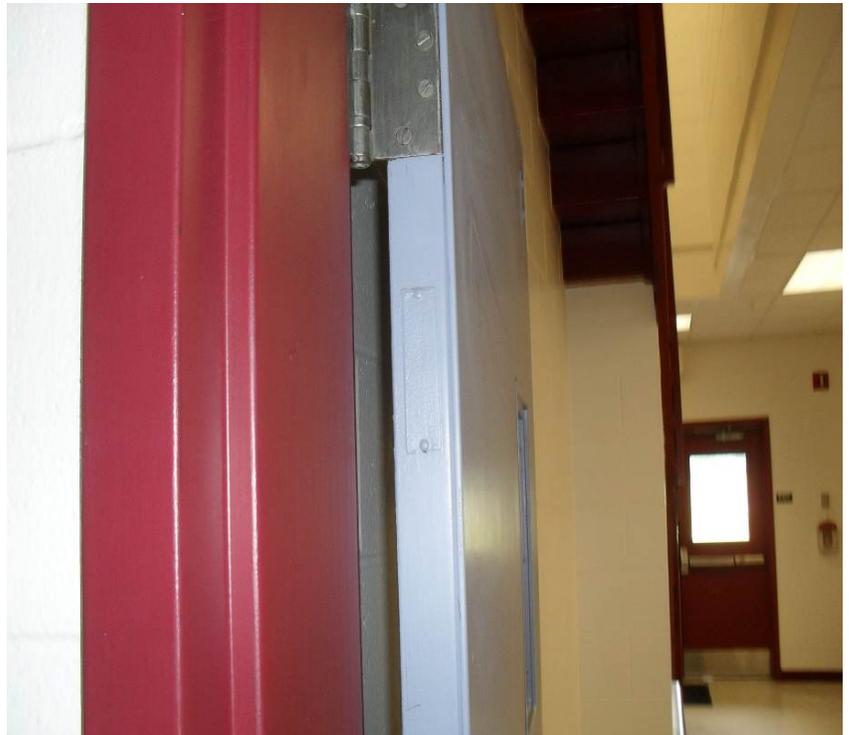
*Doors – Painted Fire  
Rating Label*

Most of the rated door assemblies on stairwells and other locations had the Rated Fire Label painted over. IBC Building Code and fire departments require that these labels not be painted over for inspection purposes.

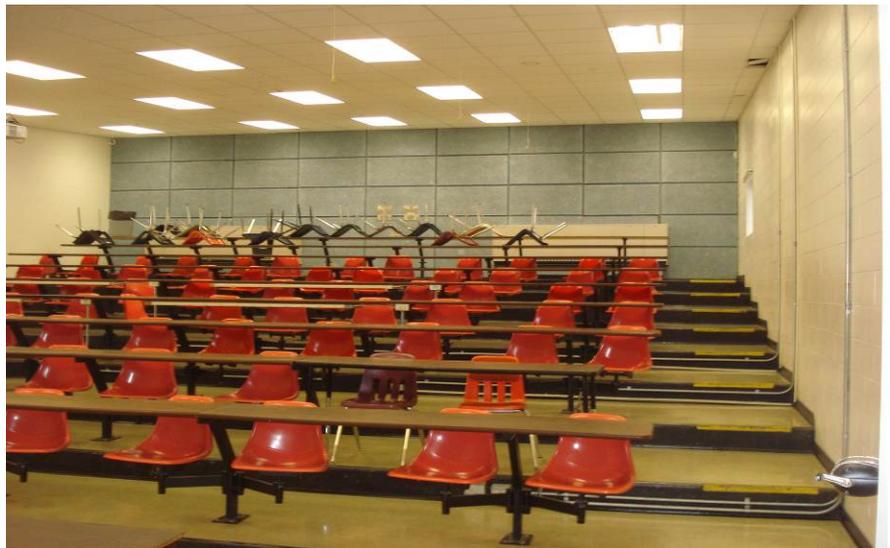
*Lecture Room – Raised Seating Area*

Third floor lecture room is not in compliance with ADA for wheelchair accessibility to raised seating areas. Recommend modification of low stepped seating area with ramp and platform accessibility by a wheelchair.

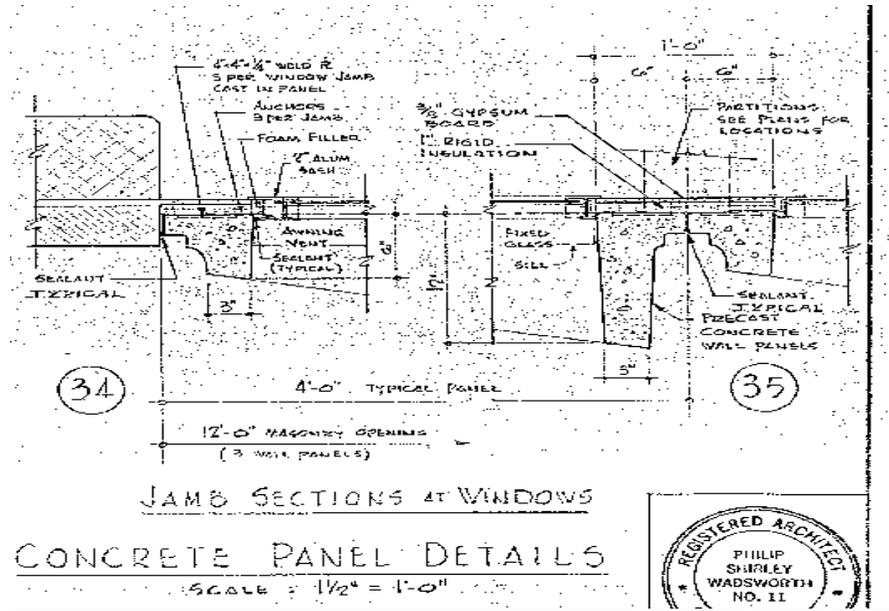
Detail 1 –  
Plan of Existing  
Windows at Precast  
Panels

Viewing the interior drywall panels around the windows it is apparent that water penetration around the windows and panels is the direct cause of the paint peeling and drywall failures and cracks you are witnessing. The window system is as originally constructed, a narrow-line non-thermally broken aluminum window frame and sash with a single glazed panel. Most of the window units have had the single pane glazing replaced with an insulated window glazing panel that appears to be around 3/4" thick.

Even though there are benefits to replacing the glazing, the unit is installed in a non-thermally broken aluminum frame system. The sill frame of the unit does not have a sill flashing under the frame. The jambs are directly anchored to the precast panel with the frame mechanically attached to this anchor.

The precast concrete window panel system is anchored to the structure through a series of connection angles and weld plates. On the back of the precast panels a layer of insulation and drywall was installed directly to the precast panel. No information could be found on the drawings indicating how the drywall was attached to the precast panel or to any direct framing behind it.

There are areas above the suspended ceiling where the back of the panel is un-insulated or a layer of insulation is applied without a drywall layer. The manner in which this whole assembly is constructed provides an environment for condensation to build over time. Even though every room with this assembly was not observed, the rooms viewed shows signs of cracking and peeling or recent repair due to previous damage.

We would recommend to the Cape Elizabeth School Department that this becomes a very high priority on your Capital Improvement Project list. The potential for mold build-up behind the drywall is very high and in the present school environment of constantly minimizing health and safety risks the potential liability exposure could be become very serious.

We would recommend a forensic analysis to verify and confirm our suspicions and an appropriate plan of action be put in place to repair this condition.

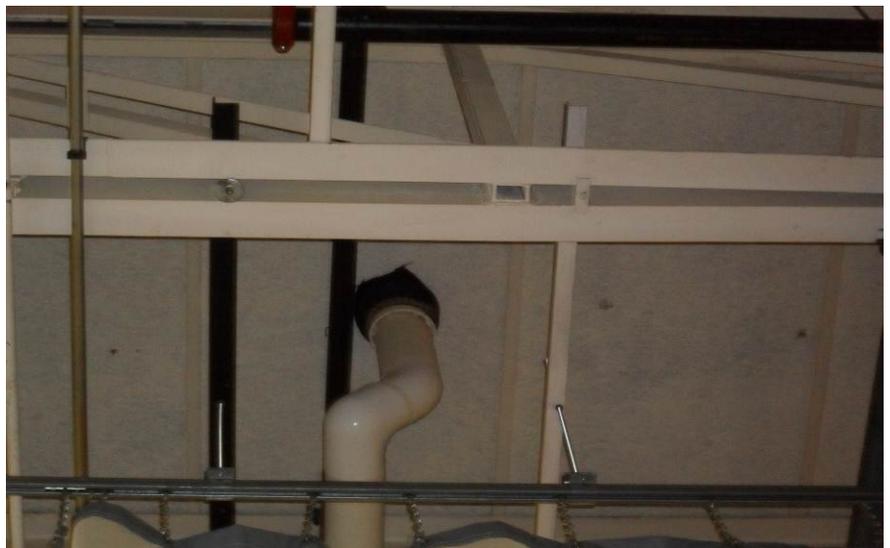
*Gymnasium Roof Drain*

Roof drain body and covers were modified with new retro-fit drains as part of the 2004 renovation project when the roof was replaced. When the roof was constructed the drain boot and roof leader would have been cast iron. With the installation of the retro-fit drain we can see that a flexible boot and drain body was attached to the existing roof leader drain pipe. The concern lies with the lack of pipe hangers to support the roof leader especially when large volumes of water enter the line and the weight could cause a failure at this connection. It is unknown how they connected the drain and flexible boot together and we would consider this connection as a potential failure point during a heavy rainstorm.

This condition occurs at all roof drain locations in the gymnasium. There were four roof drains at the time of construction and two additional roof drains were added as part of the 2004 renovation project.

We would recommend adding hangers at the elbow connection and along the horizontal leader to its vertical drop at the inside corner. At the time of roof replacement we would recommend replacement of these drains and connections.

The drain replacement will more than likely occur as part of the removal of the wood fiber roof panel and installation of a new metal deck.

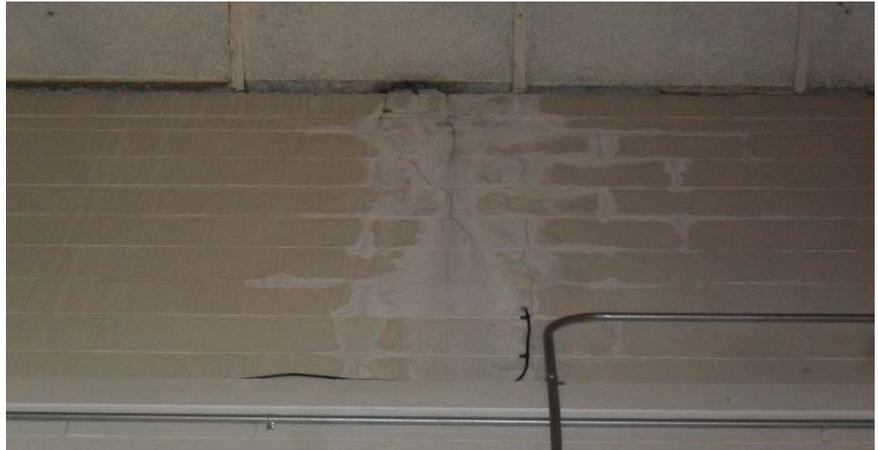
*Damaged Wall in Gymnasium*

Existing concrete block wall – interior surface and block is cracked from water entry. Recommend block repair and painting to maintain wall.

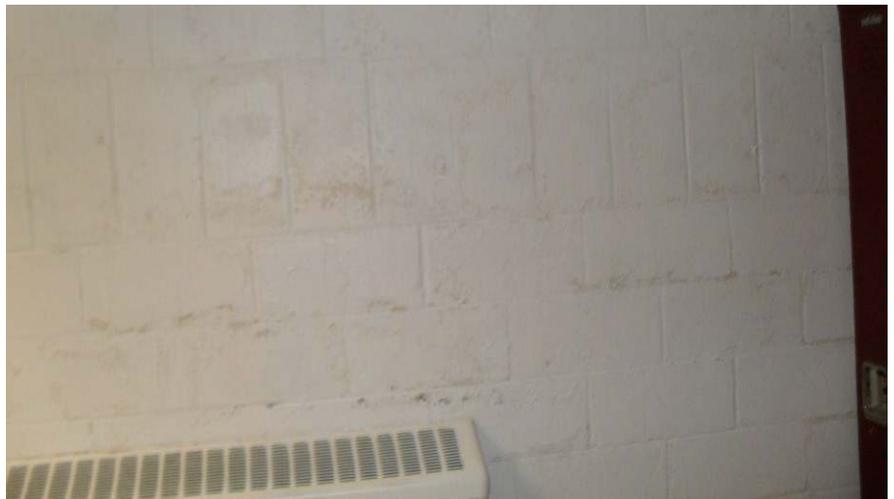
*Exterior Wall – Corridor Water Damage*

Observed some locations where water entry in the concrete block back-up wall has ruined the finish on the face of the walls. In order for this level of damage to occur, it is reflective of a large amount of water having entered into the block cell. Tracing the damage up the wall it appears that the water entry point is somewhere near the roof line. The damaged wall in the first photo is from the third floor corridor. Damage to the wall on the second floor corridor directly below was also found.

If the source of water entry is unknown then we would recommend a forensic study to find and correct your water entry source before you repair the walls and repaint.

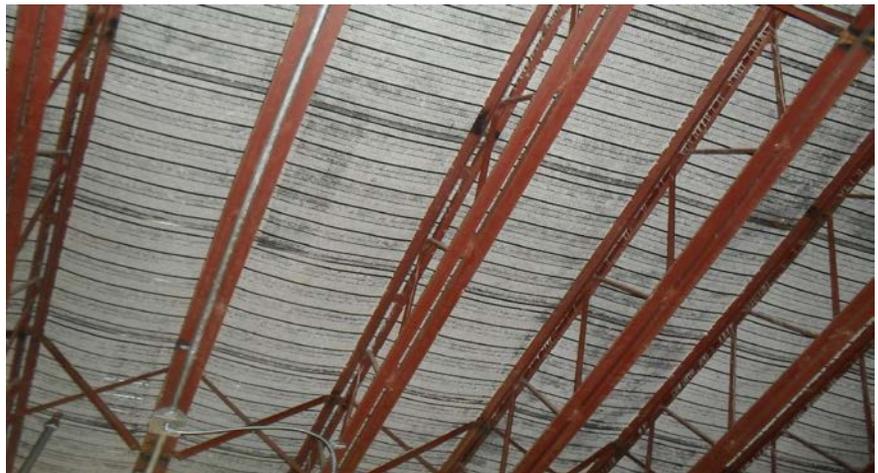
*Wire Mesh Floor Deck*

The elevated concrete deck floor systems were constructed of wire mesh and concrete slab. When walking the corridors of the building there are highs and lows in the floor line visible through the floor tile. These valleys are a result of the way the system was installed. A wire mesh deck of this type is not rigid enough to maintain a straight level surface when wet concrete is applied. Sagging most likely occurred during the placement operation. The system is structurally sound and any attempt to correct would be of substantial cost.

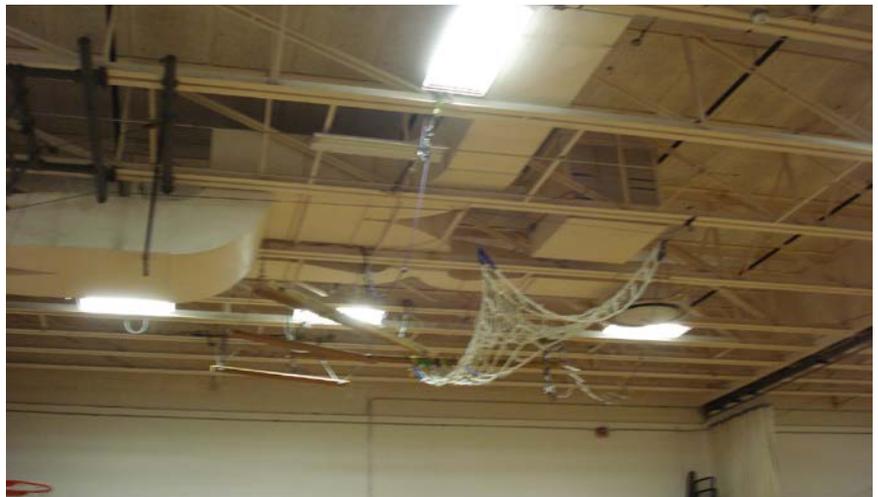
*Gymnasium Climbing System*

During the course of our observations, installation of climbing ropes and nets suspended from the lower chord of the steel joist in the gymnasium was noted. As a minimum precaution, we would recommend that all of these rope systems be attached from the top chord. The bottom chord of a steel joist is not designed to take bottom load action as currently being applied with the suspension of these ropes. These connections should be relocated to a joist panel on the top chord and a minor structural review conducted to ensure that the loads of two to five students are not overstressing the joist bottom chord.

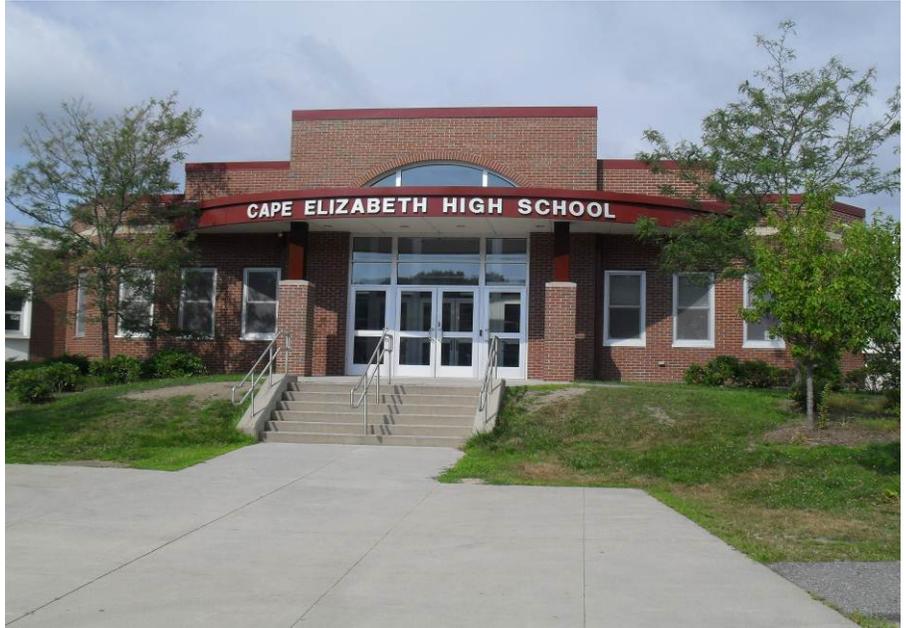
*Front Entrance –  
Existing Stairs and  
Ramp*

The bituminous asphalt ramp up to the front entrance is not in compliance with ADA requirements as a handicap ramp on an accessible route. The contract documents from the 2004 renovation project do not indicate this as an ADA ramp but it is implied by its location. There is an approximate 5' change in elevation between the bottom entry point and the front doors stoop elevation. There are a number of noncompliant issues connected with this ramp. The rise over the length is too steep; 68" in 105', change in direction widths, no handrails, and the total rise in one run exceeds 30". Per the contract documents, the entry slab at the doors is pitched too steep from the doors to the edge of the steps.

We would recommend construction of a new compliant ADA ramp to the doors and possible reconstruction of the front steps to work with the new ramp.

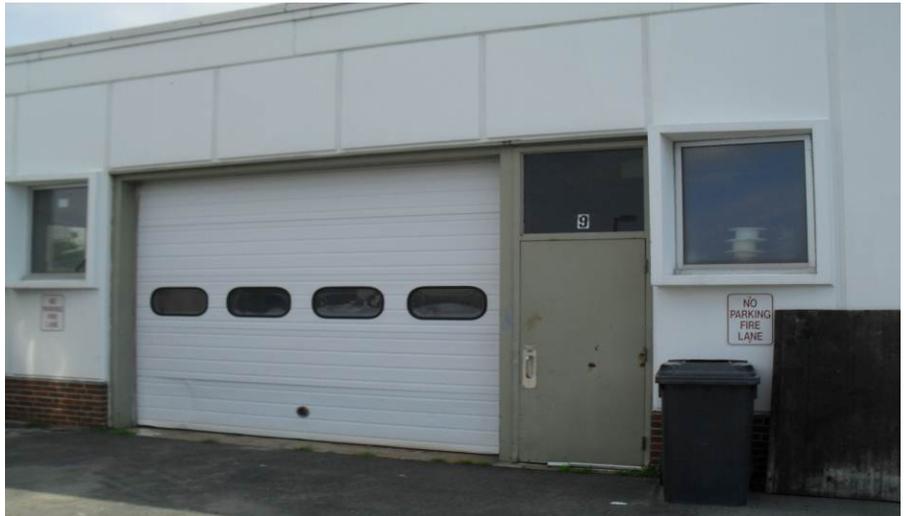
*Personnel and Overhead  
Doors*

A quantity of the hollow metal exterior doors and frames on the building are showing signs of extensive rust at the bottom of the doors and frames as well as the hinge location. We understand as part of your yearly maintenance program these openings are being replaced. We also understand that the overhead doors at the IA shops are being replaced this year as part of that maintenance program.

We would recommend replacement of hollow metal doors and frame entrances be done as part of your yearly maintenance program. For long term durability we would recommend replacement doors and frames be ordered as galvanized units and primed with a good alkyd primer and alkyd enamel coatings.

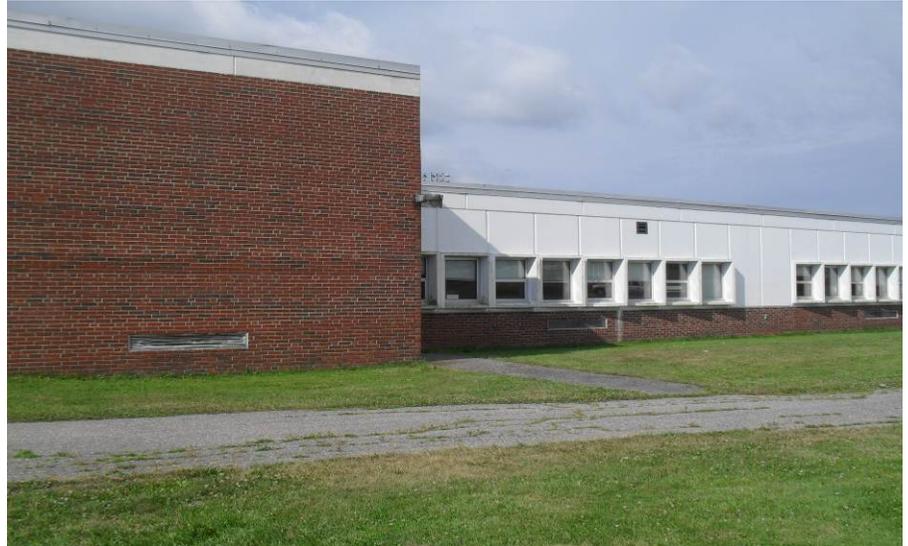
*Exterior Wall with  
Intake Louvers*

This picture shows that the brick and precast concrete walls panel system have been well maintained. We would recommend replacement of the fresh air-intake louvers at some point with a more durable louver system.

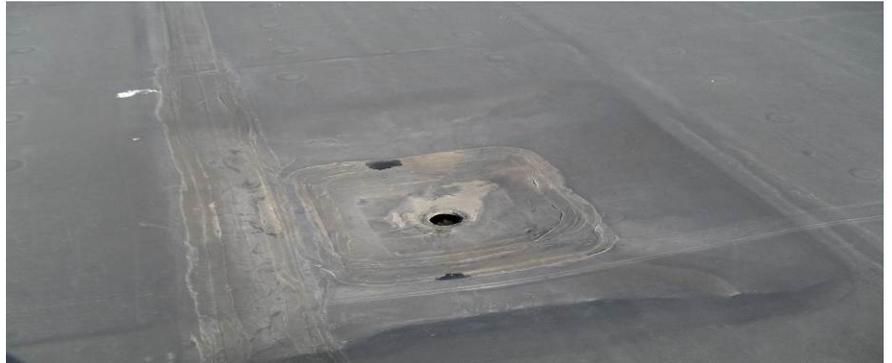
1. Provide drain cover at two drain locations – Industrial Arts roof.

*Roof Drain - No Cage*

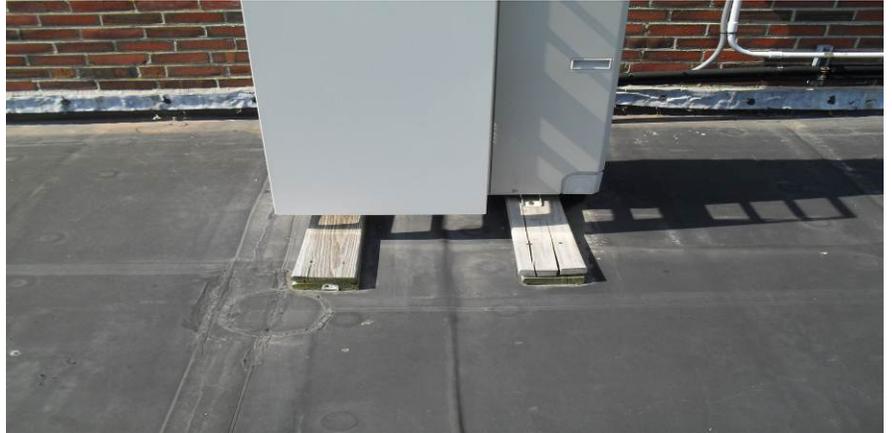
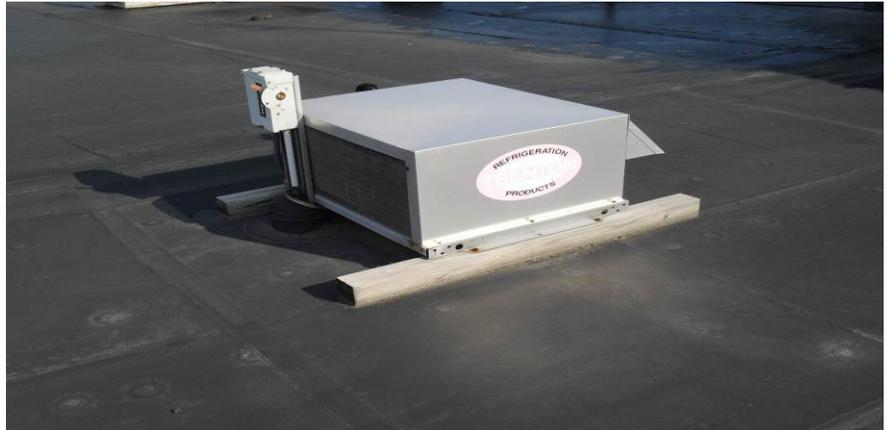
2. Provide secondary membrane under all rooftop condenser curb locations. There are some curbs that need replacement. Weight of unit will allow curb to cut into membrane causing leak location.

*Roof Curb - No Flashing Under*

*Roof Curb – No Flashing Under*

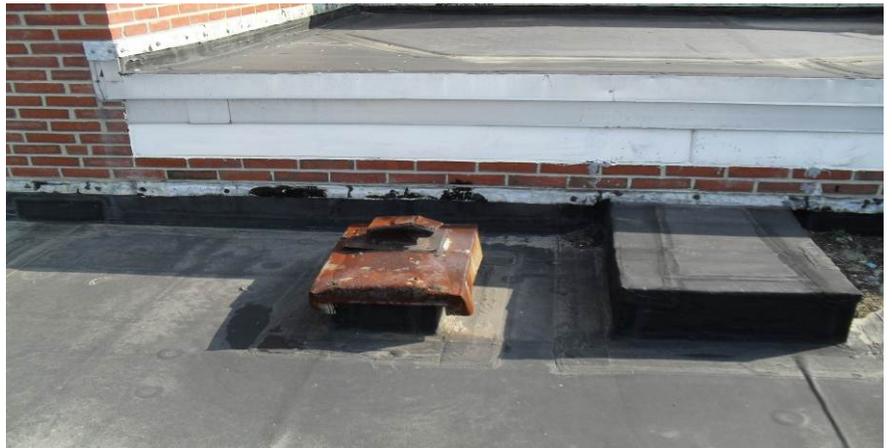
3. Remove old metal cap and provide new permanent EPDM cap flashing. Potential roof leak location.

*Replace Old Roof Curb Cap*

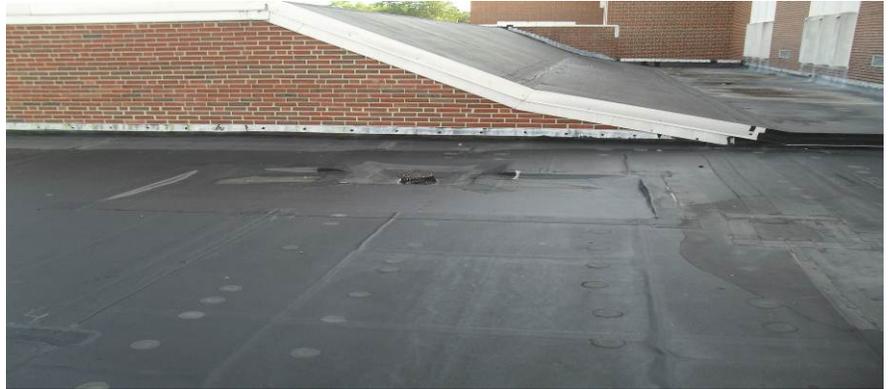
4. Rework membrane flashing to some drains – membrane is stretched over insulation with gap under – not laying flat on insulation and following insulation profile – constant stretching will cause early seam failure at drain locations. Air space between membrane and insulation can easily be punctured with foot traffic.

*Roof Flashing at Drain*

Maintain a consistent yearly maintenance and inspection process with the entire roof system. Provide re-seaming of the seams, address roof leaks as they occur and provide long term maintenance to all roofs when recommended or required.

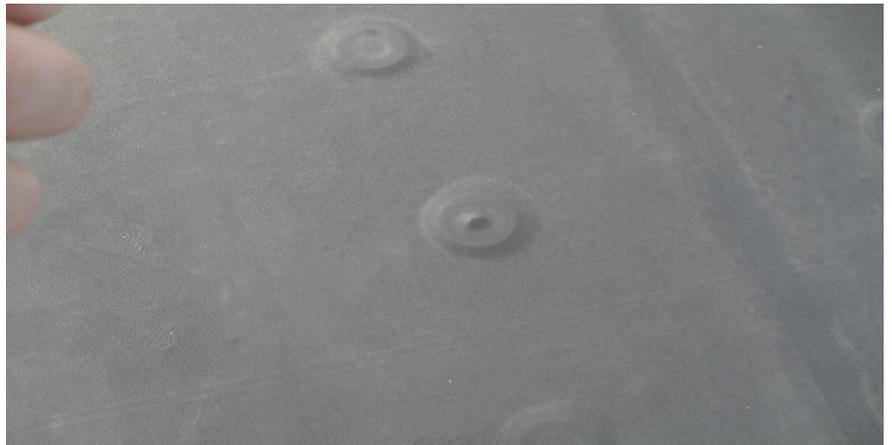
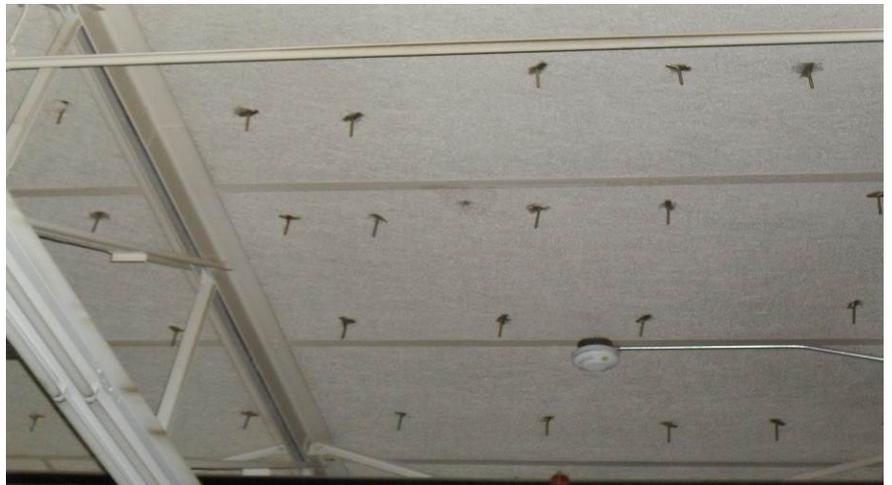
1. The roof insulation fastening pressure plates under the fully adhered membrane. The original building roof system was constructed of a 2” high T-bulb anchored to the steel joist with a 2” wood fiber roof plank set into the T-bulb and a built-up asphalt felt and gravel surface applied directly to the wood fiber plank system. The replacement roof insulation boards were mechanically fastened through this wood fiber roof plank deck with the use of a drilled pilot hole and metal molly bolts. The installation of these roof anchor bolts and pressure plates were inconsistently fastened through the plank with the wing drawn too far into the wood fiber plank. The pressure plates have loosened up or were drawn up causing a dimple in the membrane. The concern here lies with the fastener and the way they were installed through the wood fiber panel being raised up, stretching the membrane and causing a premature leak point. I would also question the amount of fasteners per board on some areas of the roofs and location in the boards and their capability to hold the roof system under wind uplift conditions. The lack of a third row of fasteners through the roof insulation boards along the perimeter of the roof through this wood fiber plank could be cause for a roof failure. The scenario of the boards lifting under wind pressure is related to specifications and the code requirements at the time of installation.

Since no record of the specifications or a copy of the written warranty were available, it would require some research and analysis to determine if in fact this condition will be problematic with this deck system. This condition is limited to those sections of roofs where the wood fiber roof plank deck was installed.

The molly bolts as shown through the deck in the lower picture have had the wings drawn up into the panel to various depths – visual inspections where the deck is exposed has shown that some wings are loose as a result of their attachment process. The result means that the amount of fasteners required to hold the roof board will be less than required by wind uplift codes thus adding to the observation about the amount of fasteners required to hold the roof system down properly.

*Pressure Plate Raised  
Up*

*Roof Insulation  
Fasteners Through  
Plank*

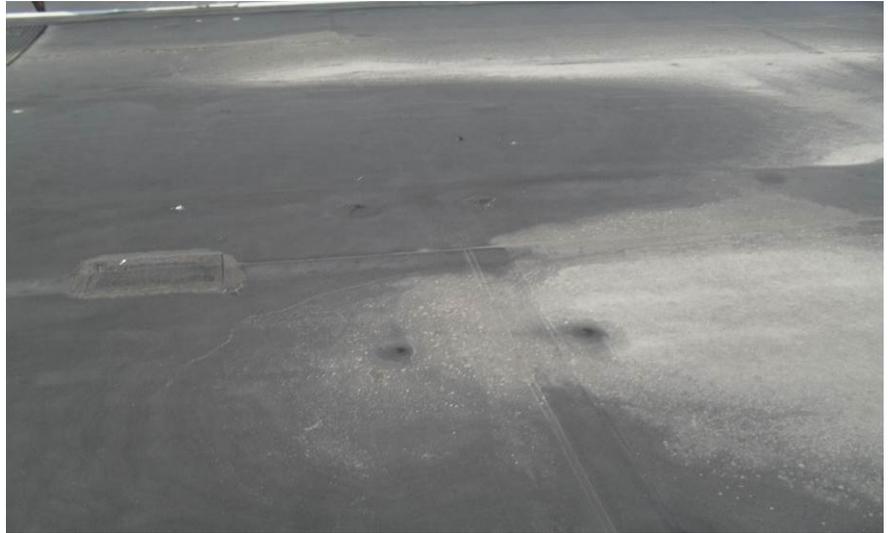
2. Lower locker room roof membrane has a number of locations where foreign material under the roof membrane is causing large dimples in the surface. Foot traffic over these locations can cause holes in the roof membrane and leaks.

*Material Under  
Membrane*

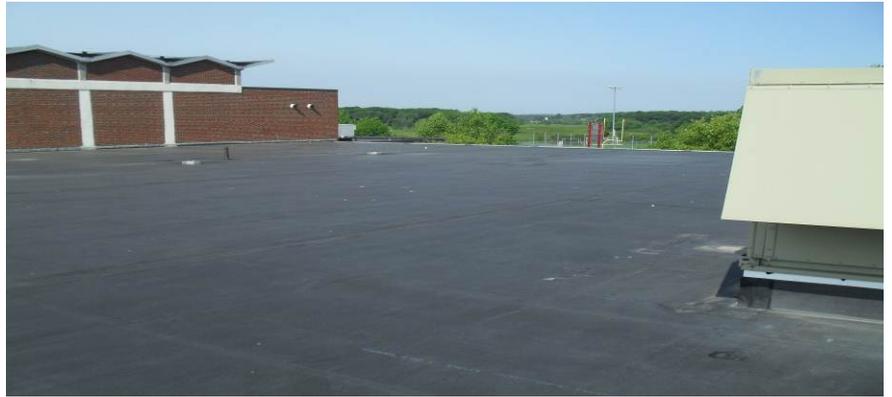
3. Low slope pitch of roof system – Existing 1/8” per ft and roof drain locations.

There is no available information as to the date the replacement roof was installed. Areas of the High School Roofs were replaced as part of the 2004 renovation project. Both those that were replaced as part of the 2004 project and the remaining areas have 1/8” per foot slope to existing drain locations.

Per the IBC Code 2003 it is required as part of that code that single membrane roofs be installed at 1/4” per ft slope. There is an exception in the code that replacement roof systems do not need to meet this requirement. There is a state statute through the Bureau of General Services on public school buildings that supersedes the code requirement saying replacement roofs will meet the 1/4” per ft single membrane low slope pitch without exception. In regards to this statute the state also requires that an analysis of the roof structure be conducted and that the roof structure and roof system be brought up to current live and drift loads. We can offer no explanation as to why the replacement roofs were not installed according to the state statute.

The current 1/8" per ft slope and the inconsistent drain locations is creating large ponding areas on all roofs that will have a long term effect on the membrane and lap seams. The large ponding areas where they occur could also present an issue if a roof drain were to plug, the pond could increase in depth and cause the wood fiber deck to be over stressed from the load and fail.

*Low Slope to Roof  
Drains*

As part of a future roof replacement project the wood fiber plank deck should be removed and a new metal roof deck installed. With this existing combustible material in your ceiling cavities and with the replacement of this material with a new metal deck it should raise the classification of the building to a Type II B rating per IBC Code.

We would recommend the replacement roof system be specified with a Class A rating and a 1/4" per ft tapered board system and new roof drains to meet current code requirements.

As part of this replacement it will be required by state statute that an analysis of the existing roof structure be conducted to establish the designed live loads, and if required, to provide a structural frame upgrade of those roof sections to bring them up to current live loads code.

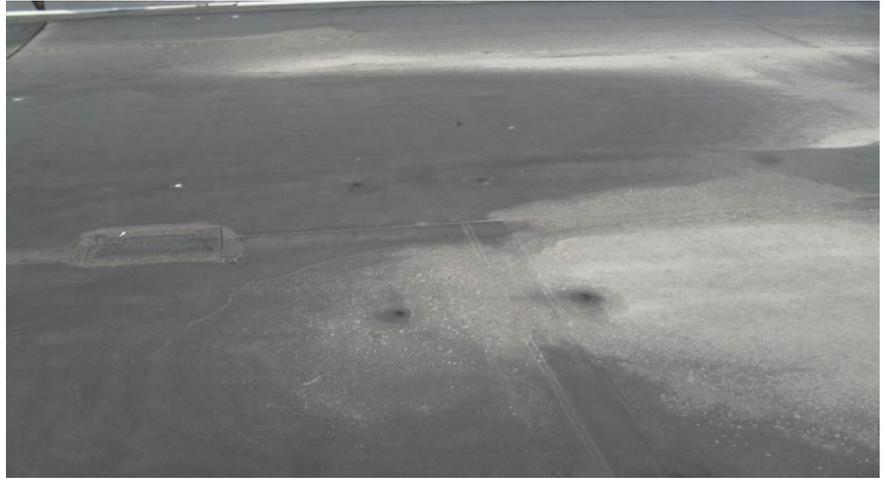
1. Numerous locations with foreign material under the roof membrane causing large dimples on the surface. Roof areas with these light colored or collection areas are indicators of ponding on the roof and the inability of surface water to be properly sloped to a roof drain. These ponding areas have a long term effect on your lap seams.

*Dimples and Light Colored Areas of Ponding*

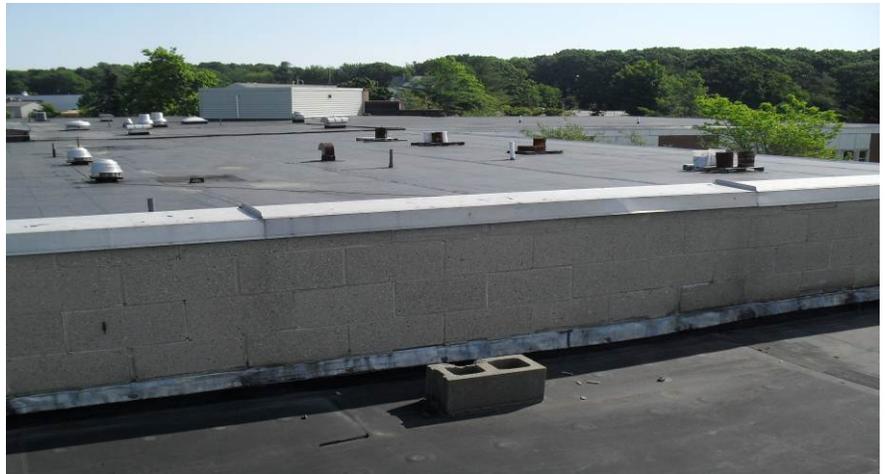
2. Parapet CMU walls above classroom wing roof are showing signs of block joint cracking and overall deterioration due to weather exposure. Water entry has entered into the block system and has caused some spalling of the grout joints and the potential issue of water entry through these joints below the roof line to the rooms below is occurring.

*Parapet Wall - CMU Failing and Cracking*

Recommend temporary waterproof system application over surface and full height flashing installation and cap at the time of replacement.

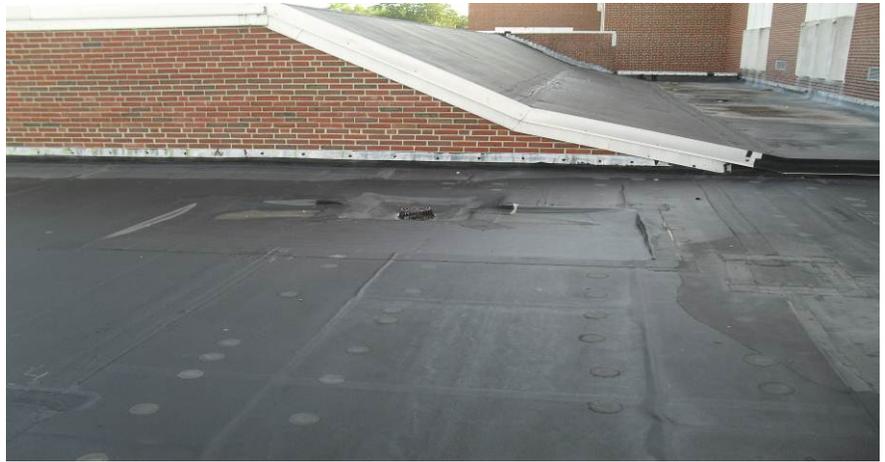
This through wall flashing is consistent around the perimeter where a lower roof adjoins a high exterior wall. The flashing used appears to be a lead coated copper flashing which is consistent with the type of flashing used for this age period. It may require special removal at the time of roof replacement and we would recommend installation of a new metal flashing that is more compatible with a new EPDM roof system.

*Metal Flashing at Base of Wall*

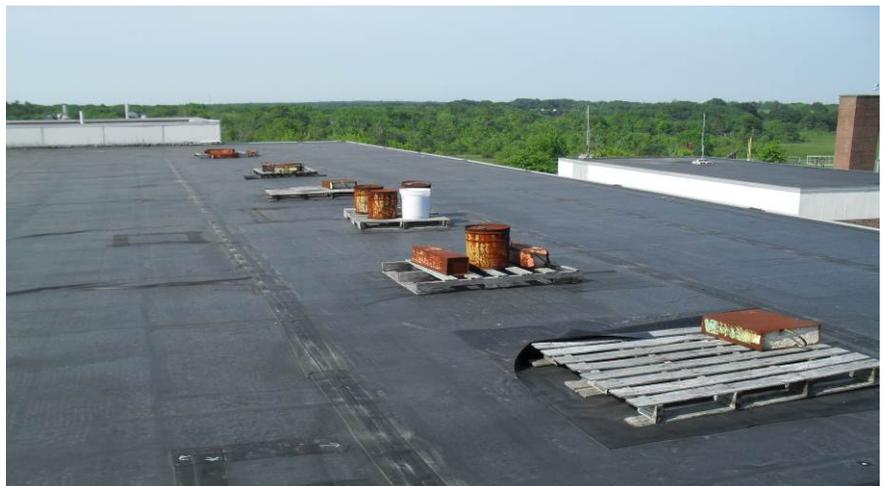
4. Under the 2004 project this area of roof was replaced. We recommend removal of leftover roofing product, weights, and pallets.

*Materials Left on Roof*

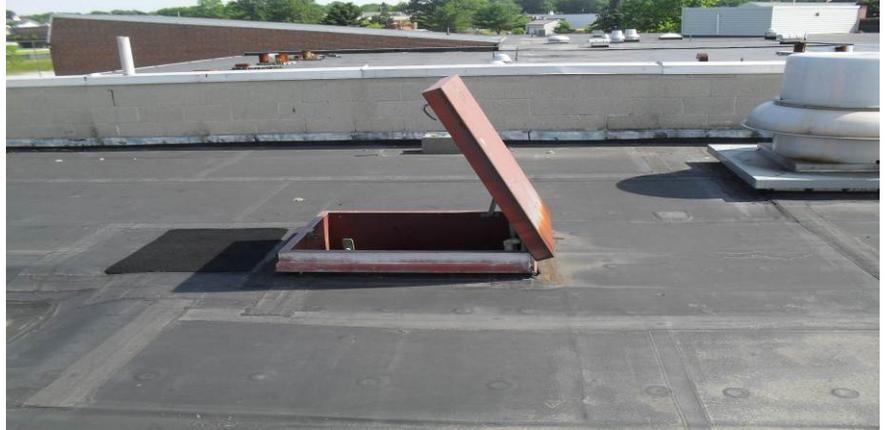
5. Existing roof hatch does not meet current OSHA Standards. Recommend installation of new scuttle hatch, ladder and safety railings.

*Existing Roof Hatch*

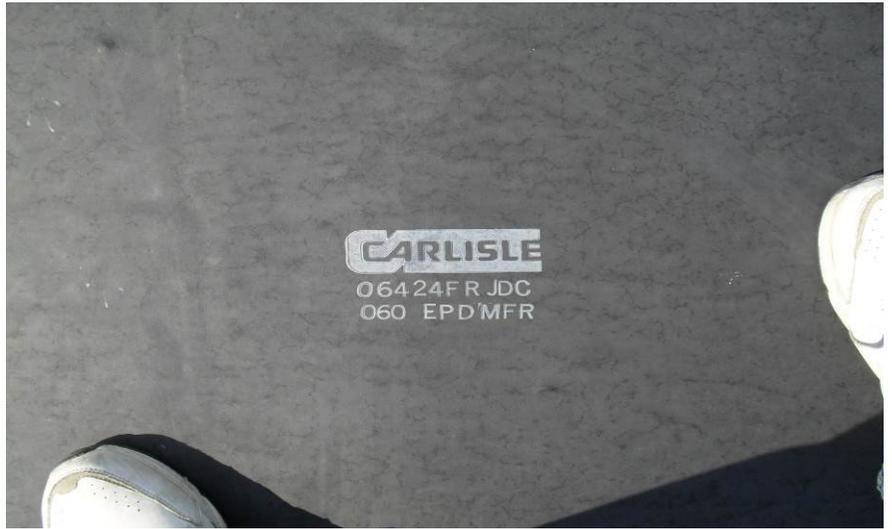
7. As part of the 2004 roof replacement we observed some sheets installed with the product label up. This type of roof membrane product is manufactured with the membrane surface on each side having two different functions. The surface applied to the insulation provides better bonding with the adhesive. The exposed surface is provided with a coating to help protect it from UV exposure. The label up indicates to us that the sheet was installed with the wrong surface up which may cause premature failure of the sheets in this area.

*Product Label Facing Up*

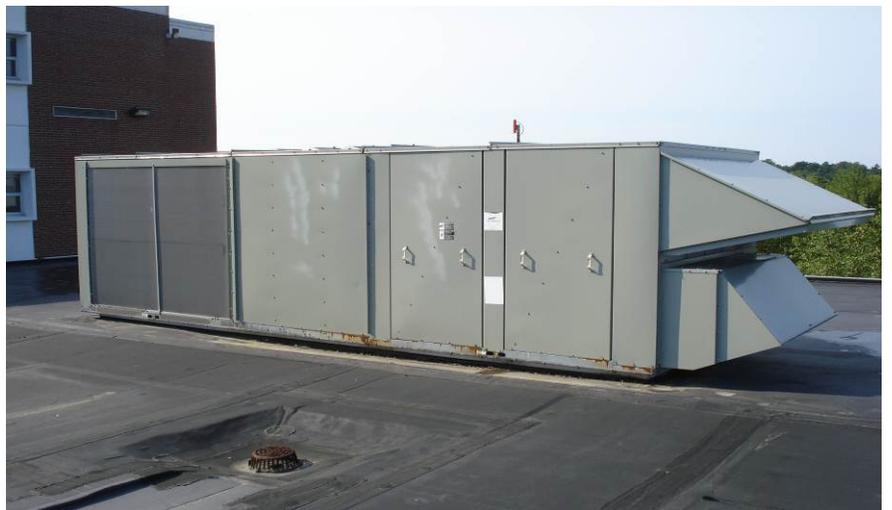
8. Base flashing for AHU unit not at recommended height.

*AHU Unit Base Flashing*

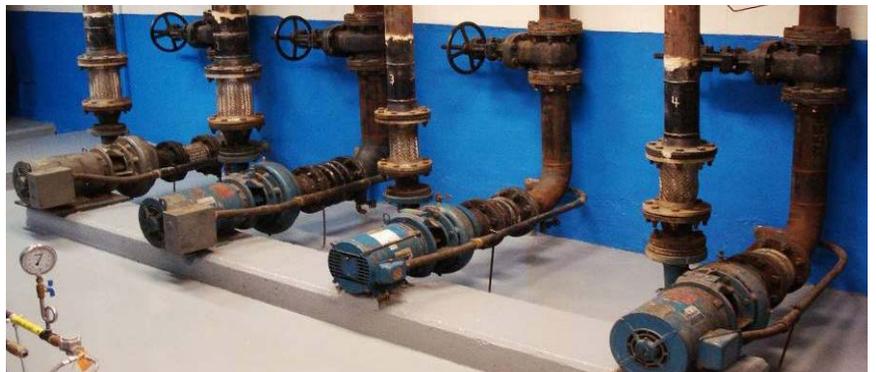
*Existing Heating Hot Water Pumps*

The heating hot water is circulated through the building by the Weinman base-mounted circulating pumps located adjacent to the boilers. One pair of pumps (left two) provides the hot water through the majority of the building. The other set of pumps circulate heating hot water through to the pool section of the building. The insulation on the hot water piping contained asbestos and was abated as part of the boiler project.

*Piping is Not Insulated*

We would recommend insulating all of the heating hot water piping and accessories in the boiler room.

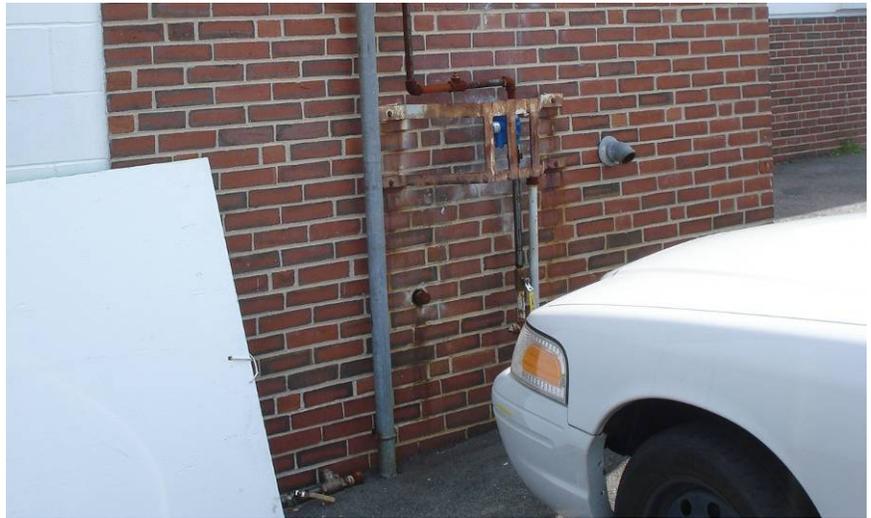
*Propane Gas Piping on Exterior Wall of Boiler Room*

The propane gas piping is installed along the exterior wall of the Boiler Room. The gas valve is protected. The piping from the parking lot level to the gas valve appears to be exposed to potential damage.

*The gas piping is exposed to potential damage.*

We would recommend the installation of protective barrier devices in front of the gas piping.

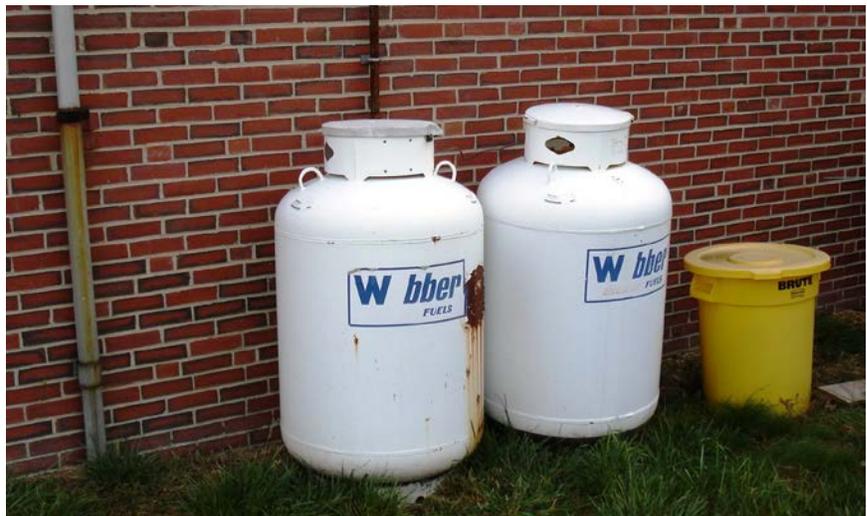
*LP Gas Tanks Serving the Kitchen Equipment*

The LP propane gas tanks serving the Kitchen Equipment are located outside of the Kitchen and do not meet code. The tanks are location of the tanks in non-code compliant.

We would recommend relocation of the LP propane tanks in accordance with codes.

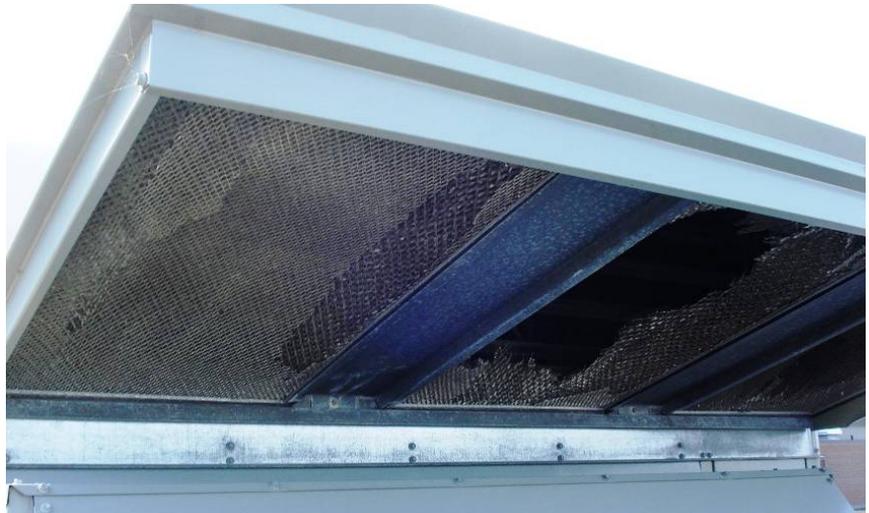
At the time of review, the unit was operating with the intake dampers 100% open, the relief fan was off, and the mechanical cooling running. At such warm ambient conditions, one would expect the intake dampers to be closed down to the minimum position. The unit-mounted intake filters are damaged.

*Damaged Packaged AC Rooftop Unit Outside Air Intake Filter*

We would recommend replacement of the filters and verification of system operations.

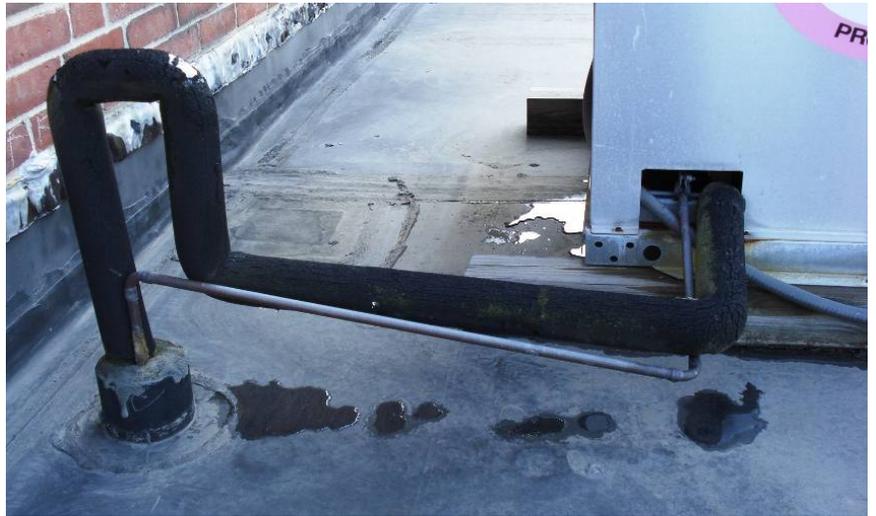
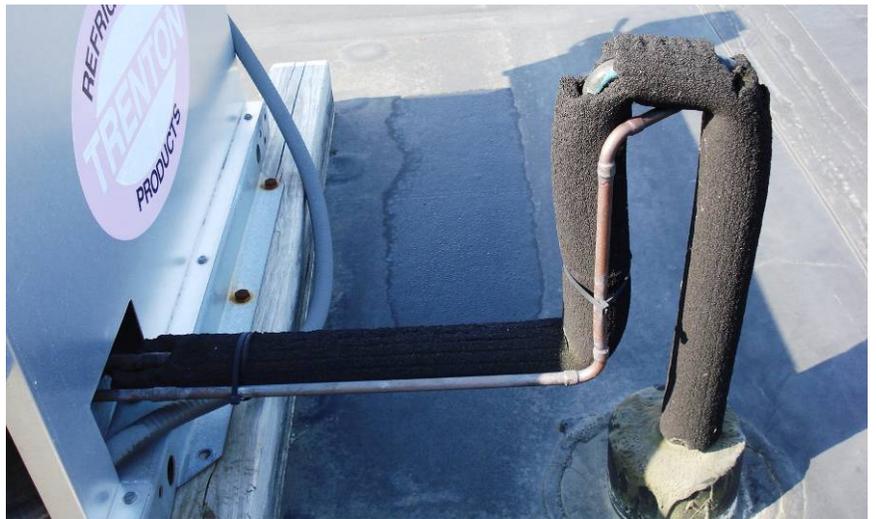
*Rooftop Condensing Unit  
Refrigerant Piping*

In general, the rooftop condensing units appear to be in good condition with the exception of some of the refrigerant piping and associated insulation. At many of the units, the insulation on the suction lines is showing signs of age and breaking down.

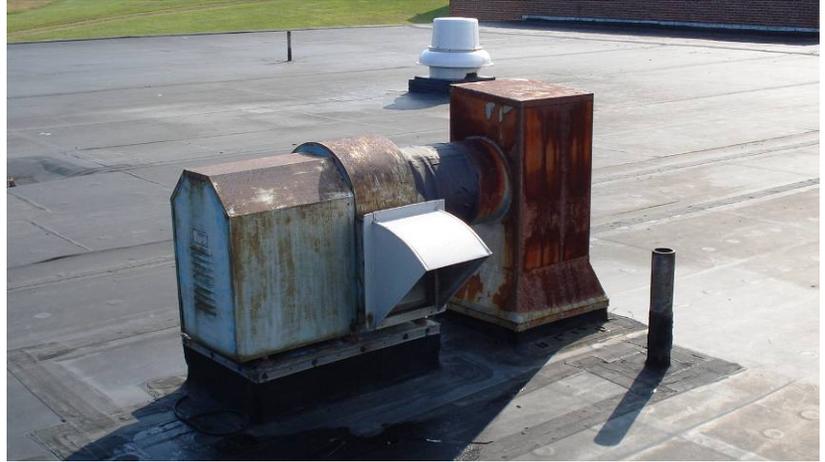
Many of the rooftop exhaust fans are showing signs of age. At the time of review, many of the exhaust fans were not operating. It is unknown which units were supposed to be running and which ones were in the off mode.

*Rooftop Exhaust Fan*

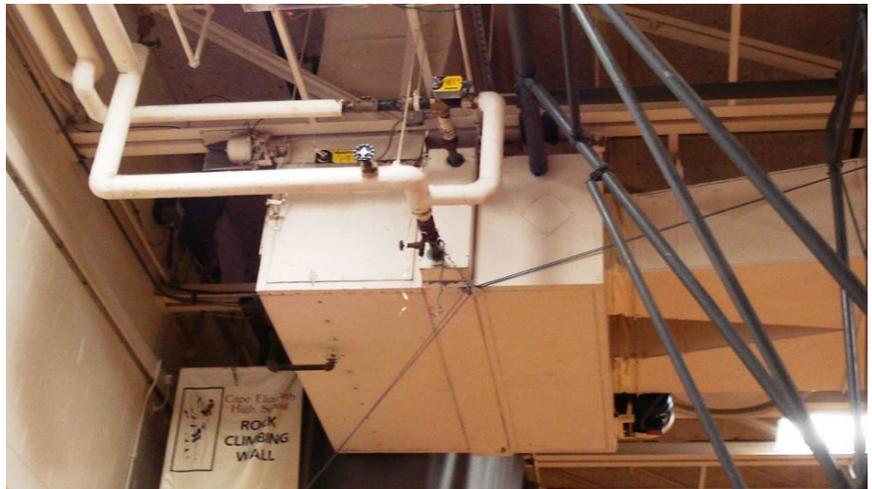
The gymnasium ventilation is provided through four air handling units suspended from the roof structure. The units appear to be original to the 1968 construction project. According to the 2004 renovations construction documents, the four existing units were scheduled to be removed and replaced with two new units. The units were not removed or replaced. During this review the units were not operating. The automatic controls and fan motors have been upgraded and variable frequency drives have been installed.

*Gymnasium Ventilation Units (Typical of Four Units)*

We would recommend replacement of the 4 units.
