**Town of Cape Elizabeth**  
Seven Building Facility Study  
*Cape Elizabeth, Maine*

**Introduction****Town of Cape Elizabeth Facilities Study**

*Facility Study Process*

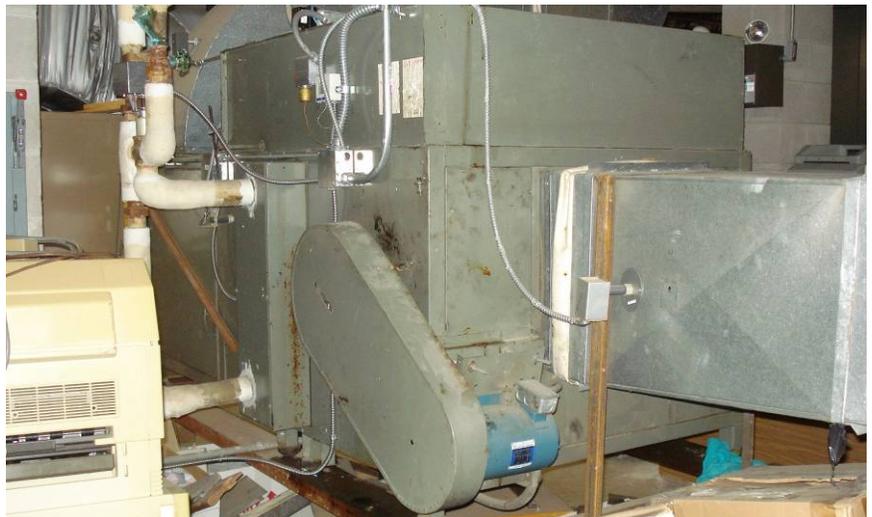
The ventilation unit HV-3 was installed during the 1968 construction project and appears to be in operation. The original pneumatic automatic temperature controls have been replaced and upgraded with DDC controls with electronic actuation. The unit originally provided conditioned ventilation air to two areas on the second floor and one area on the third floor. During the 2004 renovations project, minor changes were made to the system distribution.

*American Air Filter, Inc.  
Ventilation Unit HV-3  
Located in "The Attic"*

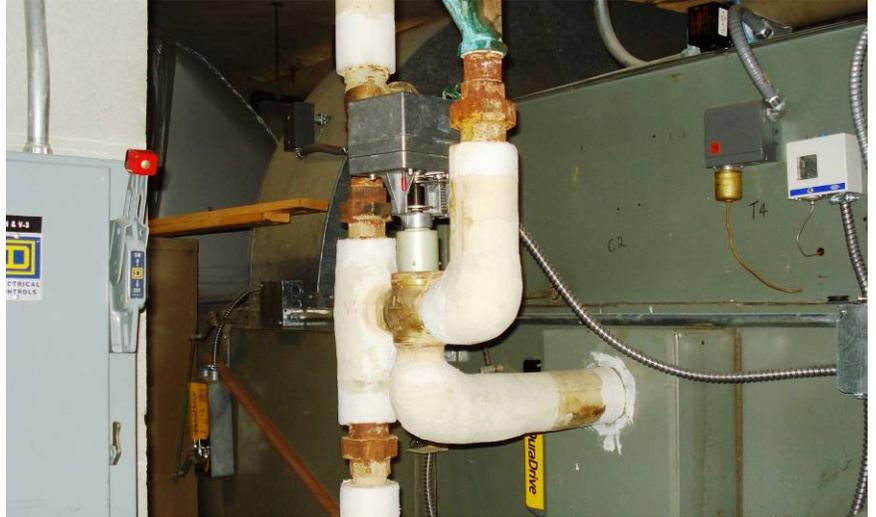
The current 3-way valve actuator replaced the original pneumatic valve actuator and was retrofitted to the original 3-way control valve. The insulation on the piping appears to be original and may contain asbestos.

*3-Way Control Valve  
and Pipe Insulation of  
HV-3 Multi-Zone Unit*

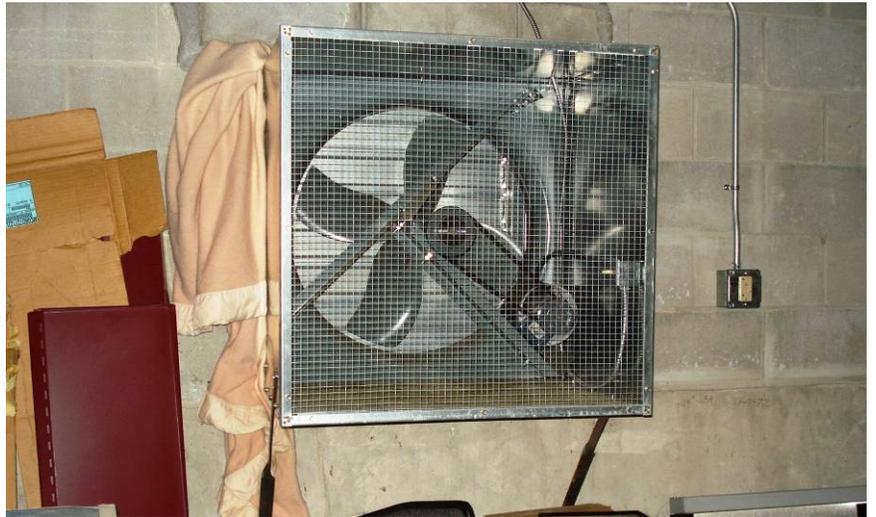
*Storage Room (Attic)  
Ventilation Fan*

The ventilation for the storage room or attic is provided through a wall-mounted propeller type exhaust fan. Recommend sealing the fan enclosure.

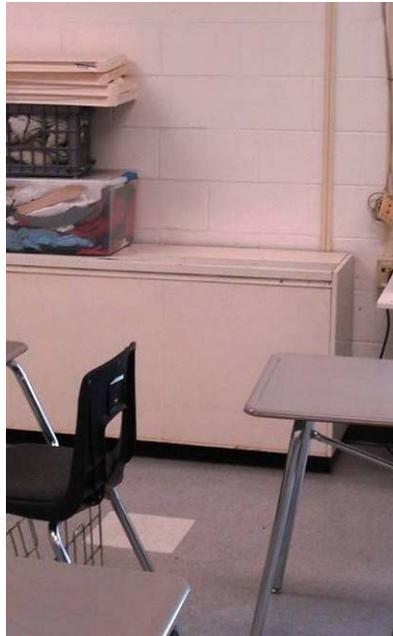
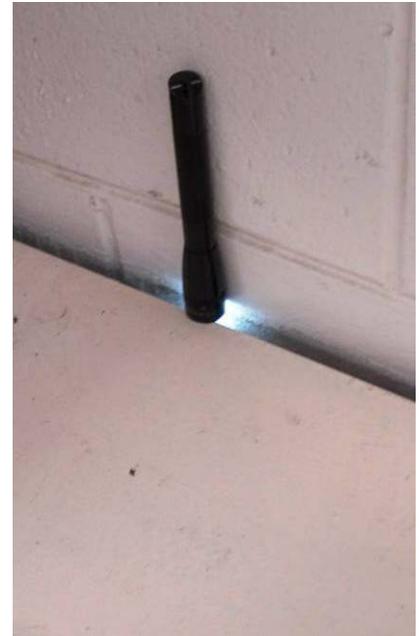
In Classroom 208, the unit ventilator has moved away from the wall creating an air gap between the unit insulation and the opening in the wall allowing for infiltration of outside air into the classroom.

*Unit Ventilator in Classroom 208. Photo on Right Shows the Gap Between the Unit and the Wall*

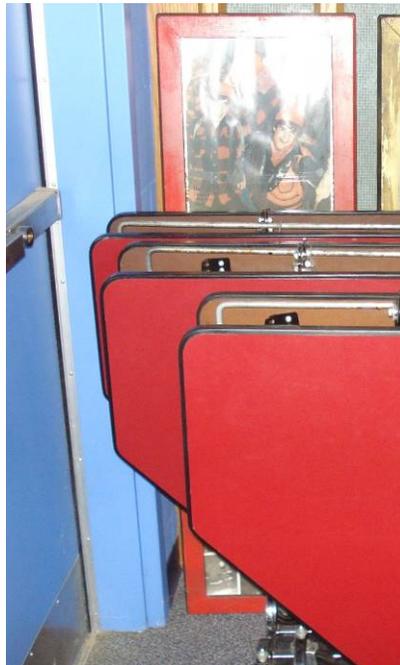
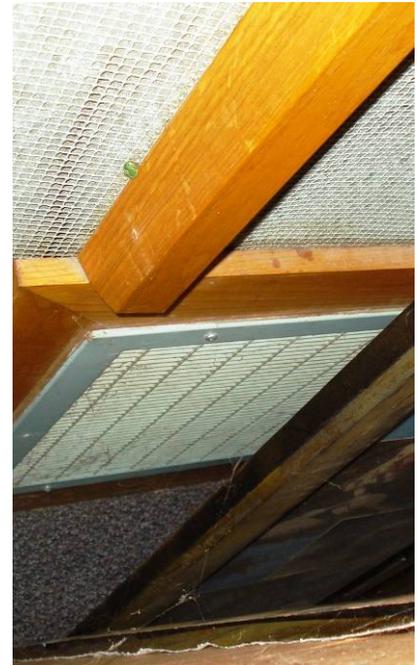
The return grilles serving the Auditorium are located along the back wall. The return grille, located adjacent to the door, is not obscured. The return grille located on the left side (shown in above photo) is completely blocked by tables and show posters lining the back wall. The photo on the left shows the exterior door and the tables and posters blocking the grille. The photo on the right shows the blocked grille behind the posters.

*Location of Return Grille at the Left Side of the Auditorium Back Area*

We would recommend maintaining.

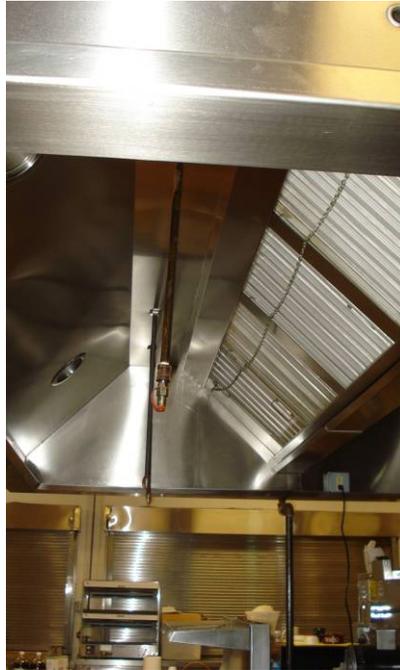
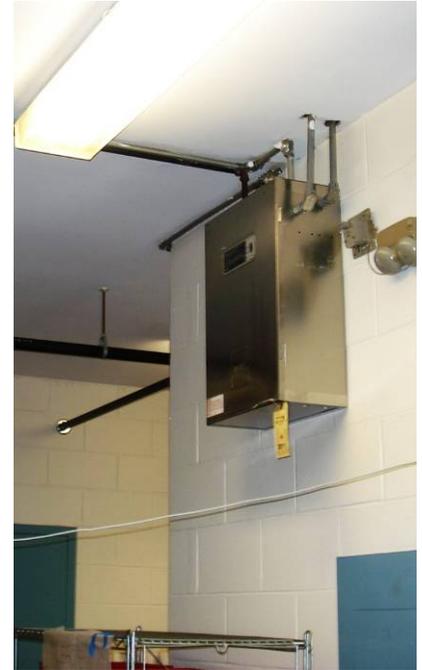
The kitchen hood system appears to be in good condition. Overall, the condition of the hood appeared to be good. Fire suppression system is provided. At the time of review, all of the hood light bulbs and globes were missing.

*View Under Hood and Fire Suppression System Panel*

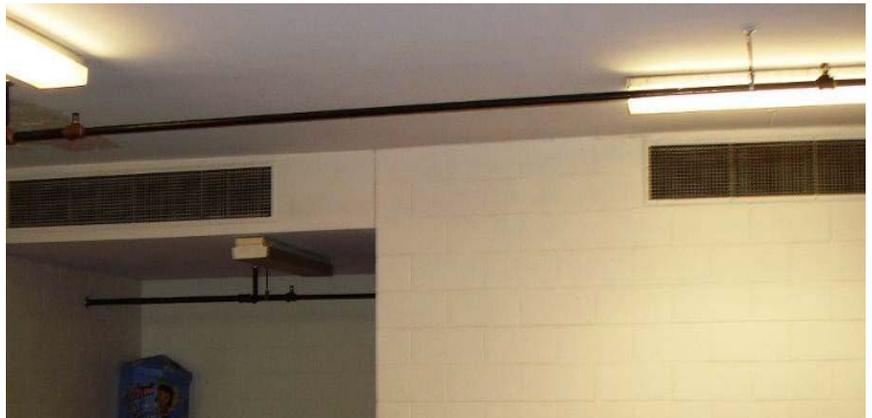
*Kitchen Ventilation Vents*

We would recommend further review of the kitchen exhaust and ventilation systems to verify proper interlocks between the exhaust systems and the heating and ventilation systems to ensure proper pressure and airflow control.

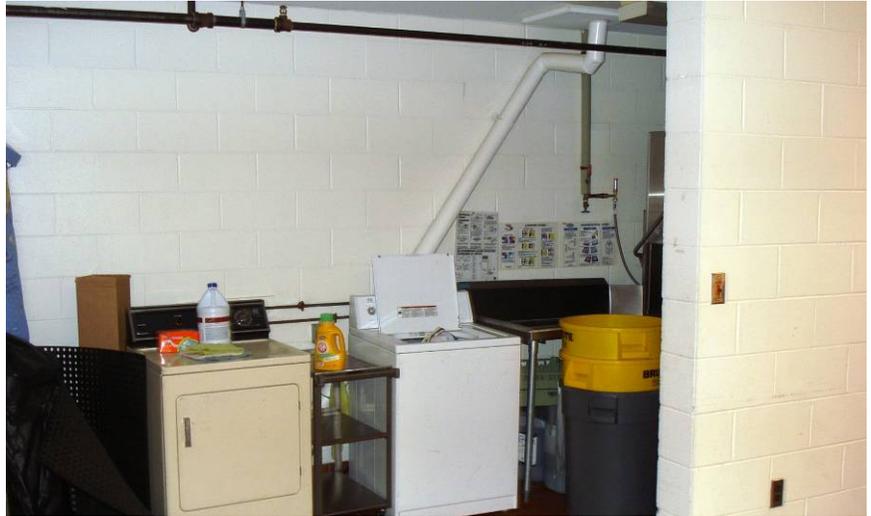
The dishwashing unit and laundry equipment share a space off the kitchen. The dryer vent is not installed in accordance with current codes. Exhaust is not provided for the dishwasher.

*Kitchen Laundry and Dishwashing Area*

We would recommend the installation of proper dryer exhaust ducting and the installation of proper exhaust for the dishwasher equipment.

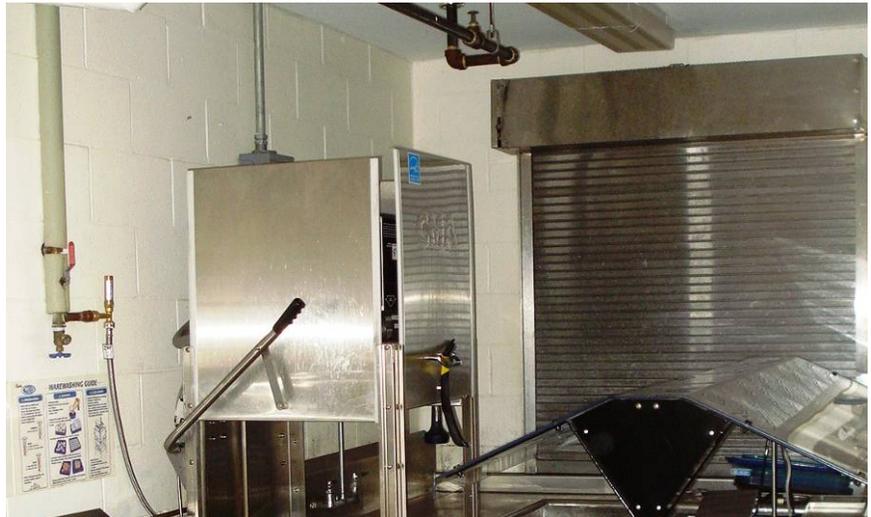
*Dishwasher Area*

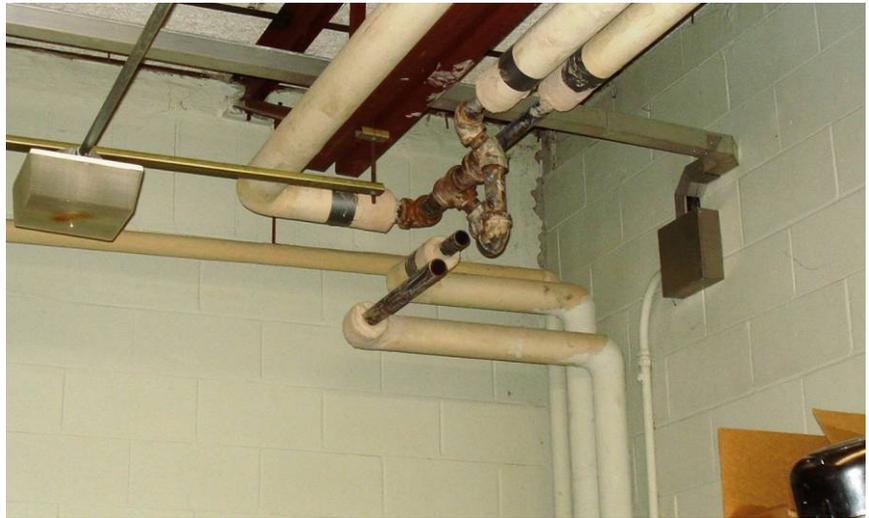
In the corner of the dry storage room, it appears some of the original heating pipes have been cut and abandoned open-ended. The piping insulation material is unknown due to the inaccessibility to the piping.

*Piping in Corner of Dry Storage Room*

We would recommend a review of the existing pipe insulation and determine proper action for pipe removal.

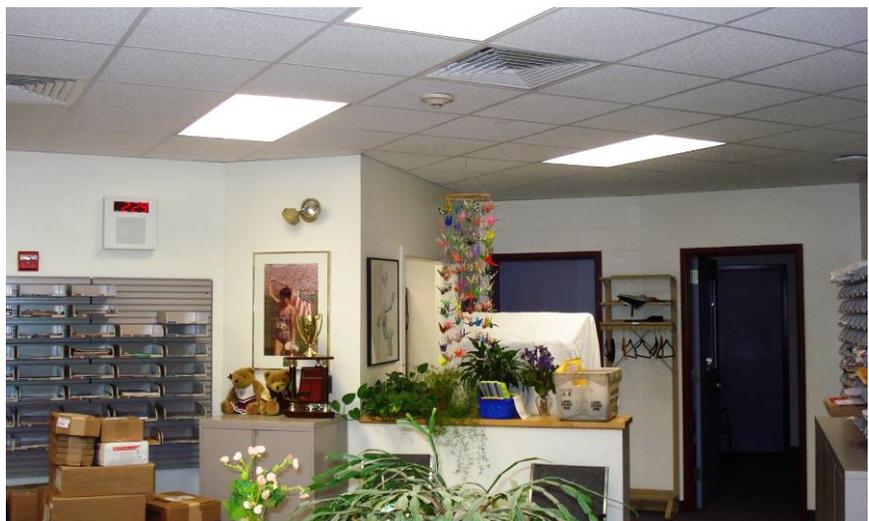
*Main Office*

Heating, ventilation, and air conditioning is provided for the office areas through the air handling unit AHU-15 installed as part of the 2004 renovations project. During our review, the spaces felt very cool. Perhaps the setpoint is set too low. Perimeter heating is provided through baseboard radiation.

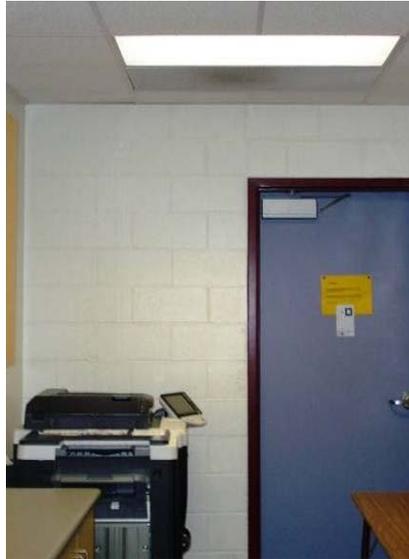
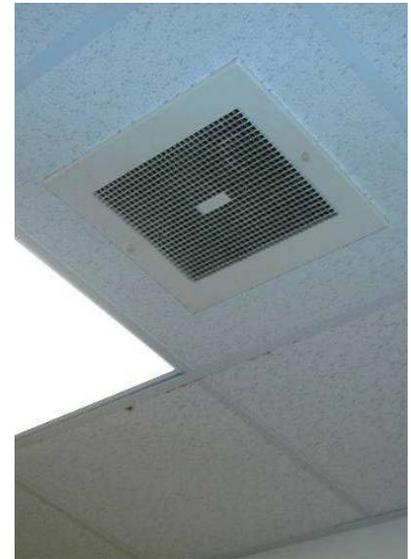
Ventilation in the print room is provided through a return air connection to AHU-15 and a separate exhaust air grille connection to the ceiling-mounted exhaust fan EF-10. The return grille is shown in the photo below. The exhaust fan/grille is located directly above the door opening. If the ventilation in this space is an issue, perhaps the return grille and exhaust fan could be relocated.

*Print / Copy Room Off Main Office. Copier and Return Grille Shown at Left. Exhaust Fan Shown at Right*

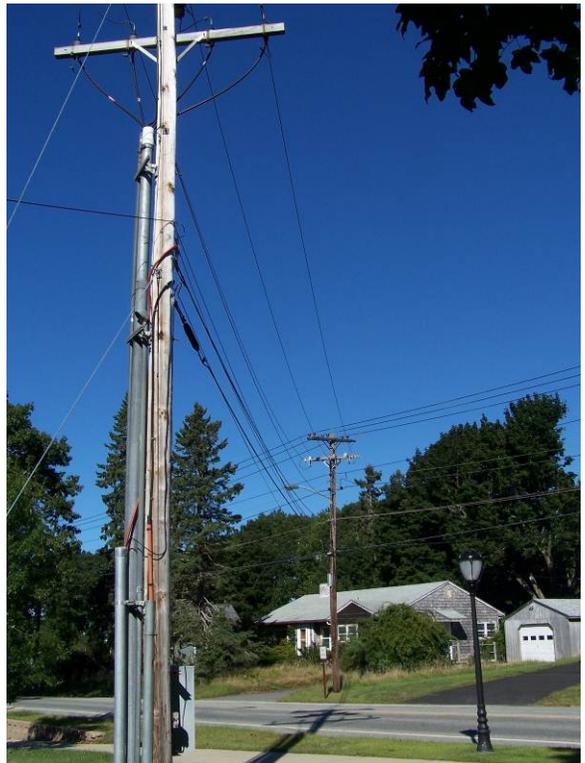
There have been multiple problems with the direct buried cable resulting in lost phases and multiple outages.

*Primary Service Riser Pole  
and Meter at Scott Dyer  
Road*

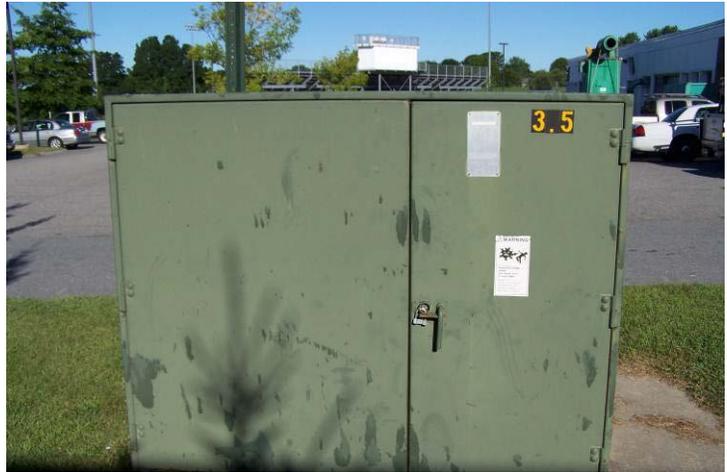
There is no peak demand data for this service as there is one primary meter for the High School and Middle / Pond Cove Elementary Schools; however, the 500kVA transformer appears undersized for the square footage of the building.  $500,000\text{VA} \div 162,630 \text{ sq ft} = 3.1\text{VA/sq ft}$  (typical design VA/sq ft  $\approx 8\text{VA/sq ft}$ ). As technology requirements increase it is likely that energy usage will increase also.

*Primary Service  
Transformer*

It is recommended the existing primary service be disconnected from the middle school and a new service be installed originating at Ocean Street and terminating in a new higher capacity pad mount transformer.

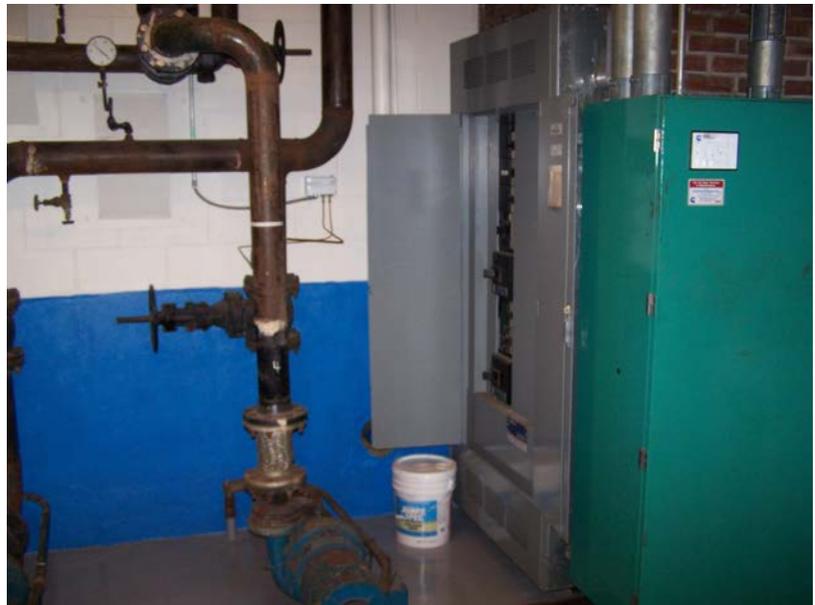
The high school is served by a standby power system. This consists of a 1000A Onan automatic transfer switch located in the boiler room. The normal side of the transfer switch is connected to a breaker in the main switchboard and the standby side is connected to an exterior self-contained Cummins-Onan diesel standby generator set rated 204kW and configured (configurable for multiple voltages) for 120/208 volts, 3 phase, 4 wire. Standby power is provided to a 1000A distribution board DP1 located in the boiler room. It was observed that the distribution board DP1 did not have code required clearances.

It appears that only mechanical loads are fed from the standby system, but the system does not incorporate the mechanical system controls. This condition renders the mechanical system inoperable during a power outage. The generator and transfer switch have ample capacity to feed many more loads in the building than are currently connected. Consideration should be given to using this system to its full capacity. This could include mechanical loads and controls, standby lighting, computer system and other non-life safety loads. With the addition of a separate transfer switch and panel, the system could be expanded as a life safety system as well.

*Automatic Transfer  
Switch and Standby  
Distribution Board*

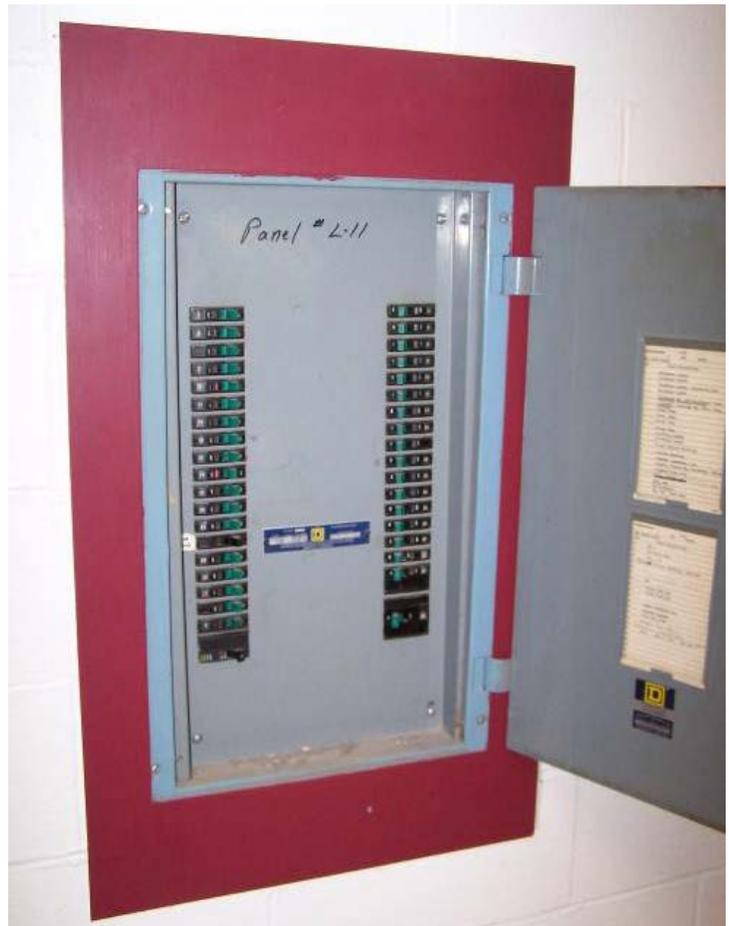
Lighting and power panelboards are located throughout the facility. Many panels located in classroom areas are filled to capacity with breakers. In areas needing additional circuit capacity, additional panels or panel replacement may be required. Panels located in the corridors and accessible to the students were not locked but should be provided with lockable hardware to prevent unauthorized access.

*Typical Lighting/Power  
Panelboard*

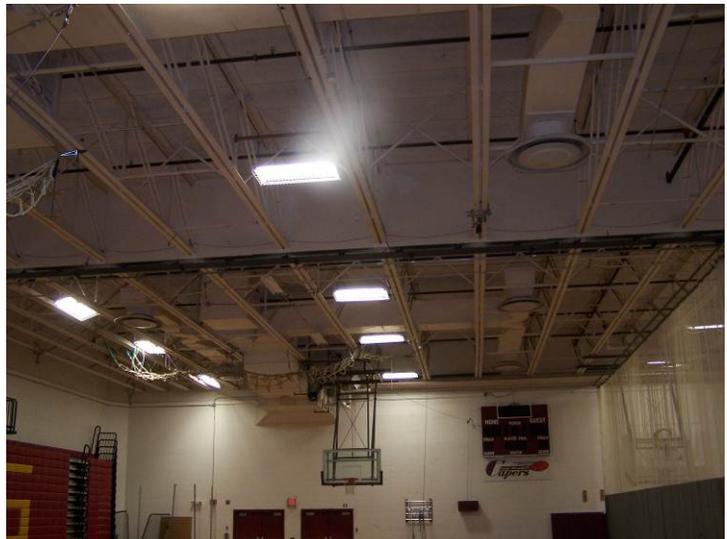
Gym lights consist of five rows of six, 6-lamp T5 high bay fixtures. Some fixtures are damaged and many need replacement wireguards. Lighting levels are fair to average.

*Gym Lighting*

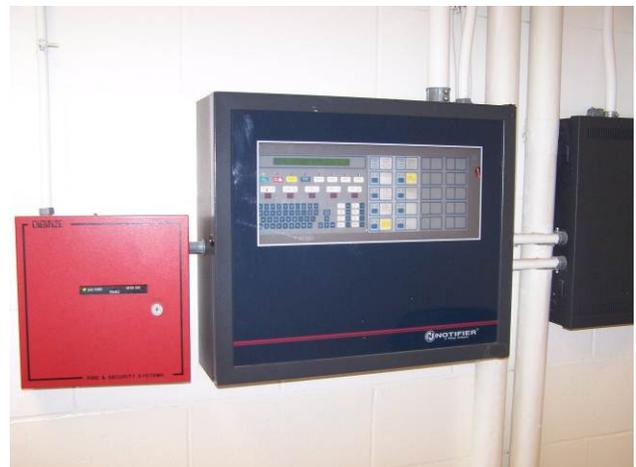
Fire alarm system is an older Notifier AFP-400 addressable system, with an associated voice evacuation system. In the event of an alarm, the system reports directly to Portland monitoring / dispatch facility. This system has had numerous device failures markedly in the pool area most likely due to moisture infiltration and corrosion.

*Fire Alarm System*

E1.8	Fire Alarm System	Older Notifier AFP-400 system with voice evacuation. Notification appliances and initiating devices throughout the building. Many trouble notifications, and failures mostly with pool area devices.	System is older but functional. Some areas need additional notification appliance coverage to meet NFPA 101. Annual inspections are performed by Eastern Fire Protection Co.	Perform study of and provide additional notification appliance coverage in all areas to meet NFPA 101. Replace devices in pool area to minimize system faults / trouble alarms.	\$40,000.00	1

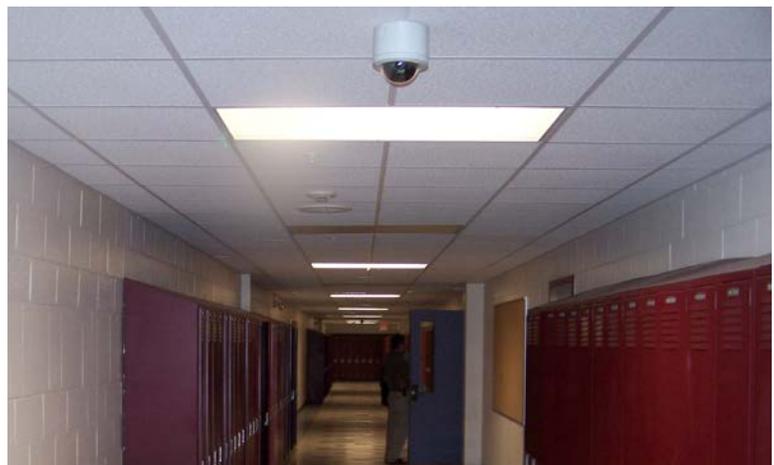
The High School is served by a video surveillance system with cameras at various locations throughout the building, mainly at building entrances. The system is an Integral Technologies system with a mixture of legacy and upgraded video platforms. The main server is based in the High School but also serves the Middle School, Pond Cove Elementary School, Police Department and Fire Department. Advance Technology is responsible for maintaining the system, and reports multiple failures of the system, with frequent database corruption and loss of camera function.

*Typical Camera*

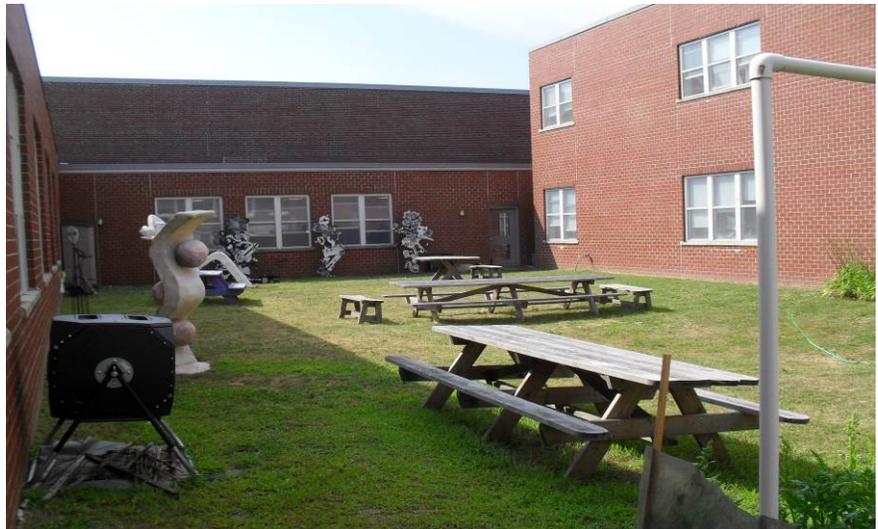
The existing courtyard is grassed and includes tables and other items that one may assume is for student use. There is only one means of egress out of the courtyard. The Life Safety Code requires minimum two means of egress diagonally across from each other. This area should be reviewed with your local fire department for approval of use as the authority having jurisdiction. Per the code, this area cannot be occupied with a single means of egress. The exit doors should have an exit sign over the top and the doors should have a proper panic device for exiting a potential of 50 people or more.

*Courtyard with One Means of Egress*

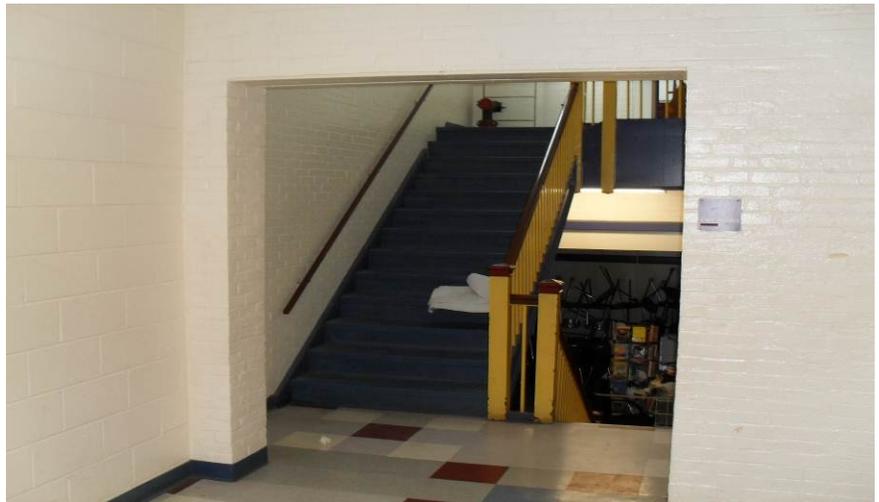
*West End Stairwell  
2nd Floor*

This current exiting setup is in violation of the current life safety codes and will expose the school to liability exposure in the event of an emergency.

*Stairwell – Exits to an  
Unprotected Corridor*

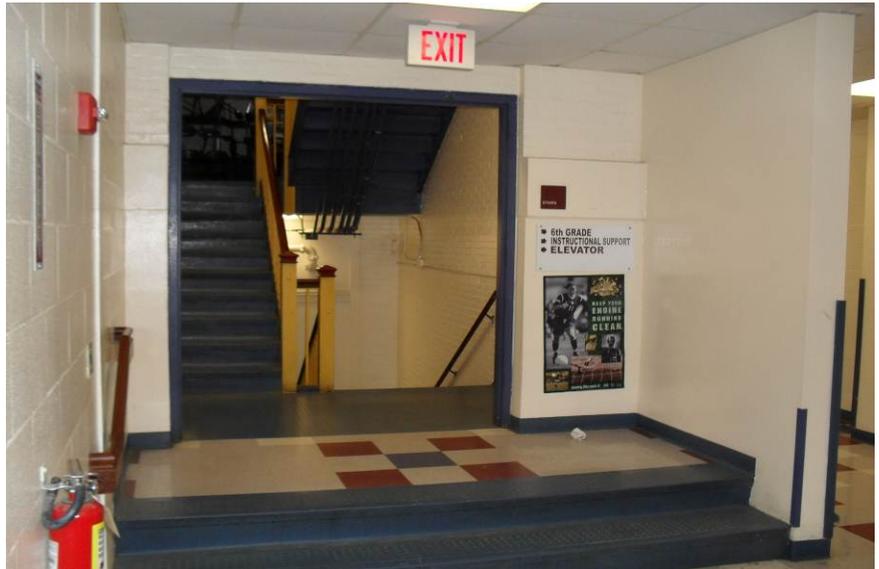
*West End Stairwell  
First Floor*

*Stairwell Opening to  
Corridor – Illegal Exit  
Sign*

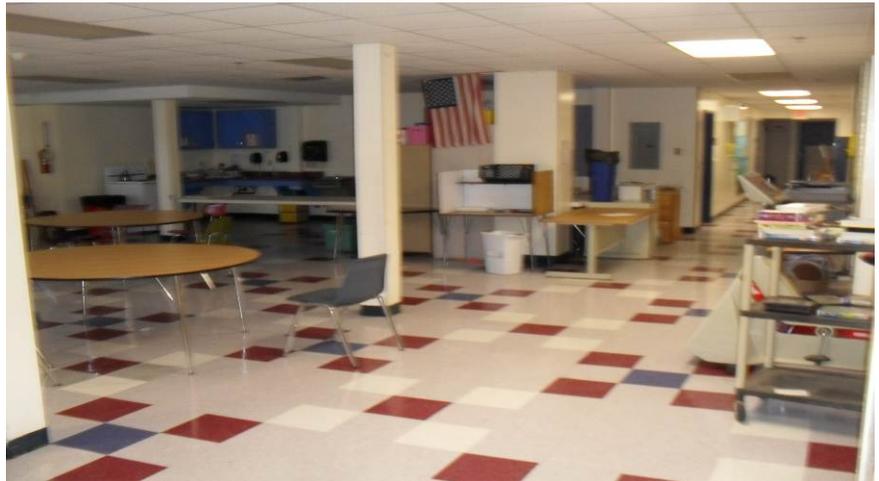
In the lower level of the original building there is a space that is integrated with the corridor. This type of assembly space and the stove and cabinets implies a usage that is in violation of the life safety code.

*Assembly Space  
Integrated with Exit  
Corridor*

The space must be separated from the exit access corridor by a wall constructed of UL type components. The other end of this assembly space exits into the west end illegal stairwell.

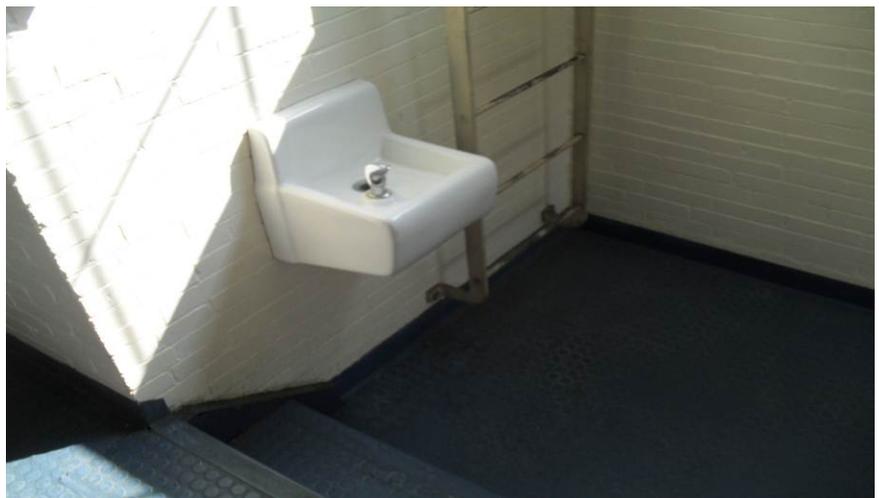
*Original 1934 Stairwell*

The east and west stairwells in the original building have a number of obstructions that remained after the renovation project. These items should be removed to provide the clearances as required by the life safety code. The handrails in both stairwells should be replaced and brought up to current life safety codes.

*Drinking Fountain and  
Ladder – Needs to be  
Removed*

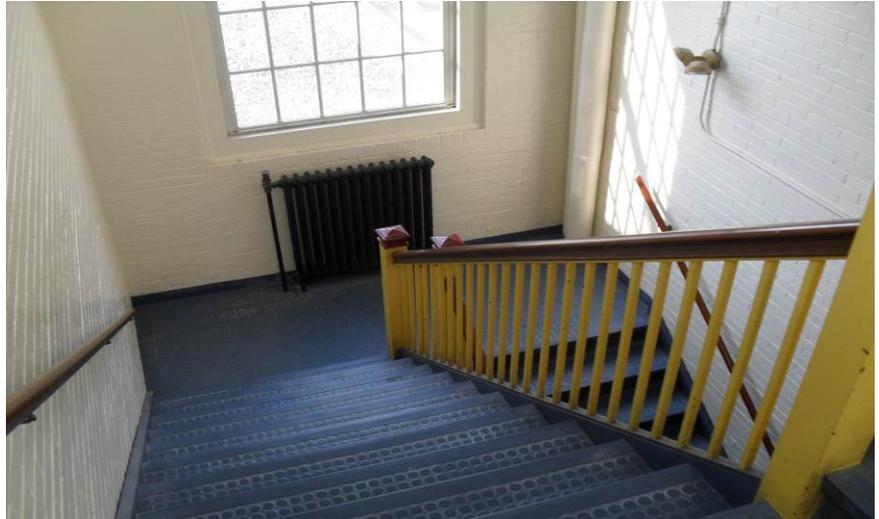
*Original 1934 Stairwell*

*Radiator Unit – Remove  
or Raise*

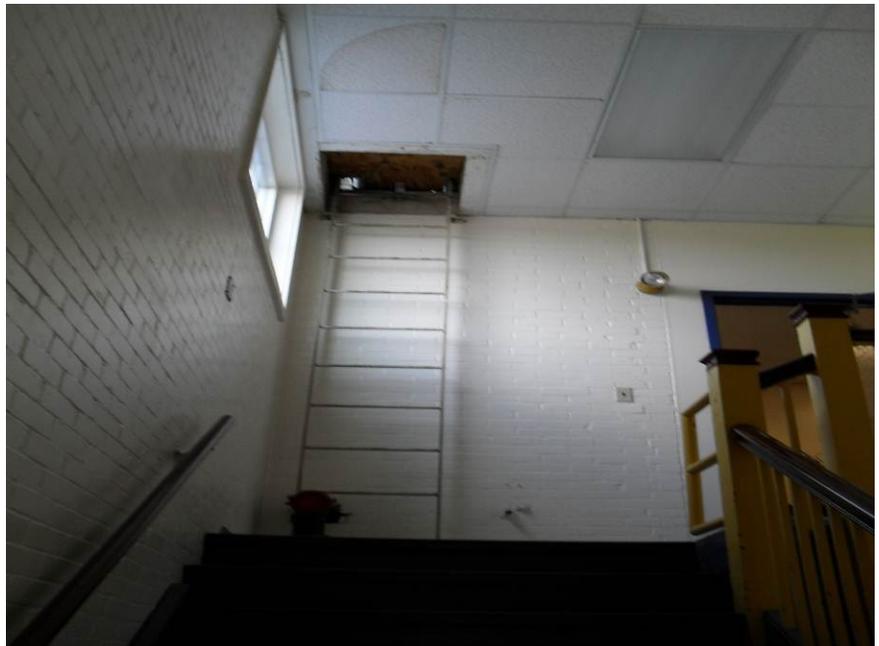
*Original 1934 Stairwell*

*Ladder – Relocate or  
Remove*

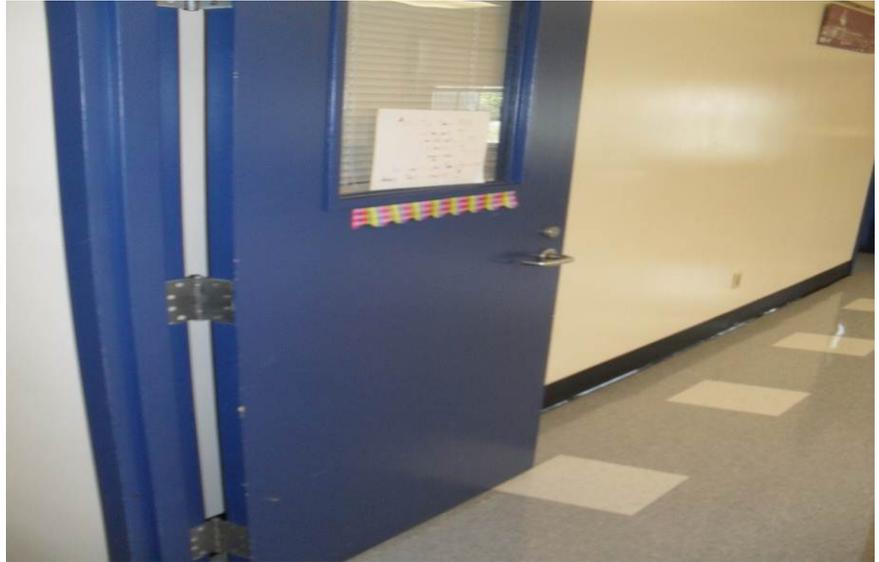
*Original 1934 Building*

Doors to the classroom have glazed panels with the bottom exceeding the allowable 42” height to the bottom per ADA.

*Bottom of Glazed Panel Exceeds 42” Maximum Height to Bottom*

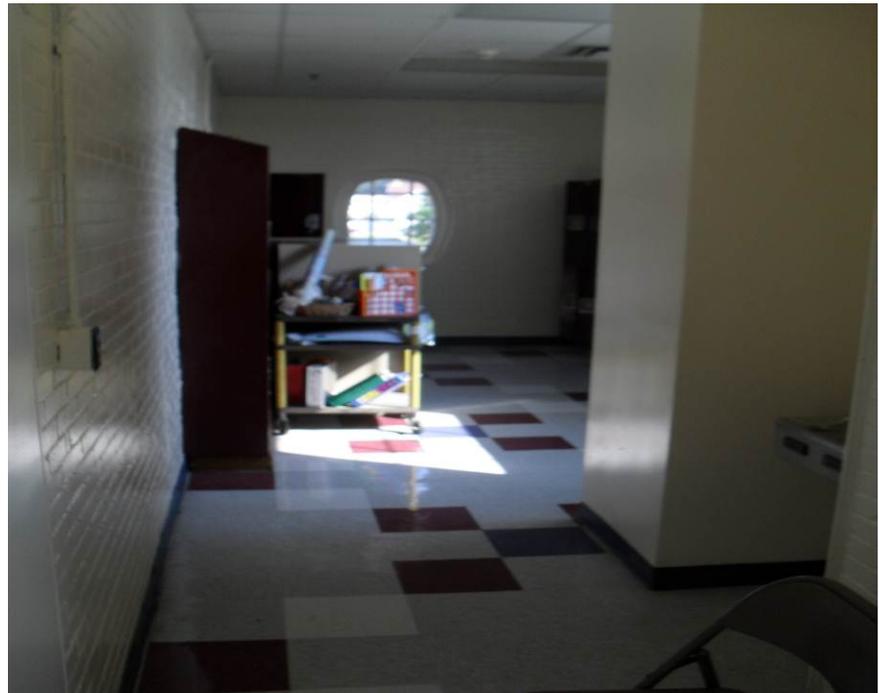
*Original 1934 Building*

In the second floor exit corridor to the stairwell there is an alcove off the east end of the corridor. This space constitutes a dead end corridor and must be separated by partition from the corridor.

*Dead End Space Off Second Floor Corridor*

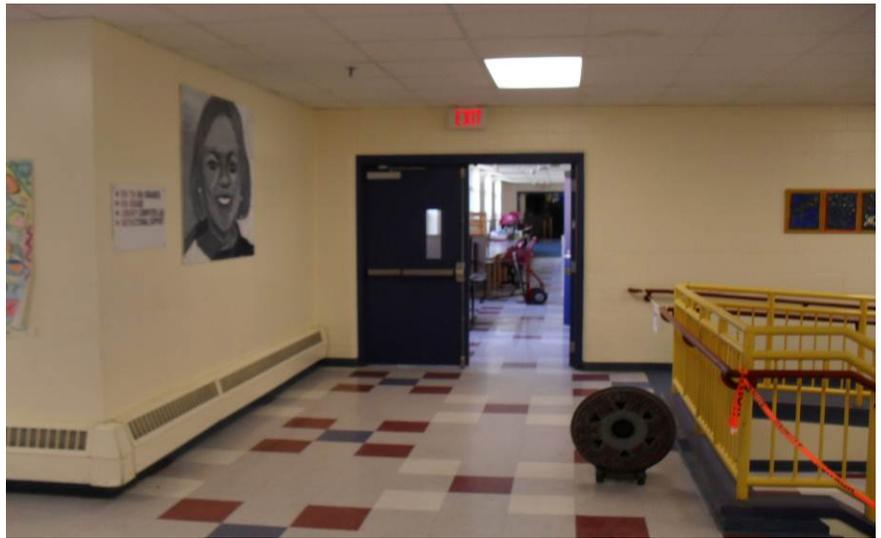
*Middle School Lobby / Corridor*

These cross corridor doors swing in the wrong direction. The exit access corridor from the library must have two means of egress out of the building. The doors swing into the exit corridor and should swing towards the lobby. The exit sign should be removed; this is a non-compliant means of egress.

*Illegal Means of Egress Door Setup at Lobby*

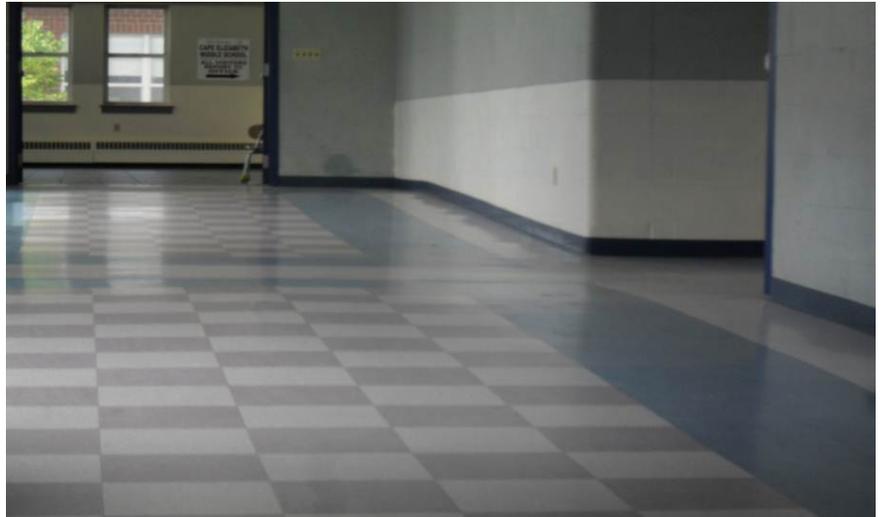
*Ramp at Cafeteria Corridor*

The corridor next to the cafeteria entrance has been constructed with a ramp to provide access to different levels of the cafeteria. The ramp transition from the upper floor level to the mid-level was not constructed to meet ADA. The ramp run was not extended long enough. The level requirements at each end and the bottom of the concrete ramp have been manually dished toward the entrance doors causing a cross slope that is non-compliant with ADA.

*Non-Compliant Ramp Entrance*

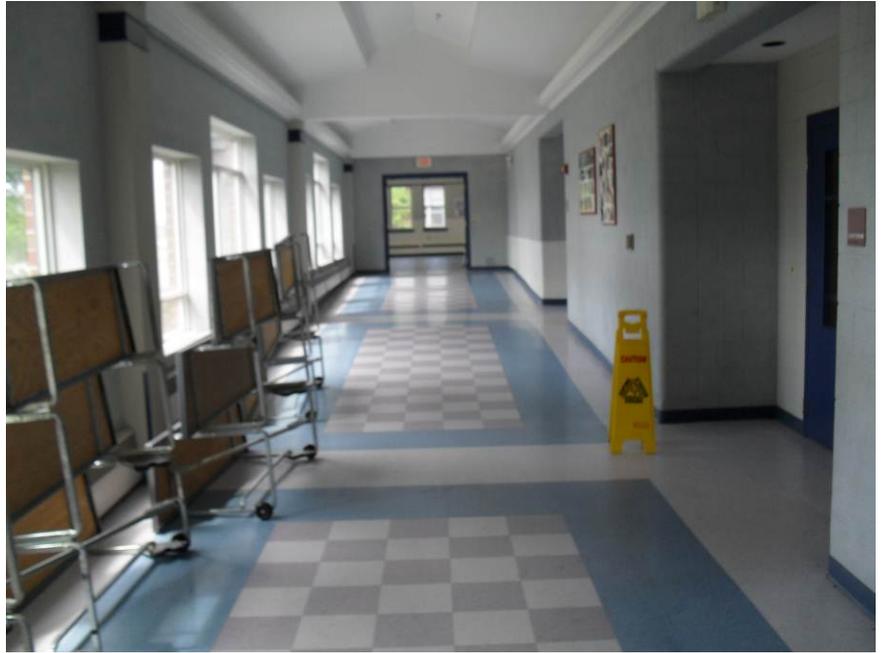
*Main Entrance Corridor  
With Ramps – Farther  
One is Non-Compliant*

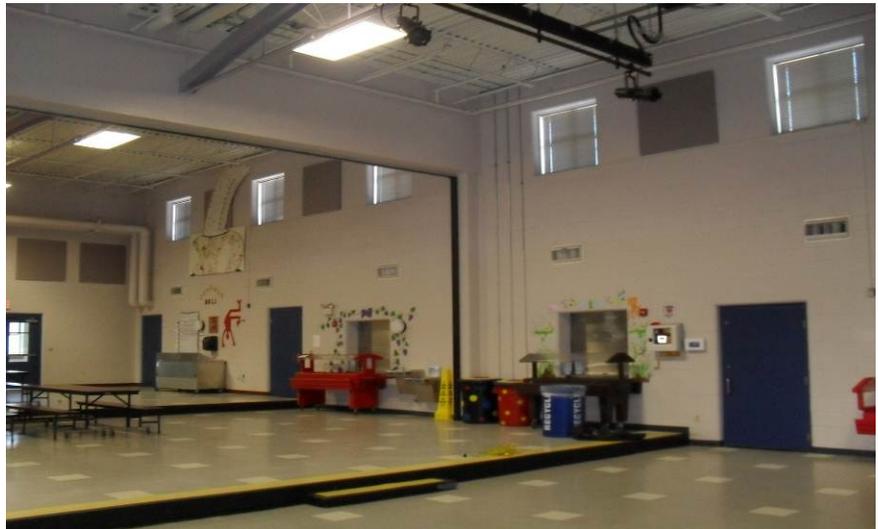
*Middle School Cafeteria*

These two steps between levels are not guarded off in any manner and also present a strong tripping hazard potential and the liability that goes with these levels.

*ADA Accessible Routes  
to Serving Line –  
Change in Level – Life  
Safety Code Issue*

Recommend a design study to propose a solution to this space that would meet ADA and the life safety code. As part of this study it should involve the serving area to see if there is a solution to steps and a more efficient use to your kitchen staff.

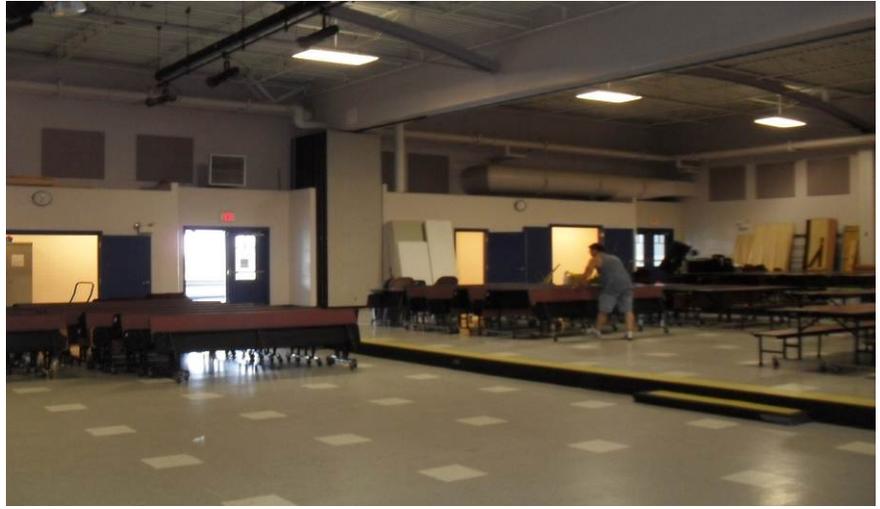
*Middle School Cafeteria*

*Low Level Lighting*

Would recommend a study and possible re-lighting to bring up light levels.

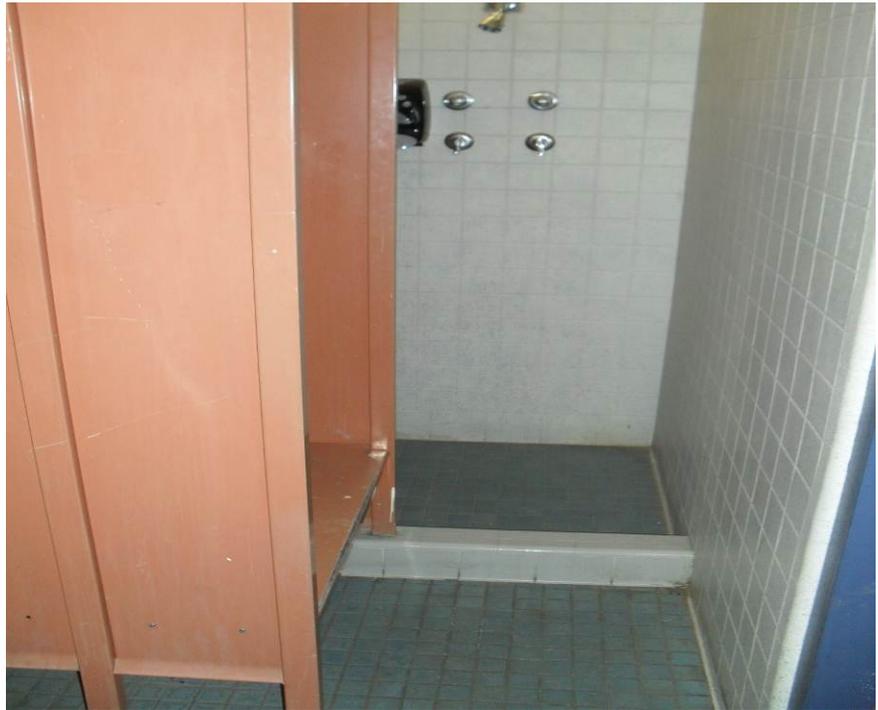
*Middle School*

*Non-Compliant Shower  
– Girls Locker*

As a method to upgrade shower areas and bring them up to ADA code we would recommend a complete renovation of both the boys and girls locker rooms.

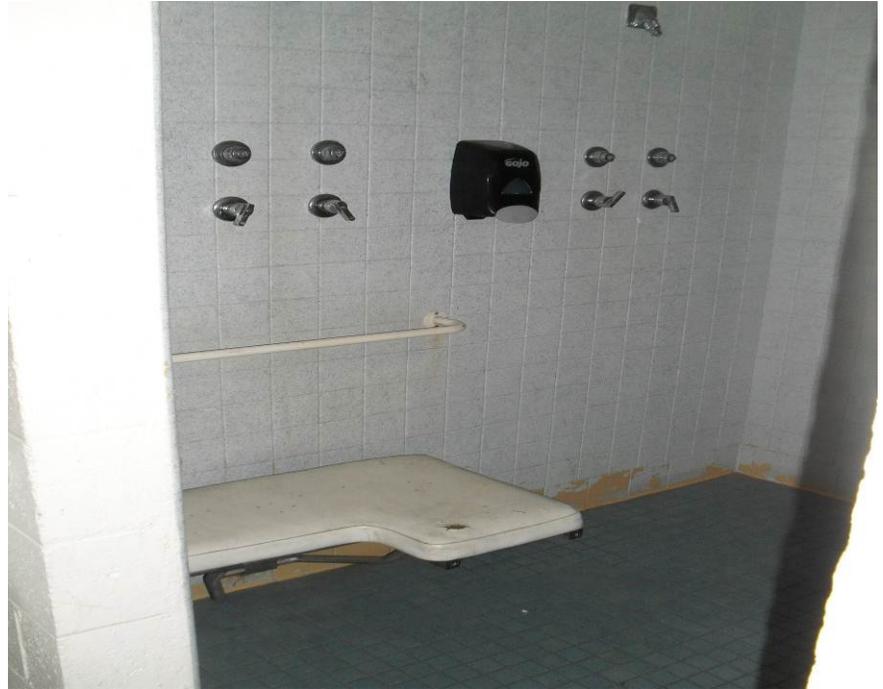
*Middle School*

*Non-Compliant Boys  
Shower*

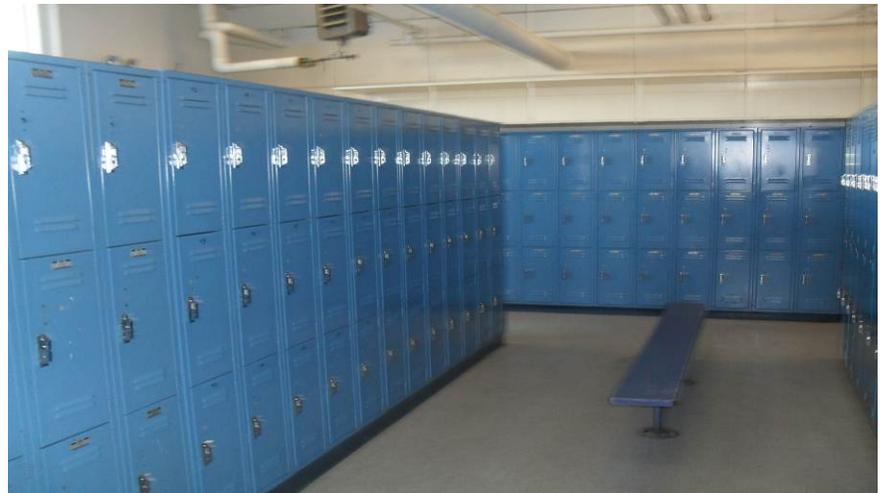
*Middle School Lockers*

*Provide ADA  
Compliant Lockers*

We recommend adding the correct amount of ADA compliant lockers to each locker room. The number is a percentage of the schools population.

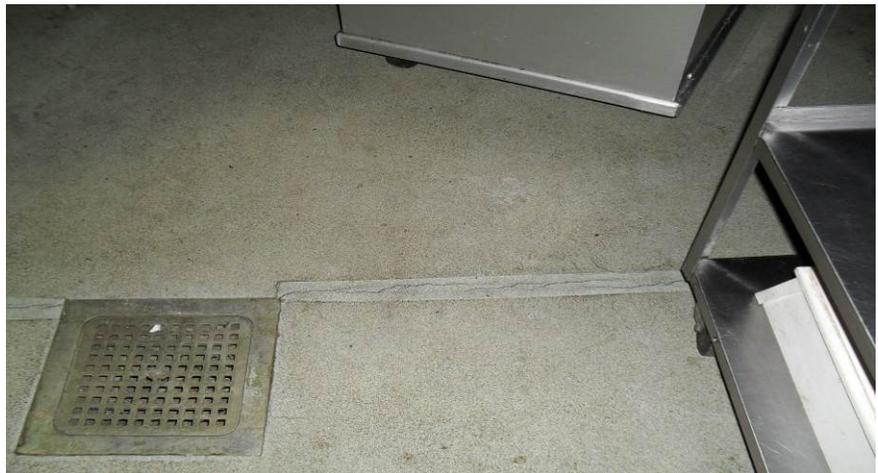
*Kitchen Floor*

The system is showing many repair areas and cracks due to the concrete slab substrate shrinking.

*Patched Kitchen Floor  
Showing New Cracks*

The system should be replaced as the cracks will allow floor washing water to enter and will only cause the system to fail further.

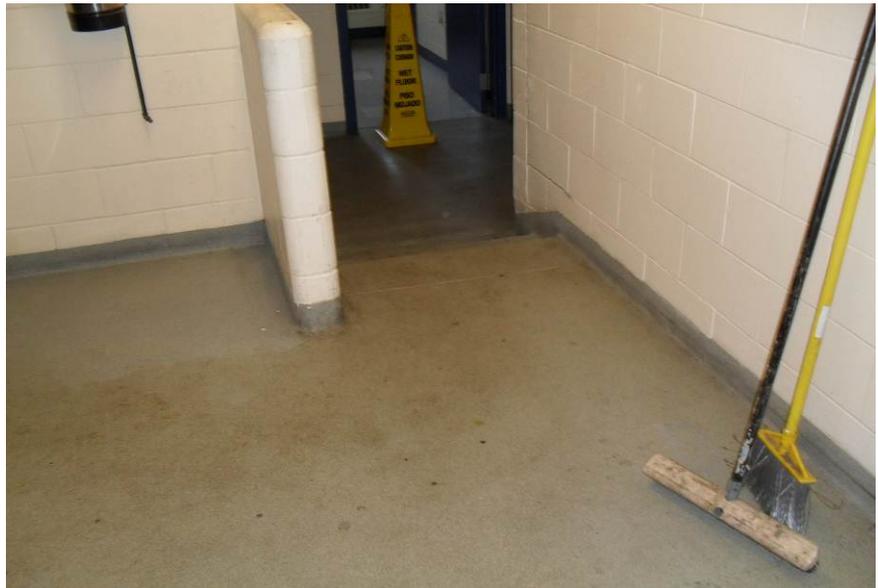
*Serving Line Area*

These steps offer liability exposure to your kitchen staff as a trip hazard.

*Steps to Serving Line*

When the decision is made to replace the floors we would recommend removal of the steps to the serving lines.

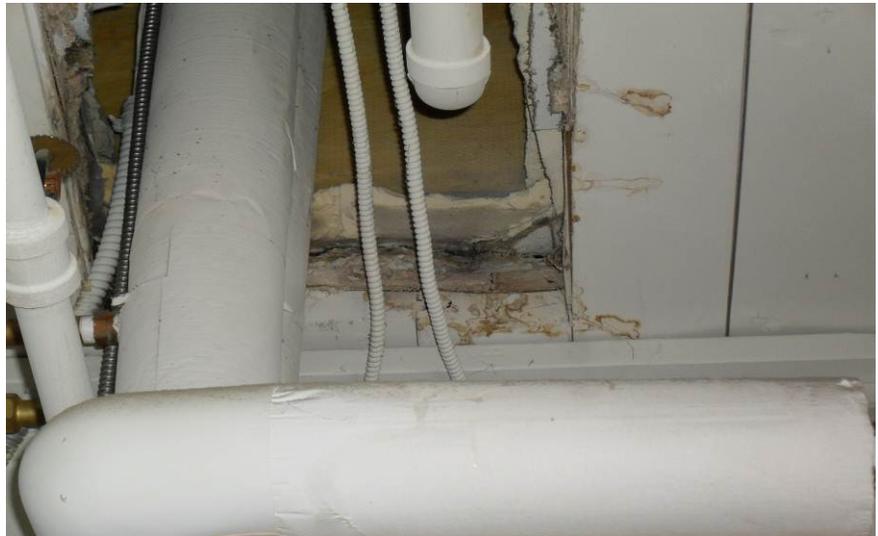
As part of a roof replacement project the new insulation was directly screwed to the wood deck over the old insulation, tar, and gravel. The picture below indicates that the roof cutout was done.

As part of any new roof replacement, and if a long warranty for the new roof is desired, the wood deck will have to be removed. It is highly probable that the existing wood deck and the bearing steel frame will not meet the new IBC roof load and drift load capacities required.

*Cutout in Existing  
Wood Deck*

This area should be considered and budgeted for a major structural upgrade as part of that roof replacement.

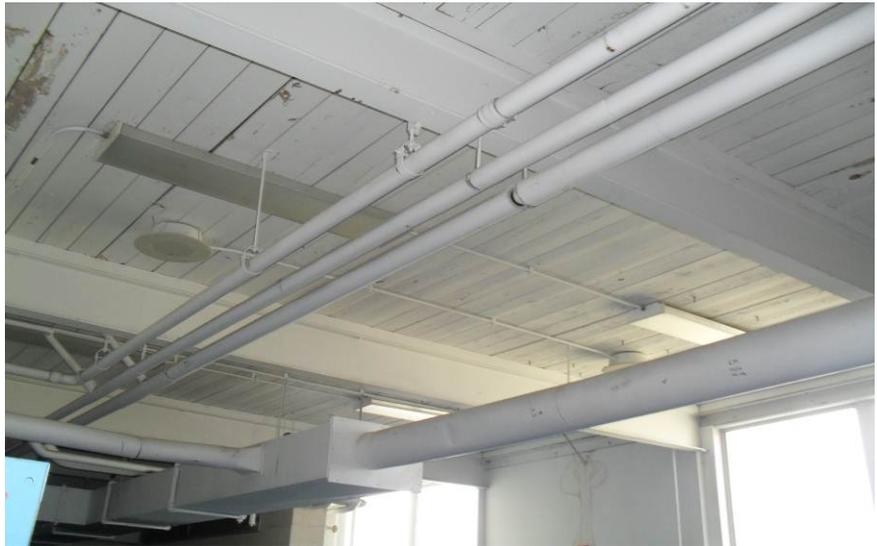
*Exposed Structure –  
Sprinkler Heads Layout*

Would recommend cutting in new heads to meet current code.
