**Town of Cape Elizabeth**  
Seven Building Facility Study  
*Cape Elizabeth, Maine*

**Introduction****Town of Cape Elizabeth Facilities Study**

*Facility Study Process*

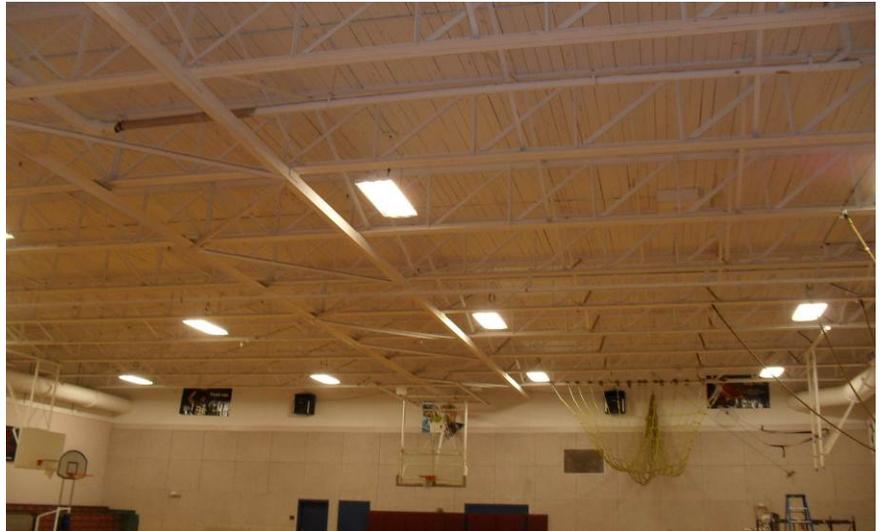
As part of a roof replacement project the new insulation was directly screwed to the wood deck over the old insulation, tar, and gravel. As part of any new roof replacement, and if a long warranty for the new roof is desired, the wood deck will have to be removed. It is highly probable that the existing wood deck and the bearing steel frame will not meet the new IBC roof load and drift load capacities required.

*Gymnasium Wood  
Decking*

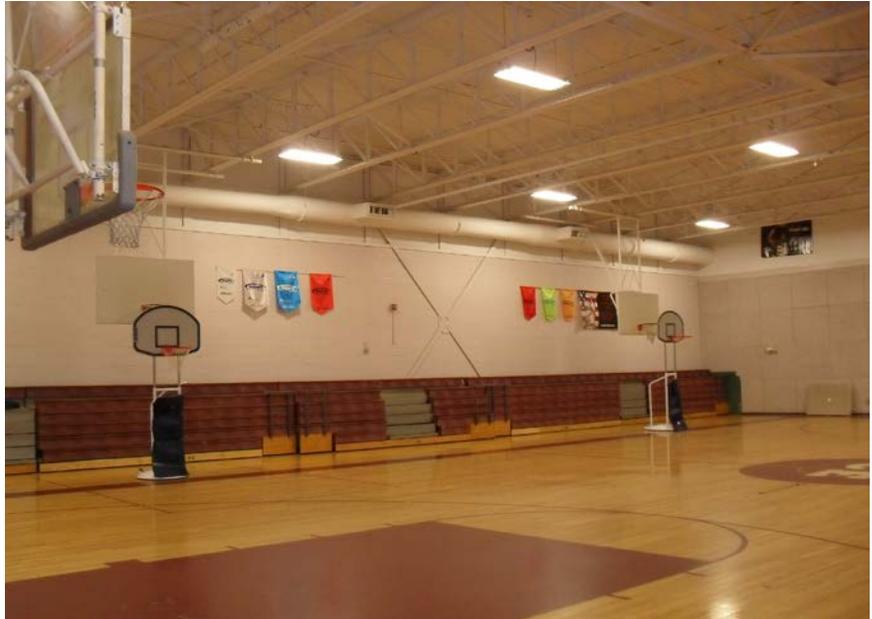
*Middle School Gym*

The gymnasium floor has been sanded as part of refinishing floor operations. There has been a substantial amount of wood surface removed during these sanding operations. The wood floor has been measured as low as 5/8" on the ends down from a 7/8" to 1" board when installed. Close inspection of the floor and one can see the tongue of the adjacent board thru the joint between. The wood floor is a direct nailed system and cannot be sanded again for a surface refinish system.

We would recommend a floor replacement be considered – the floor has been in place for almost 50 years.

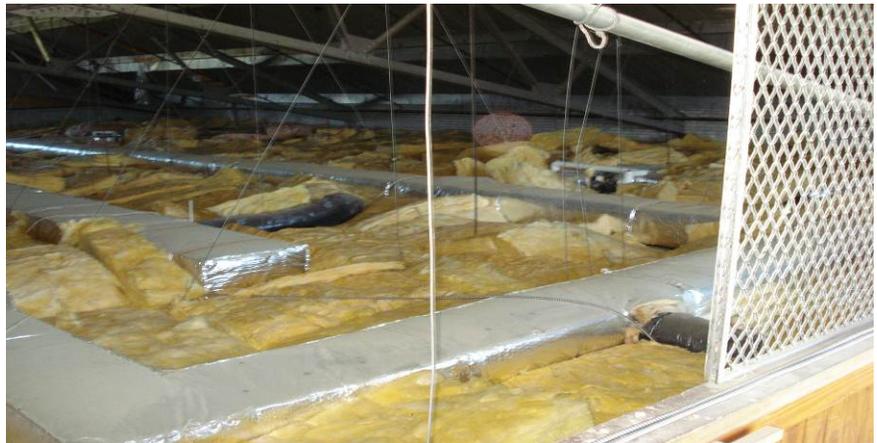
The 1934 original building was constructed with a second gymnasium space. To achieve the height for this space on a second level the roof was constructed with a series of steel angle truss girders spanning from wall to wall and steel beam cross purlins attached to the truss. On top of the cross purlins a large wooden beam was attached at each cross beam and a tongue and groove deck spanning from roof edge up the slope to the ridge is the surface for the roof shingle attachment.

*Steel Truss Girders*

Recommend removal of the entire ceiling system and construction of a new insulated drywall ceiling and air barrier at an extended height. New system should have capabilities to hang all the relocated ductwork to a cavity between the insulation barrier and a new suspended ceiling. The attic space would then be turned into a cold space and properly vented. This repair should offer an energy savings by reducing the amount of volume the school is currently heating.

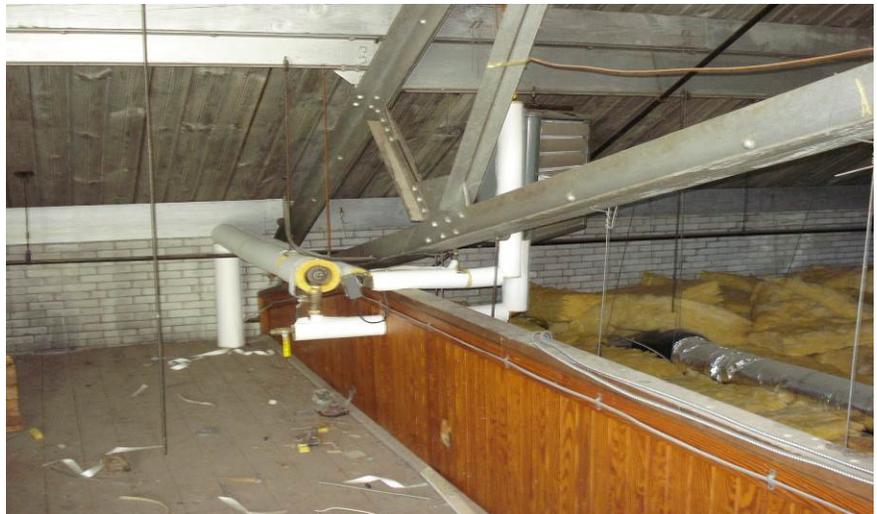
*Steel Truss Girder  
Old Wood Platform and  
Partial Wall*

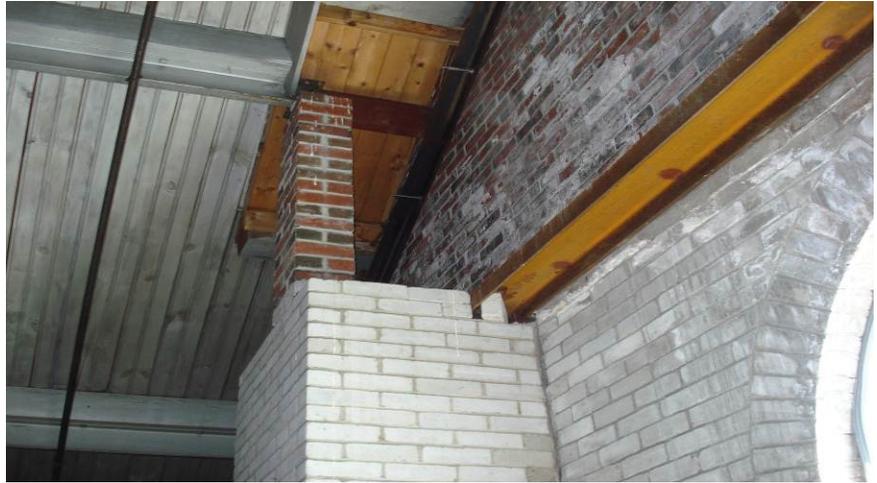
From the exterior the gable ends appears to have been repaired at some point, possibly when the roof was replaced. On the interior side of the gable ends a structural reinforcement of the walls has been installed. The picture indicates a series of structural shapes through bolted to the masonry from these new structural components and the components were welded back to the existing structure.

It would be safe to assume that added structural members were installed to brace the end wall. No design information was found to show what level of bracing was installed.

*Gable End Wall Brace  
Brick Pier off Existing  
Chimney*

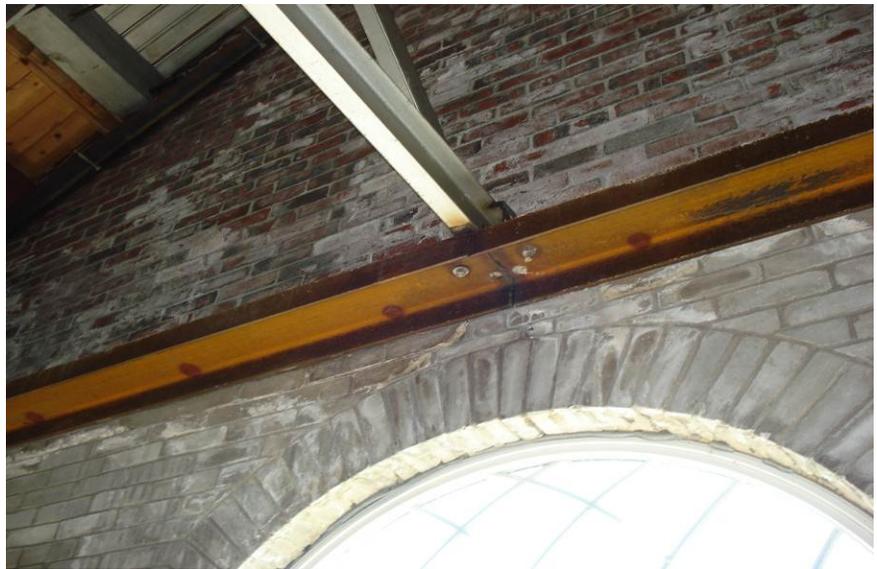
*Bolts Through Exterior  
Wall*

*Beam Shapes Welded  
and Bolted to Bottom  
Chord Cross Beam  
Extension*

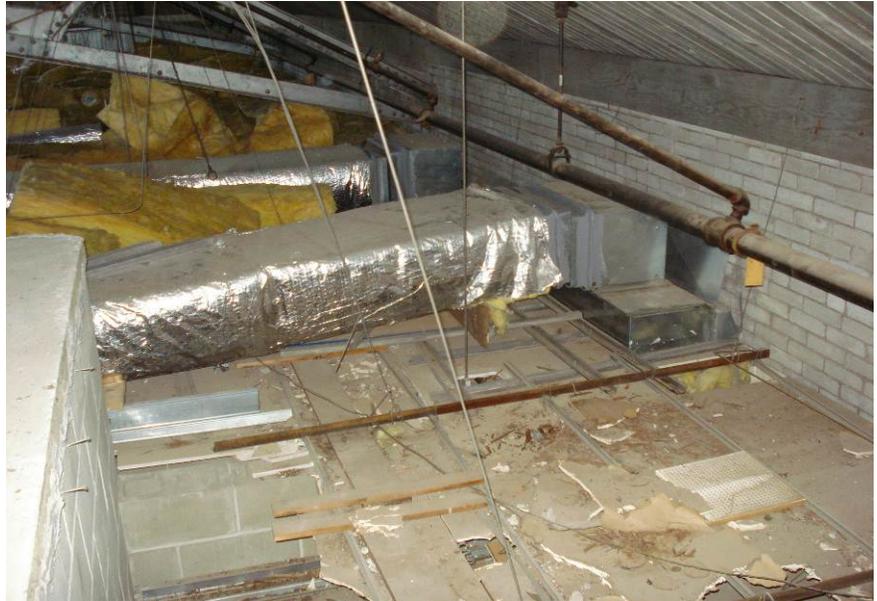
*Insulation Pulled Back  
From Ceiling*

*Drywall Ceiling  
Framing Sprinkler  
Piping Hangers to Cold  
Roll Channel Grid*

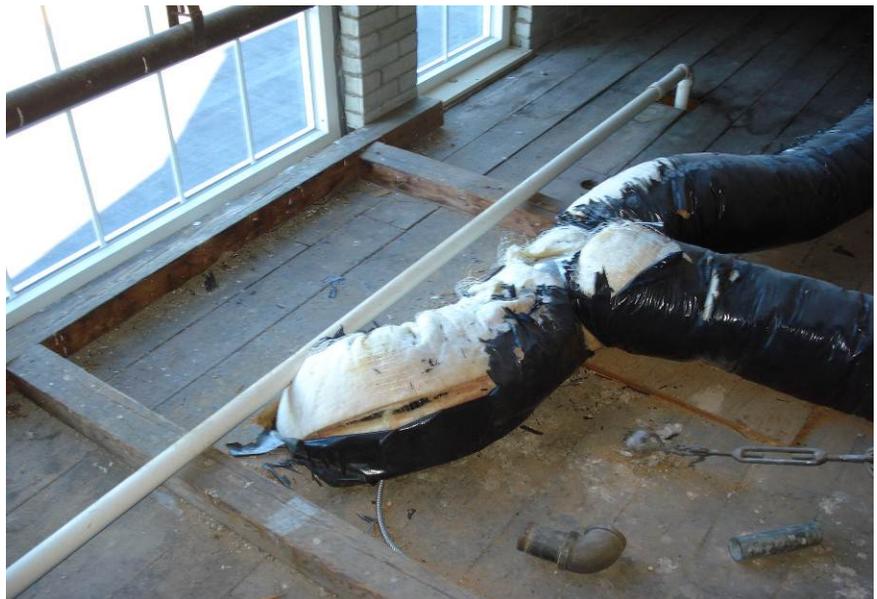
*Ductwork Through  
Existing Wood Platform*

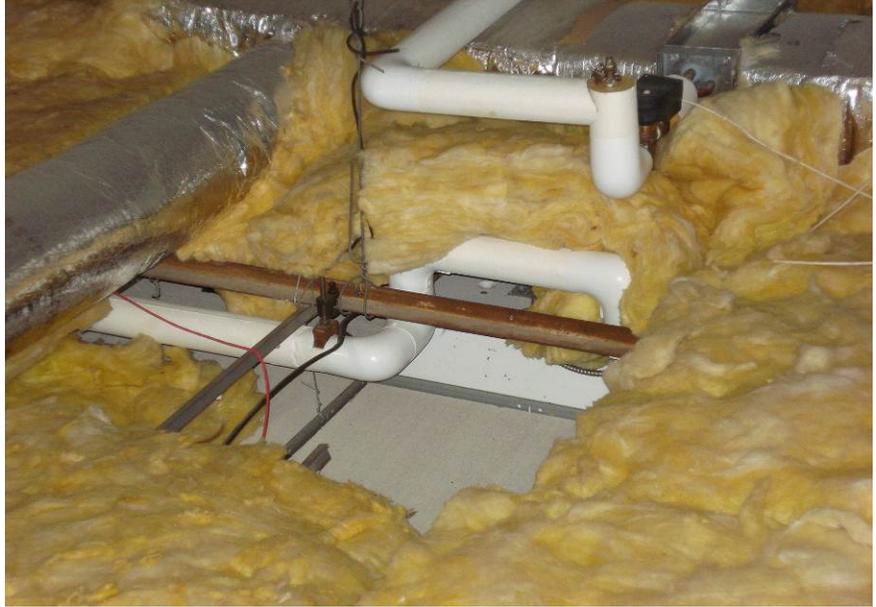
*Light Not Suspended  
Independently From  
Suspended Ceiling Grid*

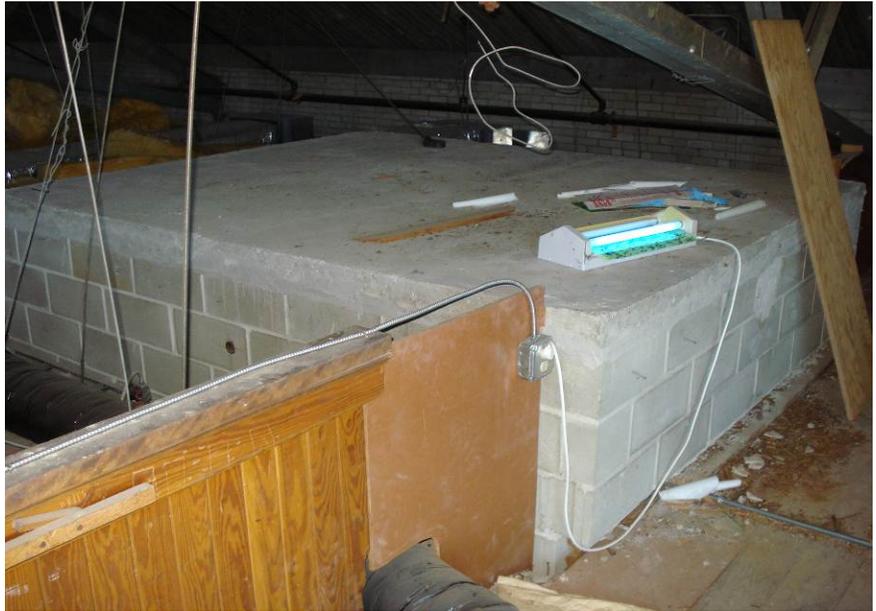
*Elevator Shaft Cap  
Existing Wood Deck  
and Wall*

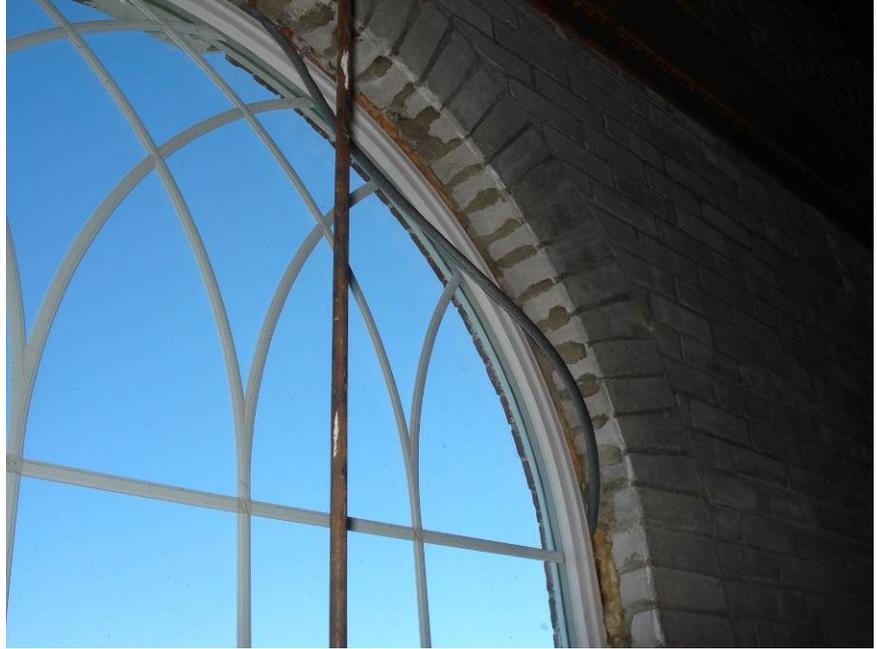
*Recent Window  
Replacement*

*Window Extends Into  
Attic Space*

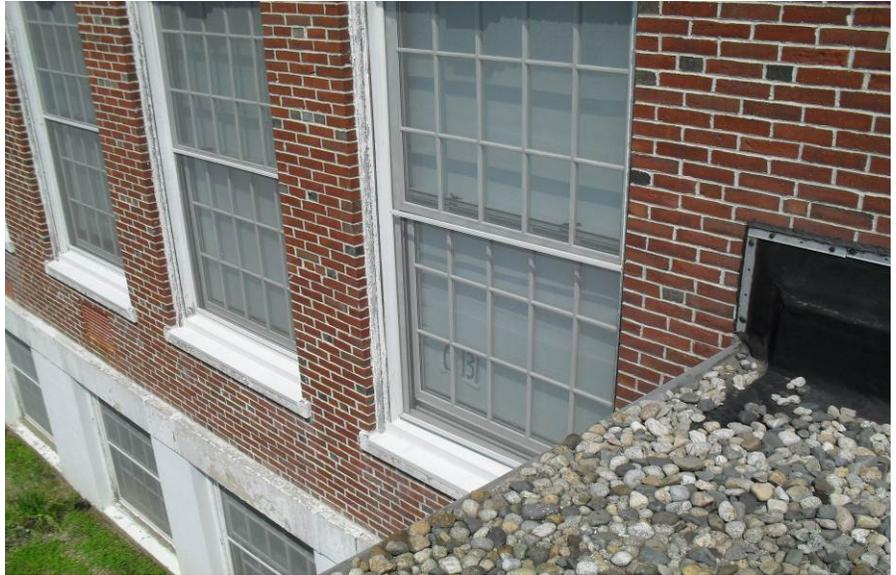
*Original School Building*

*Prefinished Metal Sill  
Over Cast Stone Sill*

We would recommend the installation of a prefinished metal panning system on all sides of the opening to extend the life of the wood frame. Currently a sanding, patching and repainting effort is underway to refinish these old frames. The frames are deteriorated to the point where this effort will be counterproductive. As a second option to this issue we would recommend removal of the existing aluminum sash unit, old wood frames, and window boxes. Provide new wood blocking and interior moulding to replicate a window of this type and install a new metal system on the exterior side as noted in option above.

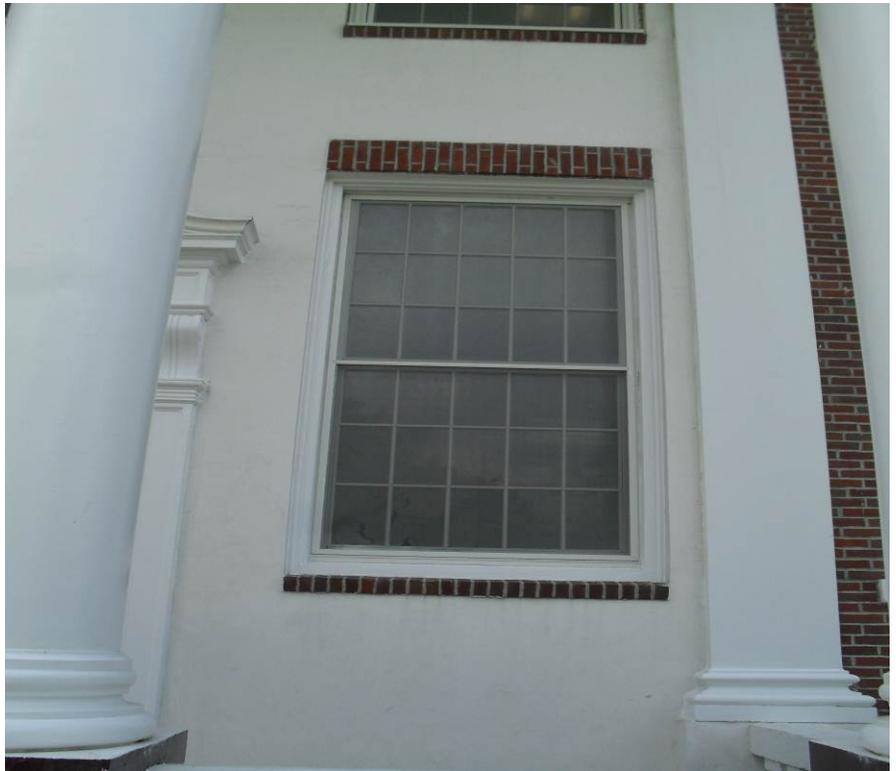
*Original School Building*

*Existing Window  
Completed With Metal  
Pan System*

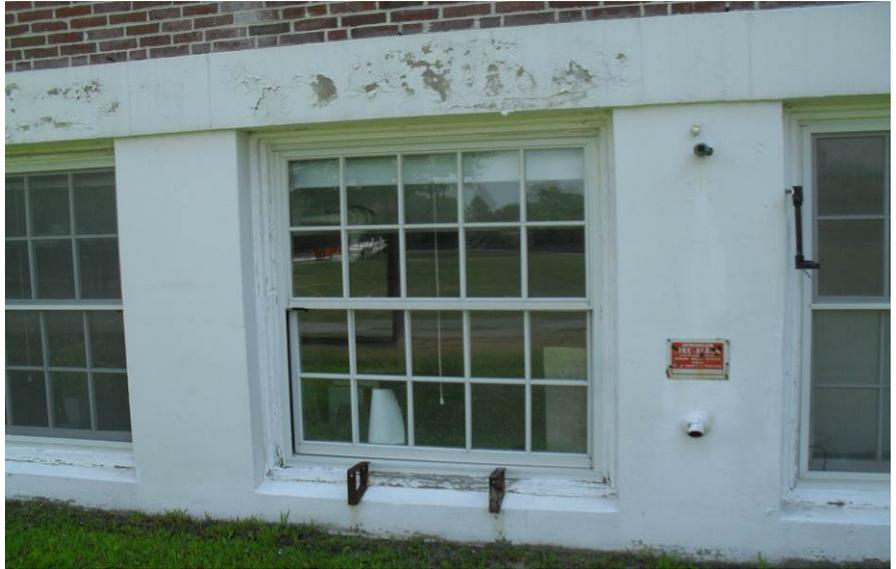
*Original School Building*

The white base of the building is the original exposed concrete foundation with a painted surface. Some exposures of the building have been repaired and refinished. Other exposures need work to the concrete surface with proper prepping and painting as well as window frames

*Concrete and Windows  
Requiring Repair and  
Refinish*

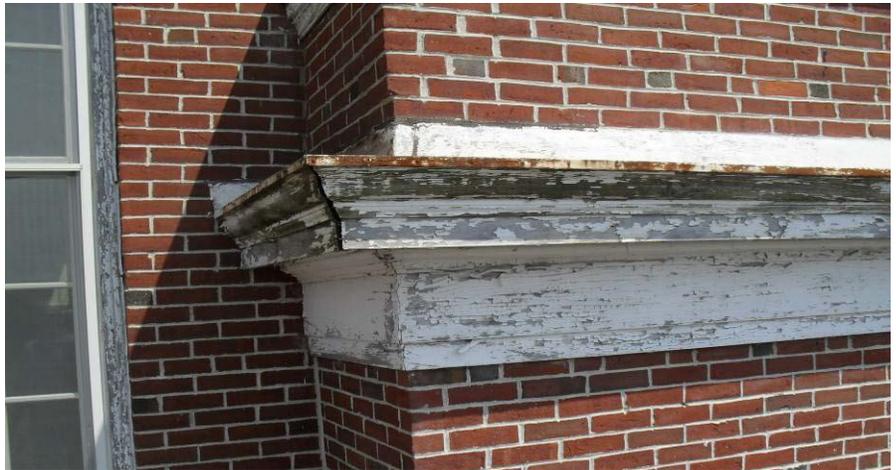
*Original School Building*

*Wood Cornice*

We would recommend the complete removal of all the wood trim and soffit boards and any rotted blocking system behind. Provide a new pressure treated wood frame system with a prefinished white metal bent cornice with a profile to match what was removed. By replacing this old wood cornice with a metal system it would preserve the appearance of the building as originally installed with low maintenance long term.

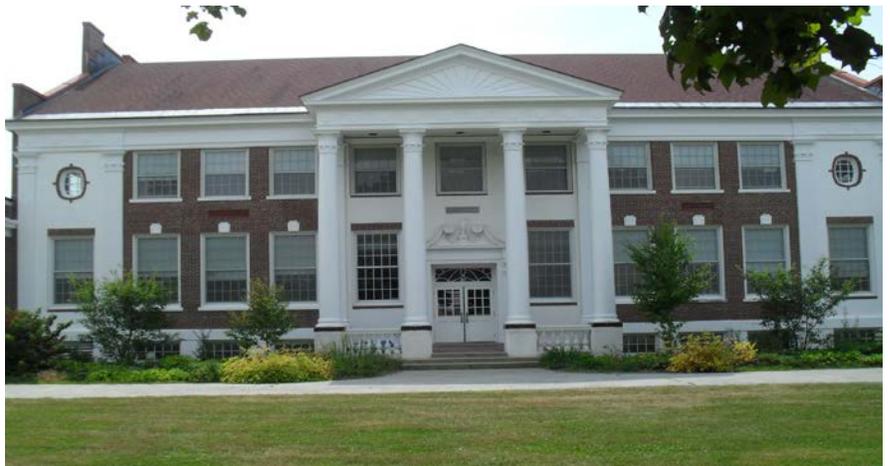
*The 1934 Building  
Exterior Columns at  
Front Entry*

The bases of the large exterior wood columns at the 1934 building have rotted out due to age. The columns are constructed of wood. Columns of this type and size will have to be custom made and we would recommend they be constructed of fiberglass. When the decision is made to repair the columns, at that time when the work commences it could be determined, depending on the condition, to do a partial replacement or if the condition is too deteriorated then complete replacement would be warranted.

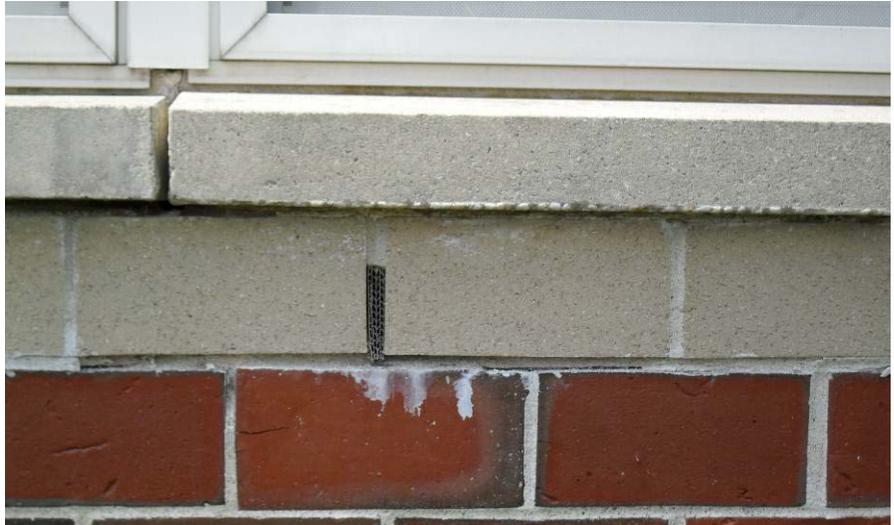
The new brick veneer installed on the elementary/middle school as part of the 1994 project has an issue with an improperly installed flashing system at the window sills. The brick module is an economy brick unit which is 4" x 8" extruded, with core holes in the brick center, it is not solid. In the contract documents a flashing system was indicated on the window details locating the flashing under the window sill and extending down to under the precast concrete sill. The constructed detail shows the flashing was extended down one course below the precast sill through the mortar joint. This flashing installation is trapping water and a freeze/thaw action has destroyed the mortar joints at the precast sill and the brick course below.

*Flashing at Location  
Different From Contract  
Documents*

*Fabric Flashing Extended  
Through Joint – Joint  
Spalled Off*

Recommend a corrective repair to all existing windows that were built with this condition. It would involve removal of the precast concrete sill, brick and flashing down to the course where the flashing extends through the brick veneer. Though BIA recommends flashing under window sills we have, through our experience in this weather climate, not installed this flashing system. The issue with flashing not installed correctly thus forming a sag and trapping water at that level along with rapid changes in temperature during winter conditions leads to this type of damage. The brick should be re-installed with the same size unit and blend to match, and then reset the precast sill with a proper anchor and soft sealant joints at the butt and end joints. No anchorage of the sill was indicated on the contract documents but is required currently by IBC in conjunction with Siesmic Codes.

This type of damage should be corrected ASAP due to water entry causing more damage to the veneer and a more extensive repair cost.

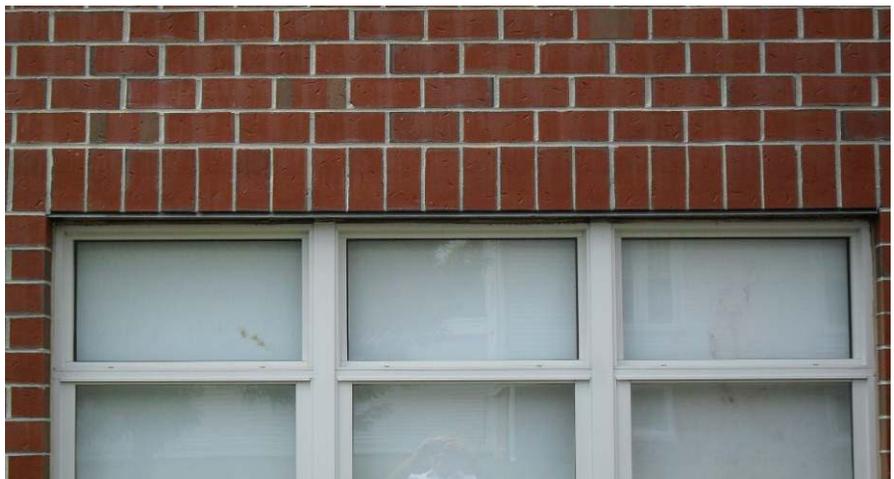
The new brick veneer installed on the elementary/middle school as part of the 1994 project has not been properly weeped at the window head. The contract documents indicate a location for the flashing on top of the lintel angle which has been verified. The weep hole was not installed as part of the construction process. The 2-story classroom wing appears to be the area with the most amounts of windows without weeps.

*Window With No Weep  
Holes*

We would recommend a corrective action of cutting in new holes at the proper location at a maximum spacing of 2'-0" o.c. at all window heads that have no weep holes. We also recommend at those window heads with a few weep holes that additional weep holes be cut in to provide the proper water drainage out from behind the veneer.

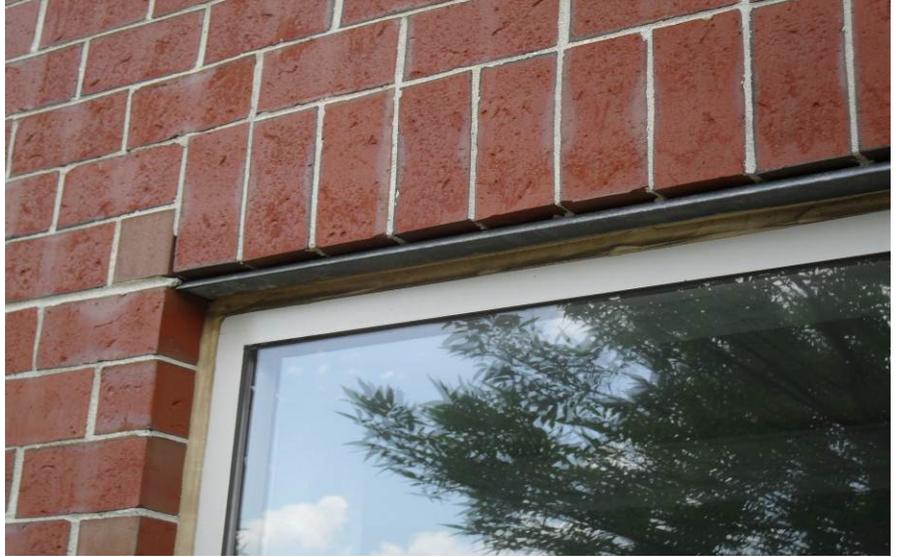
*Flashing at Window Head*

The flashing over the windows that was installed was not extended to the end of the steel lintel. A properly installed metal flashing at this location would extend a minimum 8" into the jam with an end dam turn up to keep water from migrating off the end and under the lintel.

*Flashing – Not Extended Properly – Weep Hole on End Only*

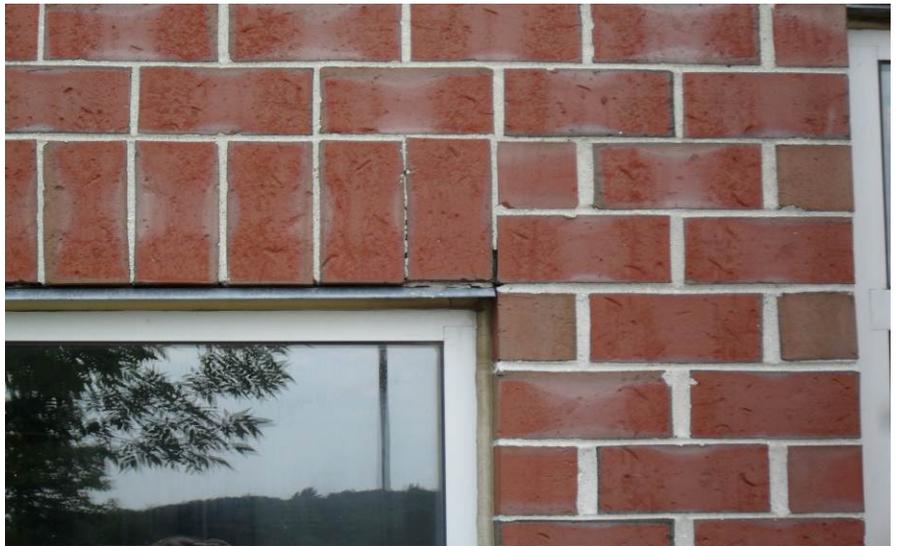
*No Butt Joint, Flashing Not Extended – Weep Drains Down Edge*

*Improper Window Head Installation*

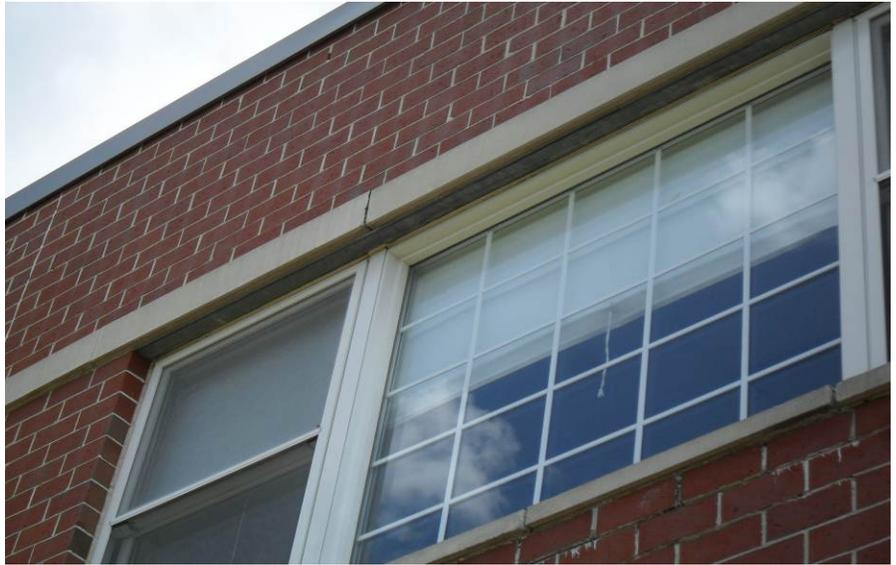
*Precast Concrete Lintel  
Head*

At locations where the precast concrete lintel is shown as an element over the top of windows, the flashing as indicated on the contract documents was installed. Most of the vertical butt grout joints between the pieces has broken and fallen out. The grout was broken either due to the expansion/contracting of the precast units or the fact that no weep hole was installed and freeze/thaw action has broken the mortar and allowed it to fall out.

*Broken Joint Between  
Units*

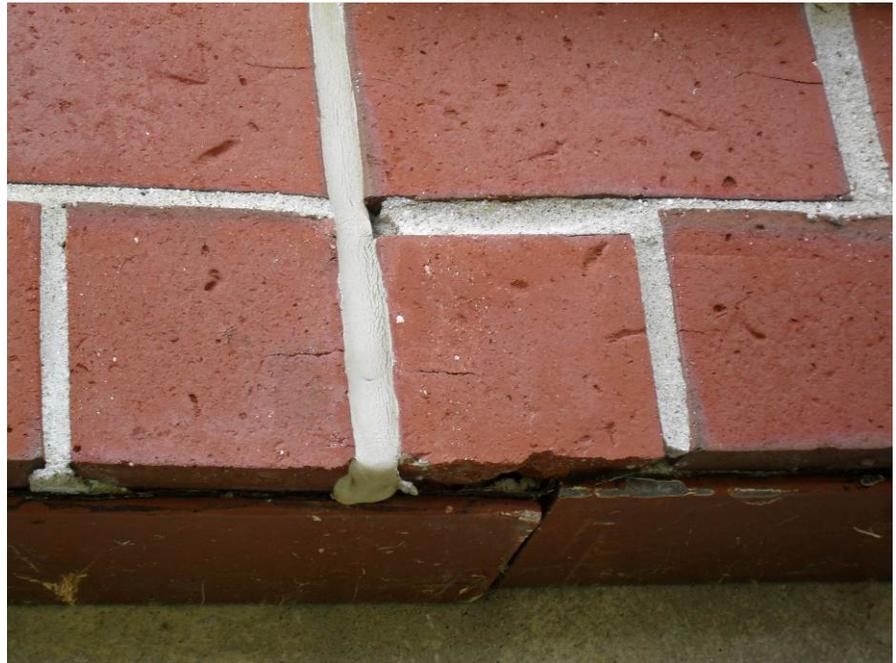
*Brick on Support Angle*

On two wings of the existing elementary school the 1994 construction documents called for installing a new brick veneer out beyond the face of the existing foundation. The detail shows a support angle bolted to the existing foundation with a new through wall flashing and weep holes. Field observation showed that no flashing was installed and no weep holes were observed at that point. Some locations showed weep holes at the same height as the bottom of the windows but no flashing was installed under the windows.

*No Flashing Pulled  
Through at Support  
Angle*

Since it was not constructed as detailed, we would recommend a forensic removal to find out how it was constructed. A corrective repair action could then be put in place. If left long term in its current state it would potentially have a long term impact on the life of this wall, especially on the support angle.

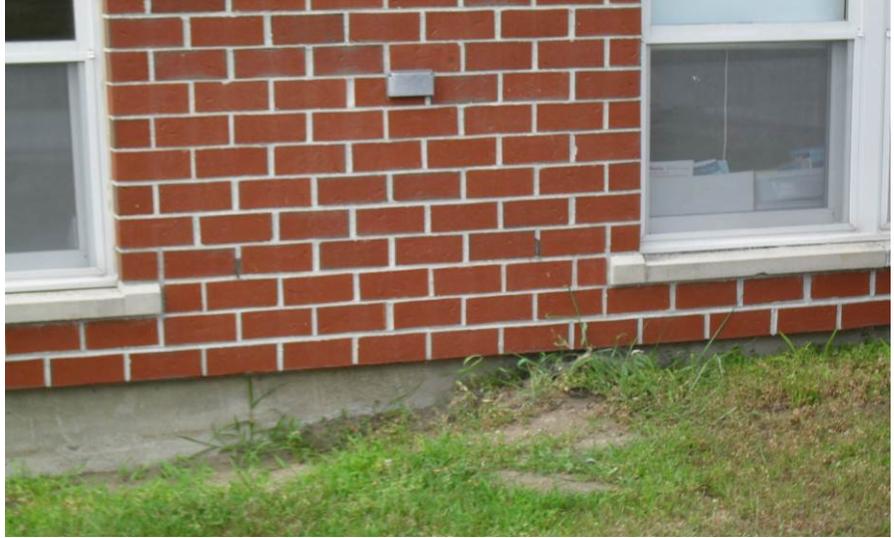
*Weep Holes Installed at Unexplained Location*

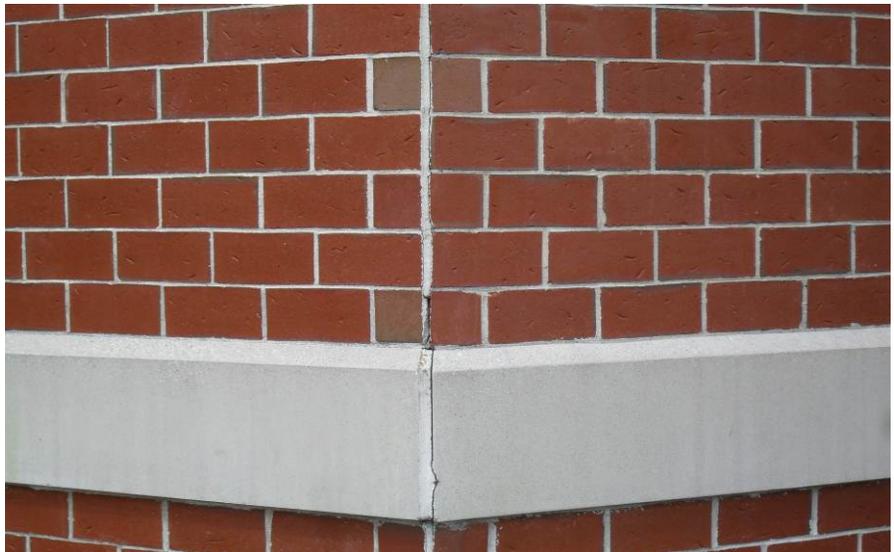
The precast concrete bands that horizontally course the new veneer were head jointed with mortar. Most of them have cracked from thermal expansion and some mortar has fallen out leaving an open joint. The open joint creates a water entry point that will only allow for more damage to the veneer in the future.

*Joint Failure*

Recommend that all head joints in this condition be routed out and then filled with a backer rod and sealant joint. Some joints have had an attempted repair but the improper installation has failed.

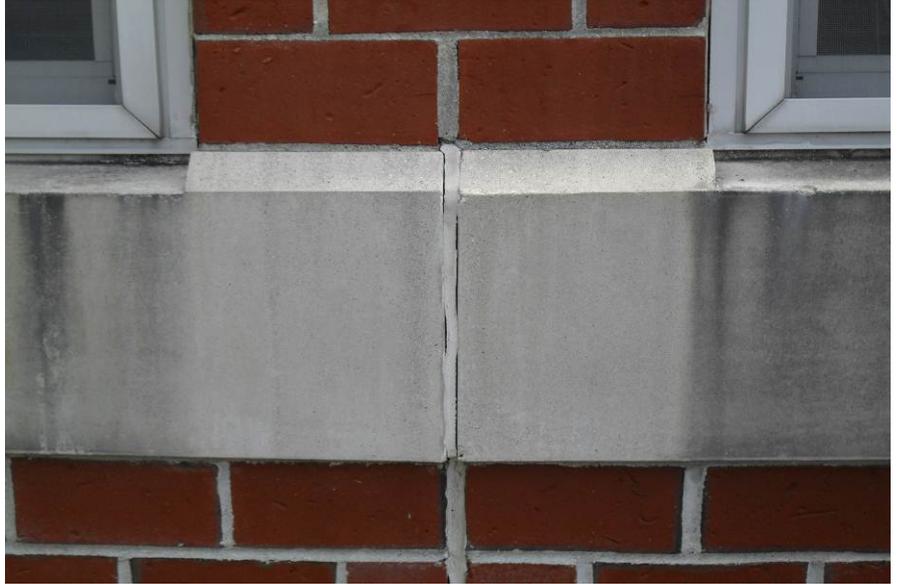
*Repair Failed*

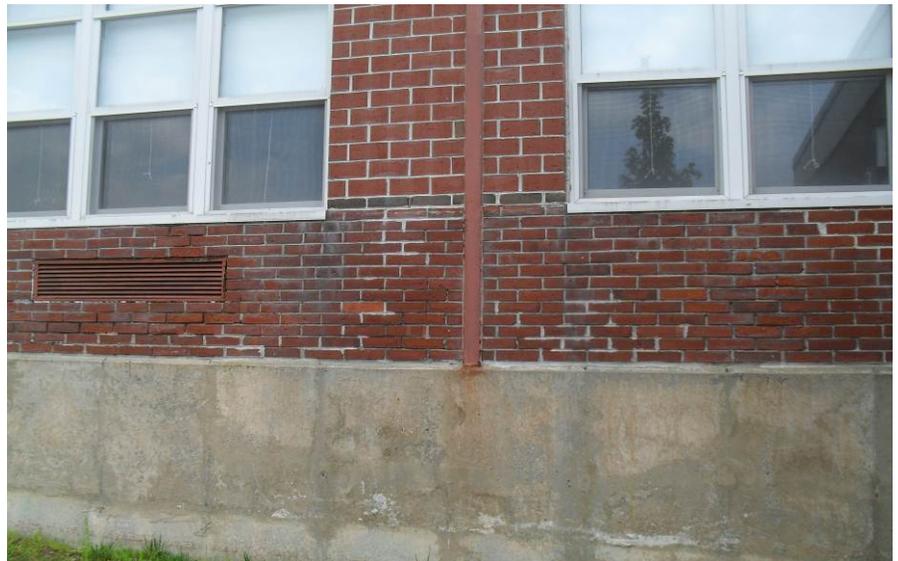
*Elementary School - Wall*

As part of the 1994 construction project the old window-wall system was removed and replaced with a new stud backup and brick veneer infill. The old window system was removed down to the bottom of the old window-wall sill and the old brick was left to the top of the knee foundation wall. The remaining face brick needs a major corrective repointing and brick patching. Some joints have been caulked up to stop water entry and patch mortar has been applied elsewhere. The original mortar is over 60 years old and needs work.

*Face Brick in Bad Condition*

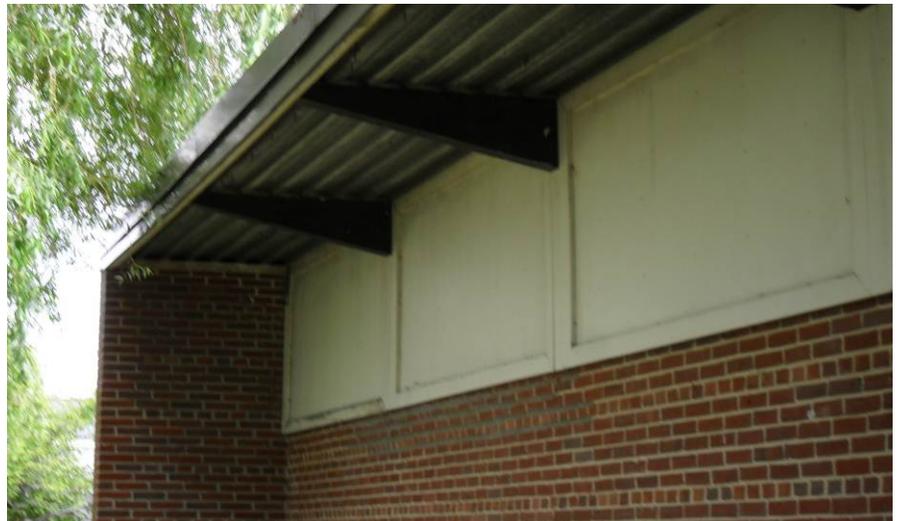
*Original 1948 Primary School Building*

*Plywood Panels Needs Painting*

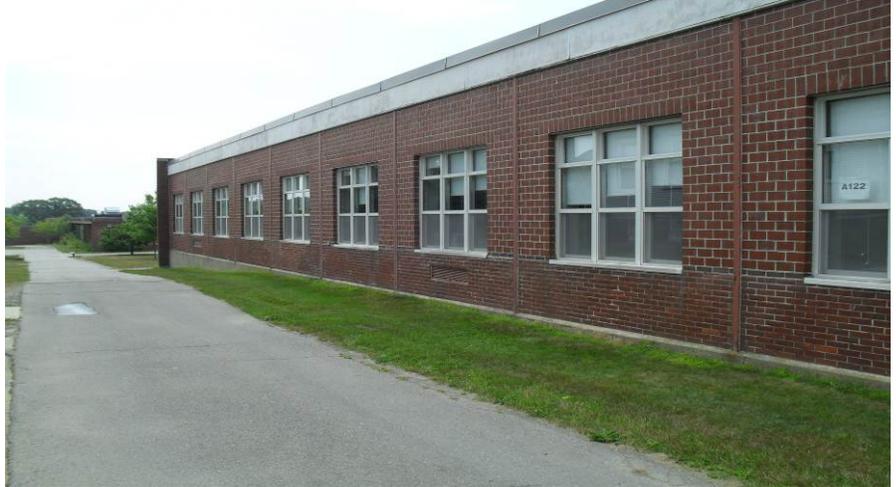
*Original 1948 Primary  
School Building*

*Opposite Side Exposure –  
Brick Condition*

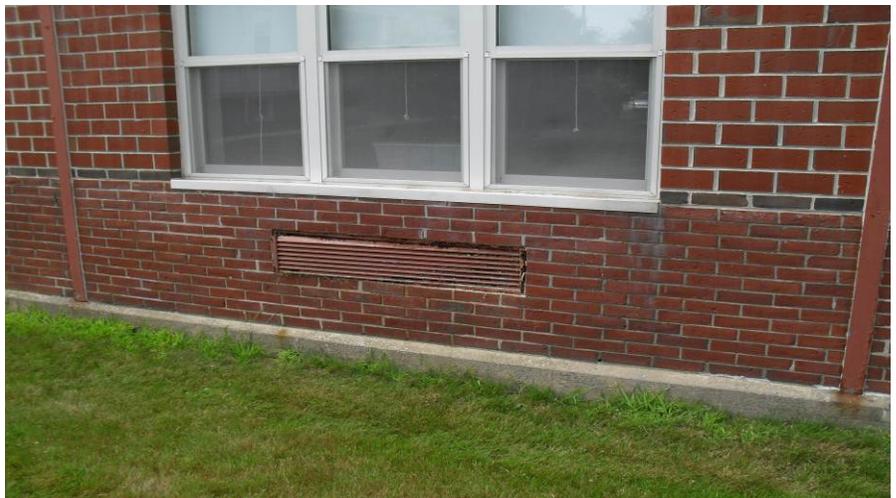
*Original 1948 Primary  
School Building*

*Unit Ventilator lower in  
Bad Shape*

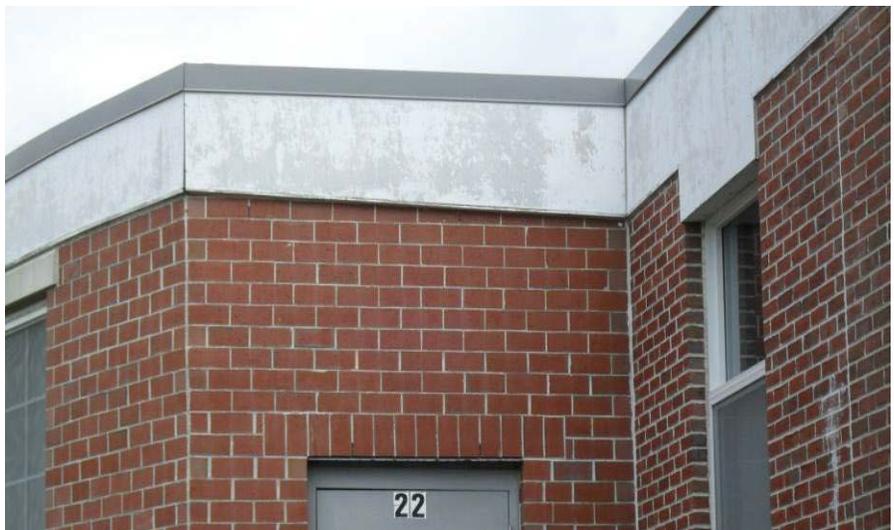
On the library addition and other locations there is a wood panel MDO panel attached to a wood backup framing system. The panel has become completely deteriorated due to weather exposure and should be completely replaced. Would recommend a maintenance free coated metal skin panel for long term durability.

*MDO Panel Has Failed*

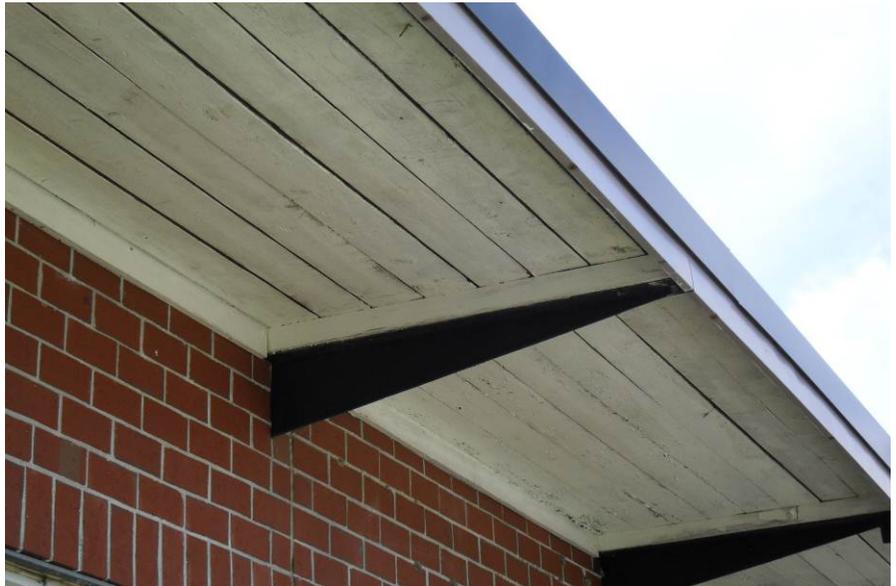
*Exposed Wood Decking*

As a potential roof replacement project for this area, the wood decking would have to be removed for a new metal deck to meet current loads.

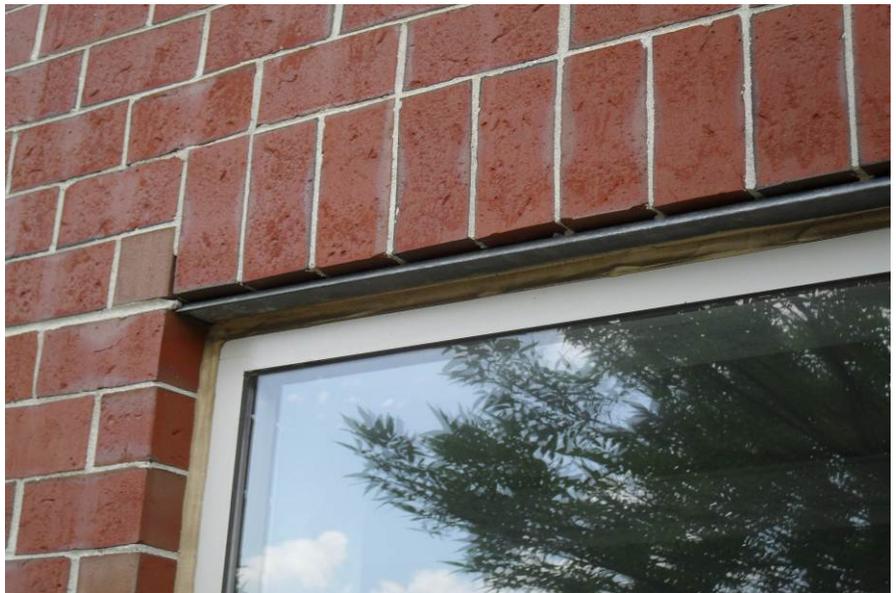
*Window Sealant System*

The caulking system that was applied around the windows as part of the 1994 additions is showing signs of imminent failure and discoloration. The head joint at the top was installed as an extremely large joint and on an average the installation was not very good. The joints at the jambs were done as an overlapping joint and traditionally this type of sealant joints are the first to fail in this type of application.

*Window Head Sealant Joint*

The sealant system around all your openings will have to be replaced in the near future.

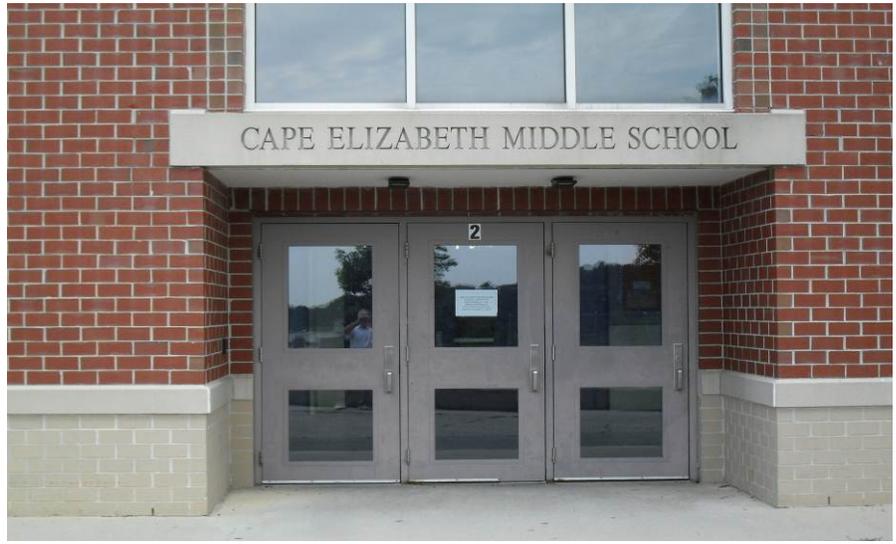
*Main Entrance*

The main entrance doors have a brick course directly over the doors. It would appear that the door frame was installed a few inches short and when the space discrepancy was discovered and was infilled with brick. The brick appears to be sitting directly on the door frame below the lintel.

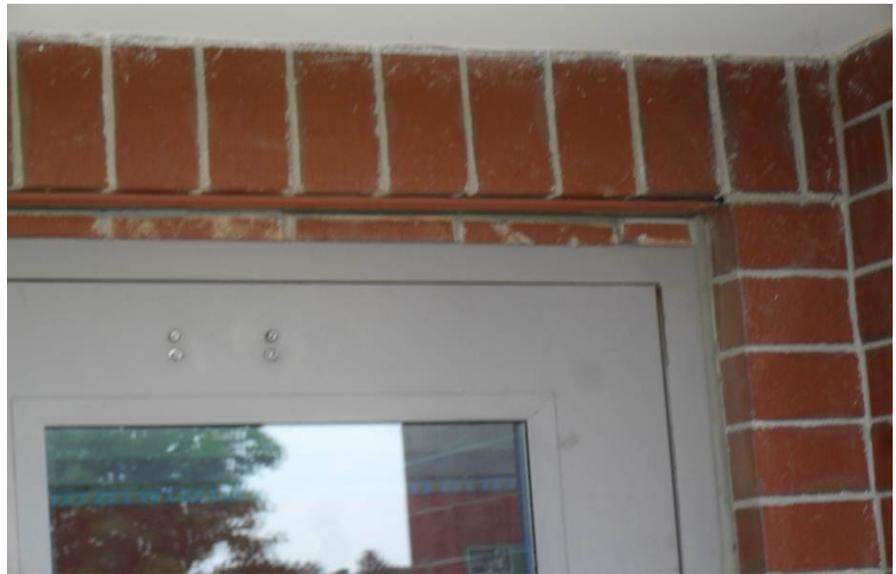
*Main Entrance*

*Close-Up of Brick on  
Door Frame*

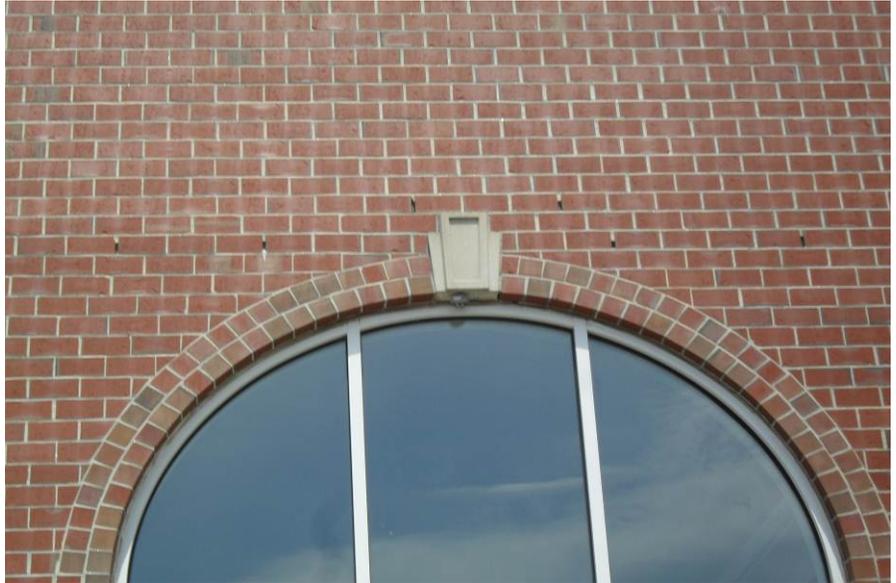
Over the main entrance there are weep holes in the brick that were inserted for an unknown reason. No through wall flashing indicated on details.

*Weep Holes Over Arch  
Masonry*

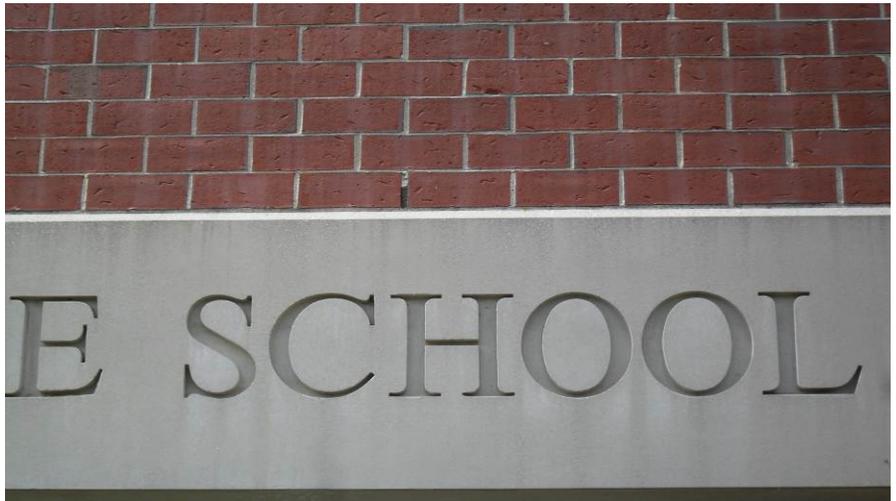
*Precast Entrance Sign*

Weep holes have been installed in the brick course above the precast concrete sign, but there is no evidence that flashing was installed. Metal through wall flashing edge should be exposed.

*Flashing Not Evident*

*Weep Holes Without  
Flashing*

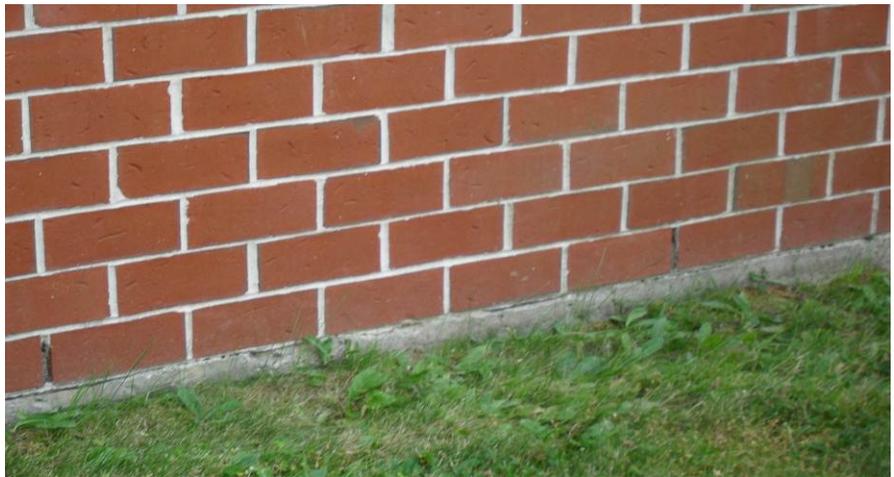
Around the perimeter base of the new brick the weep holes were installed at an odd spacing. The spacing is inconsistent from wall to wall with some locations exceeding 5'-4" o.c and others as short as 16" o.c. The weep holes are recommended by BIA to be inserted at a maximum spacing of 2'-8" o.c.. The spacing in the picture is at 3'-4".

The through wall flashing shown is a fabric flashing and was installed in a poor quality manner. Would recommend cutting in new weep holes on all walls.

*Weep Hole Spacing too  
Far Apart*

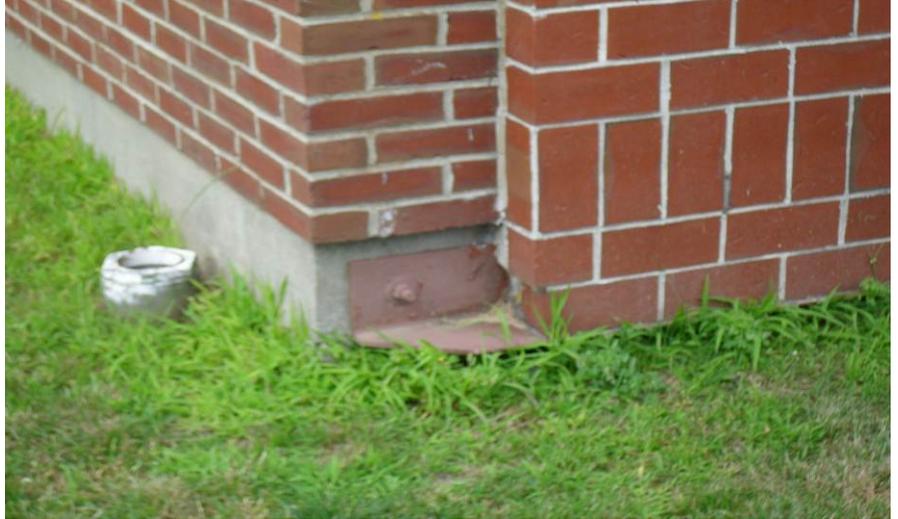
On existing buildings where the existing window-wall was removed a new support angle was bolted to the existing foundation to support the brick. There is no indication on the contract documents that these angles were galvanized.

*Exposed Support Angle*

They should be closely monitored and maintained to keep the angle from rusting.
