**Town of Cape Elizabeth**  
Seven Building Facility Study  
*Cape Elizabeth, Maine*

**Introduction****Town of Cape Elizabeth Facilities Study**

*Facility Study Process*

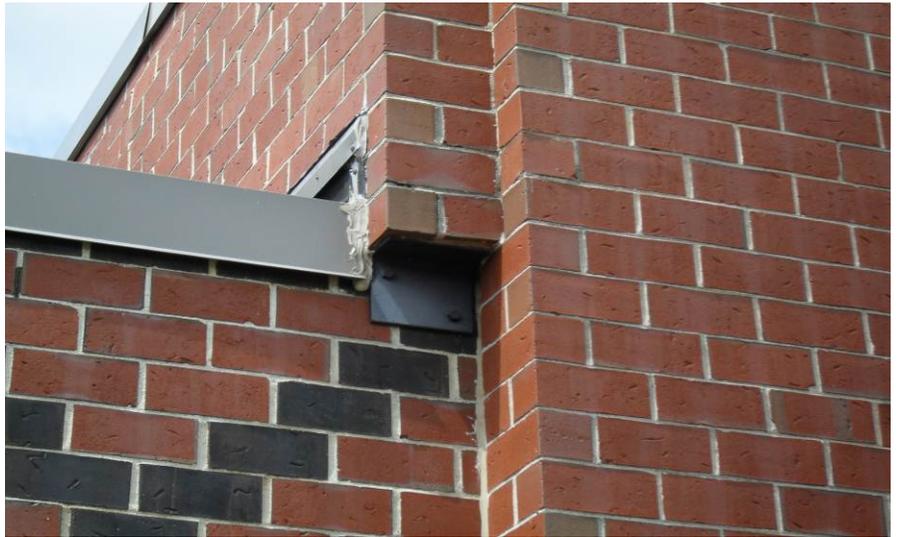
*Brick Detail*

Exposed angle for brick support.

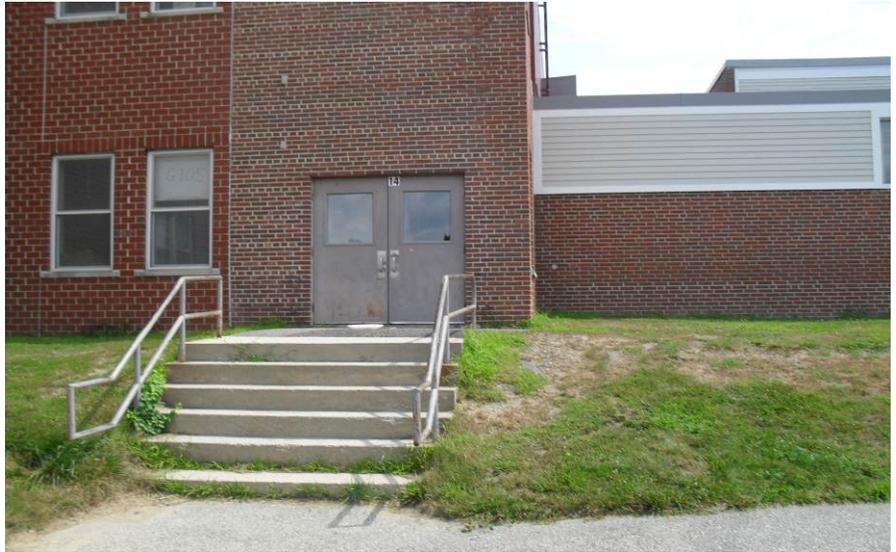
The hollow metal doors and frames around the building will require replacement at some locations. Some are showing rust through the bottom of the frame or door edge. Most need to be repainted.

*Hollow Metal Entrance  
Doors and Frames*

Recommend replacement as part of your annual maintenance budget. Install new galvanized doors and frames for long term durability.

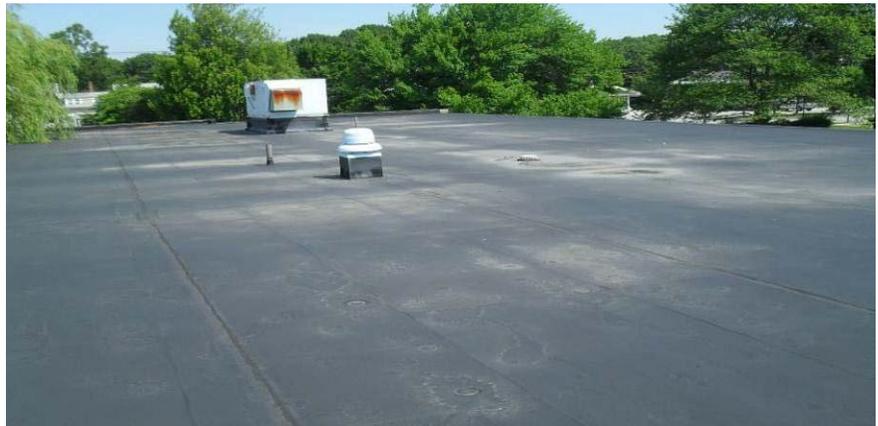
*Original Primary School  
Built in 1948*

- Fully adhered .060 EPDM roofing membrane with two layers roof insulation mechanically fastened to wood decking.
- Denoted on the 1994 addition/renovation project as a replacement roof system.
- Roof is in good condition. Roof has been maintained as part of a regular maintenance program.
- Roof membrane is 18 years into its potential 20 to 25 year life span.
- Would consider this roof for replacement in the near future.

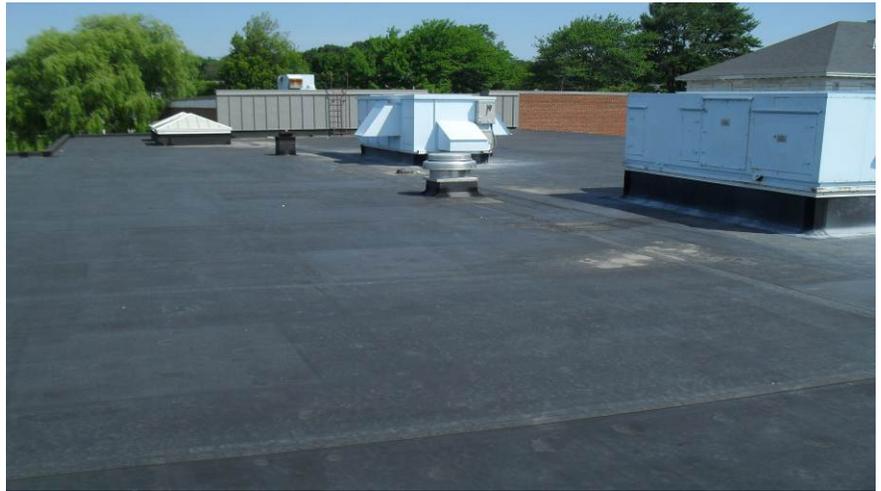
*Addition to Primary  
Constructed in 1955*

- Fully adhered .060 EPDM roofing membrane over roof insulation boards mechanically fastened to the existing wood deck.
- Denoted on the 1994 addition/renovation project as existing EPDM roofing to remain.
- Based on the note and no record of replacement we suspect this roof is already beyond its 20 year life span.
- This roof would be on a higher priority schedule for replacement due to its age since installation.

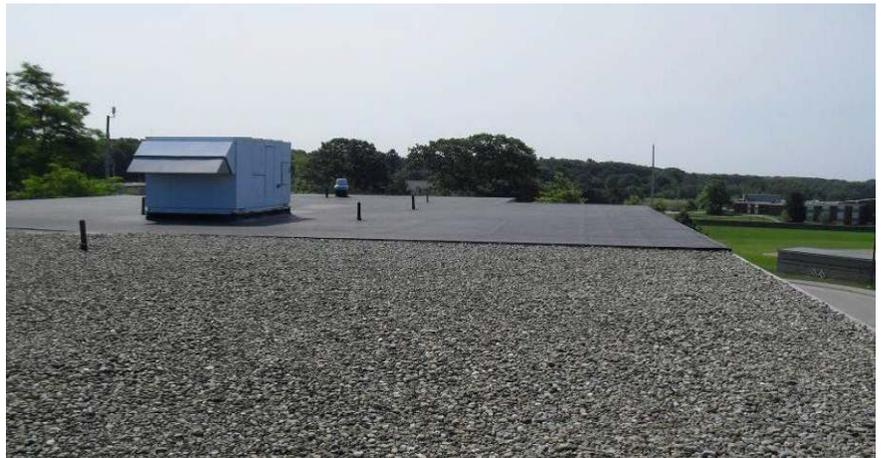
*Lunt Building –  
Addition to Primary  
Built in 1962*

- Fully adhered EPDM roofing membrane over two layers of 2 1/2" roof insulation mechanically fastened to the existing wood deck. Lunt roof is shown beyond the ballasted roof in the foreground.
- Denoted on the 1994 addition/renovation project as existing EPDM roofing to remain.
- Based on the note and no record of replacement we suspect this roof is already beyond its 20 year life span.
- This roof would be on a higher priority schedule for replacement due to its age since installation.

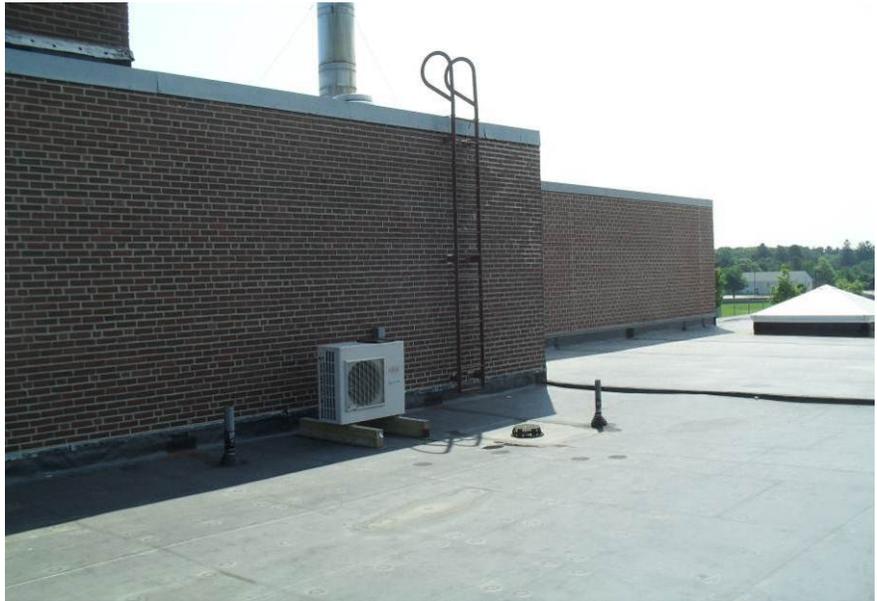
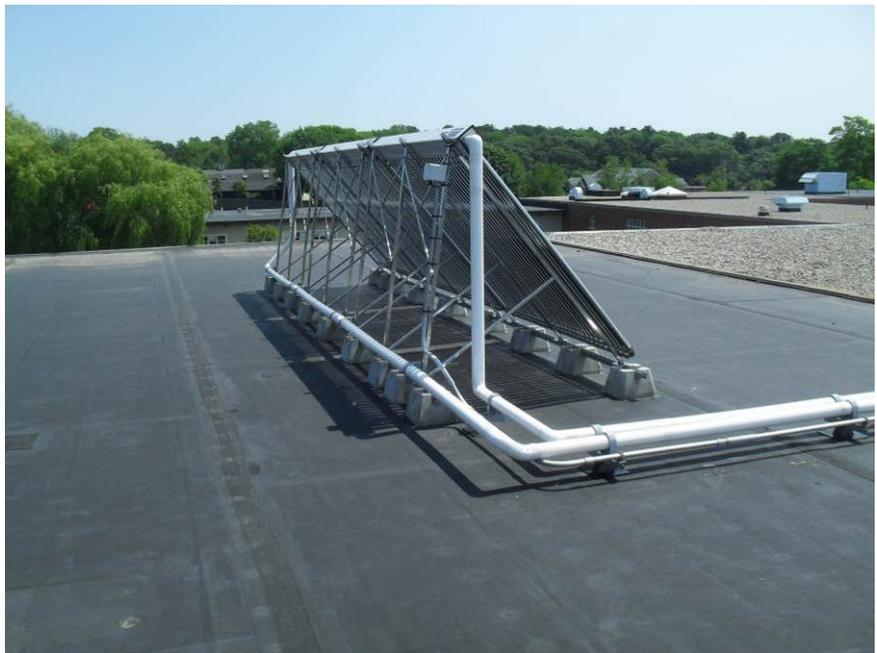
*Gymnasium /  
Classroom Addition to  
High School Built in  
1962*

- Fully adhered .060 EPDM roofing membrane over roof insulation boards mechanically fastened to the existing wood deck.
- Denoted on the 1994 addition/renovation project as existing EPDM roofing to remain.
- Based on the note and no record of replacement we suspect this roof is already beyond its 20 year life span.
- This roof would be on a higher priority schedule for replacement due to its age since installation.

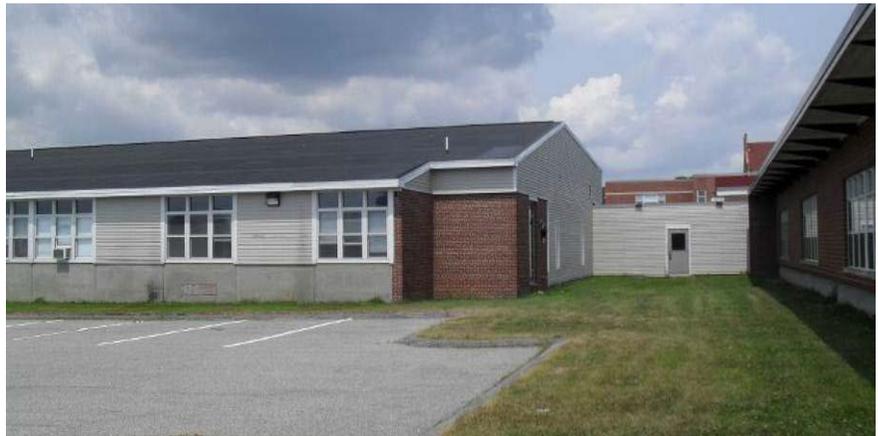
*Vocational Arts Wing*

- Fully adhered EPDM roofing membrane and roof insulation adhered to the existing wood deck.
- Existing wood beam and wood deck is visible from rooms below. Appears a wood truss pitched system was installed directly over the wood beam and deck system and an adhered membrane installed to the deck.
- Denoted on the 1994 addition/renovation project as existing EPDM roofing to remain.
- Based on the note and no record of replacement we suspect this roof is already beyond its 20 year life span.
- This roof would be on a higher priority schedule for replacement due to its age since installation.

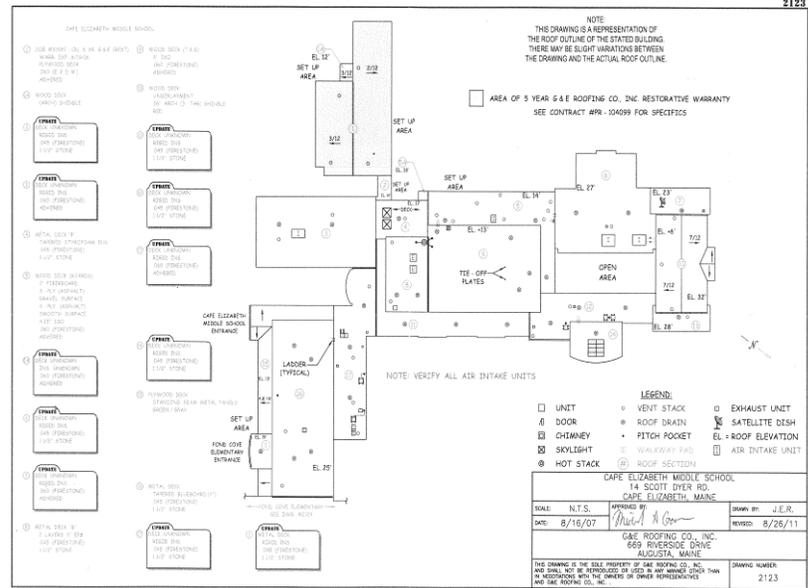
Pond Cove Elementary / Middle School  
Roof Plan

1. The roof areas on the plan above plan designated No's 3, 5, 9, 18, 20, 22 should be considered high priority for replacement. These roofs have been down the longest and have been exposed to UV. The seams are showing signs of deterioration and may require closer attention from a maintenance perspective. The picture below shows repair work to membrane and seams.

2. The ballasted roof areas denoted on the plan above as areas 6, 8, 11, 12, 14, 16, 17, 19 should be considered for replacement based on the age. Though these types of roof systems would be considered to offer a longer life to the membrane there are a number of issues connected with this installation that we will highlight further on in this report.

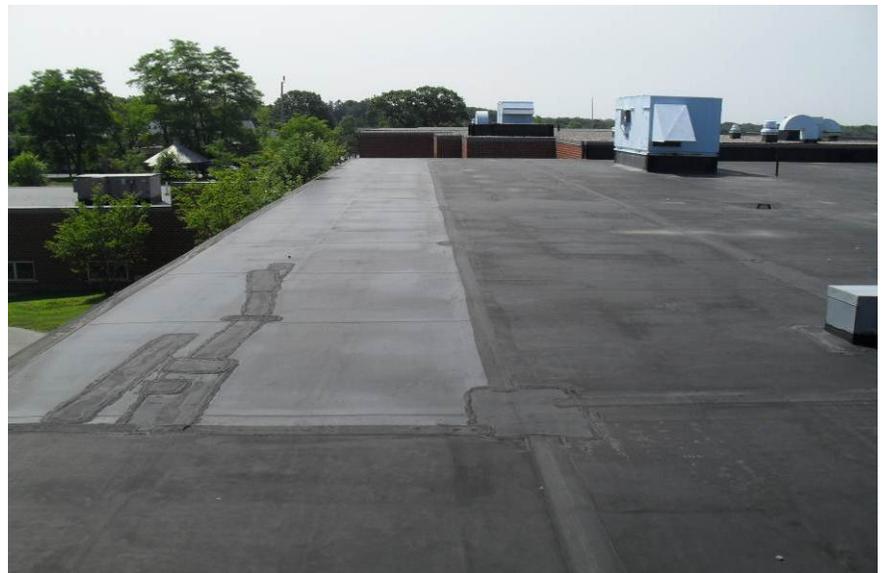
EPDM Roof with Seam  
and Membrane Repair

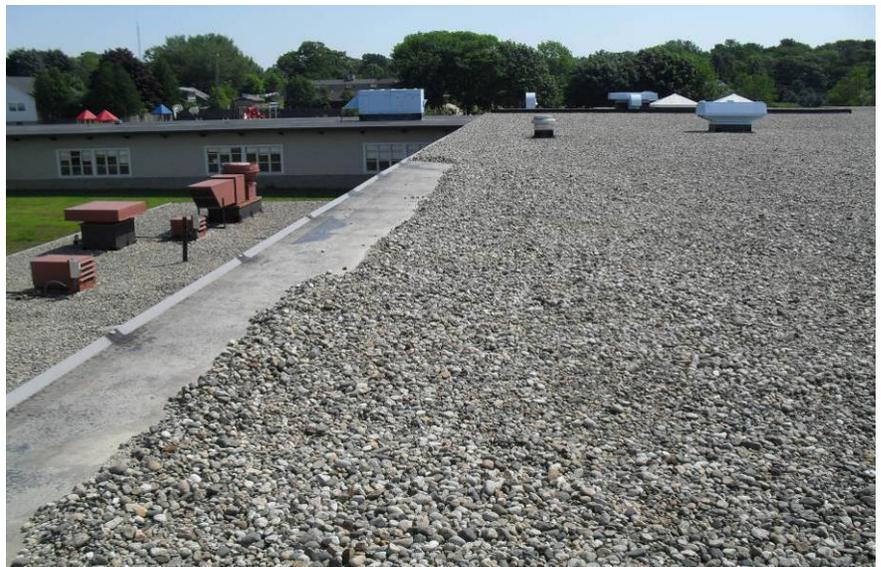
*Ballasted Roof System –  
Stone Directly Over the  
Membrane*

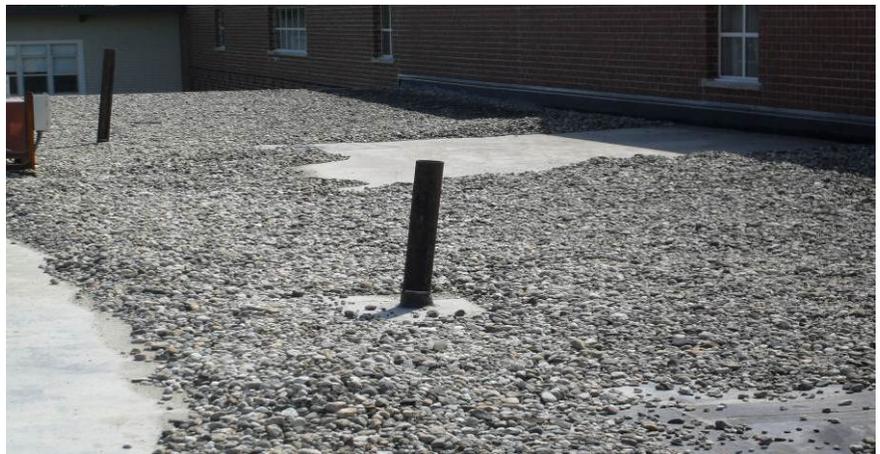
The picture below shows an area where the ballasted stone has been pulled back to reveal possible water leak locations. Patches were installed as a corrective action. The stone was never spread out back over the area. It is difficult to review the condition of the roof membranes with the stone ballast over. There were a number of locations on the roof where the membrane was exposed due to corrective action and this exposure is revealing that the membrane has prematurely started to wear out. Normally with a stone ballast roof there is a nylon protective mat that is laid down over the membrane to protect the membrane surface from the type of wear revealed at the locations where the stone was pulled back. At other locations where the stone was pulled back the membrane was showing similar wear. Based upon the visual observation at these locations I think you can assume the entire ballasted membrane is in similar condition.

*Roof Membrane Badly  
Worn*

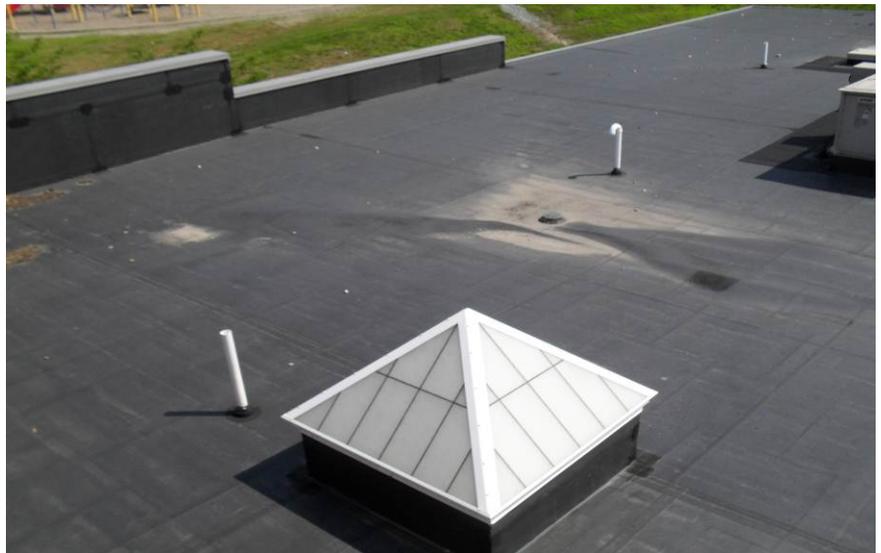
3. On the kindergarten roof addition there are two large major buckles with the roof membrane. Per the contract documents, the system was installed as an adhered membrane to adhered insulation direct to a concrete deck and our observation indicates that there has been a separation of the membrane from the insulation.

*Roof with Major Membrane Buckle*

This condition requires immediate correction because of the potential of a high wind condition lifting and causing the entire roof to separate from the insulation and causing a total roof failure.

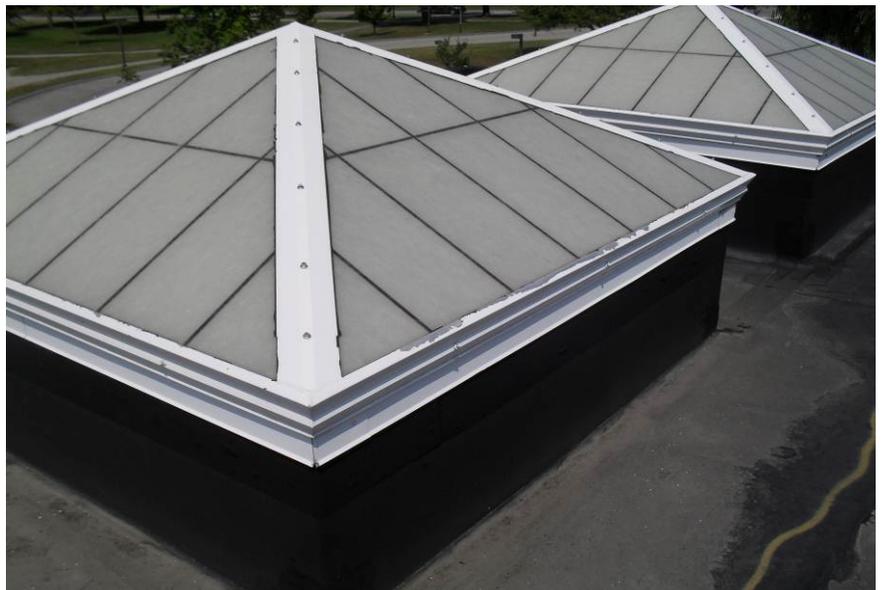
1. Most of the skylights on the school are showing signs of paint peeling off the frames. This is a sign of low quality paint finish on the frames.

*Skylight Frame – Paint Finish Flaking Off*

We would recommend as part of a maintenance item, to procure a Glass and Glazing company which services this particular skylight and have them clean and patch all the paint finish flaking locations, dismantle the frame and panel and apply new seals between the frame and panels to bring the units back to the originally installed condition. If for some reason the clamping frame was removed from the panel, the original seal on both sides would have had to be replaced – this is a manufacturer’s requirement. The units may not have been installed correctly and thus the leak issues.

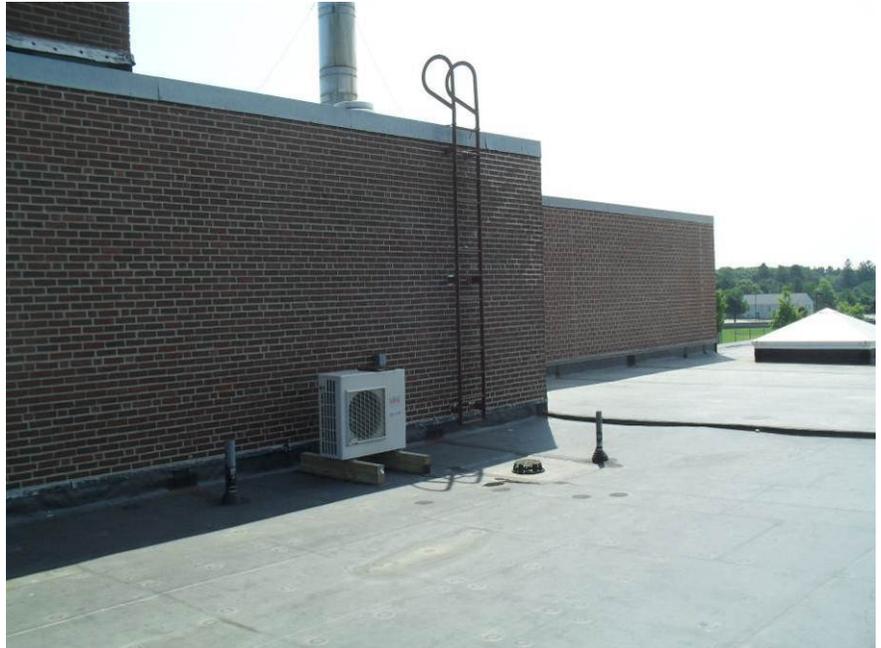
*Vertical Ladder –  
Noncompliant*

We would recommend replacement with new compliant ladder and cage.

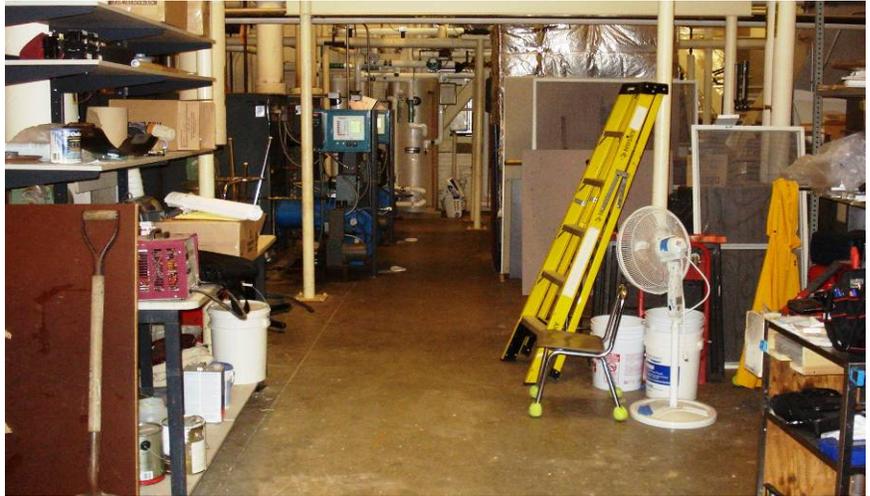
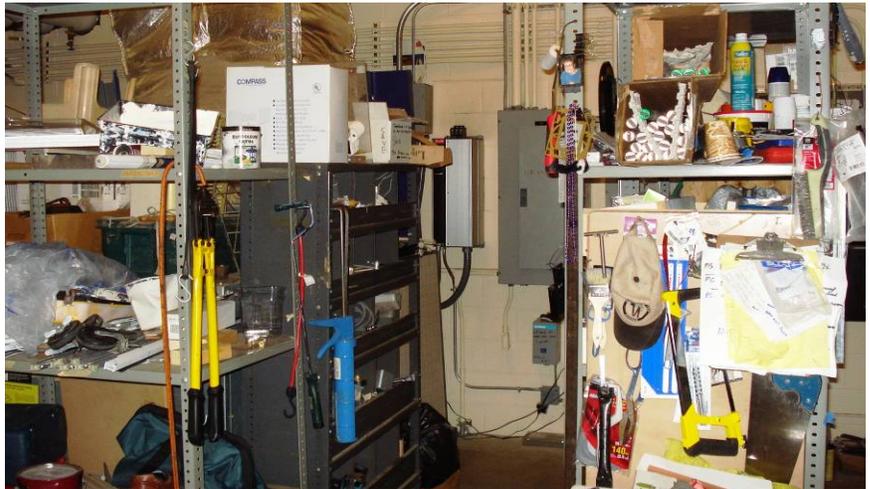
*Boiler Plant – Code Violations*

We would recommend replacement of the boilers and a redesign of the entire Boiler Room, including the air handling systems, to increase system efficiency and meet code requirements.

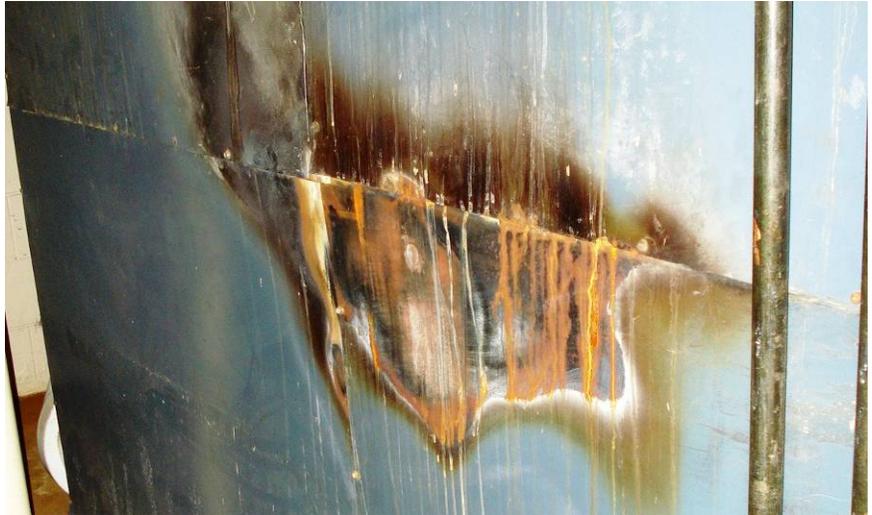
The enclosures of the boilers are showing signs of their age. The side of Boiler 1 shows signs of combustion and gas leakage between the cast iron sections of the boiler. With proper maintenance and repair, this type of boiler can provide many years of service.

*Left Side of Boiler 1 (left-hand) Showing Signs Burned Surface*

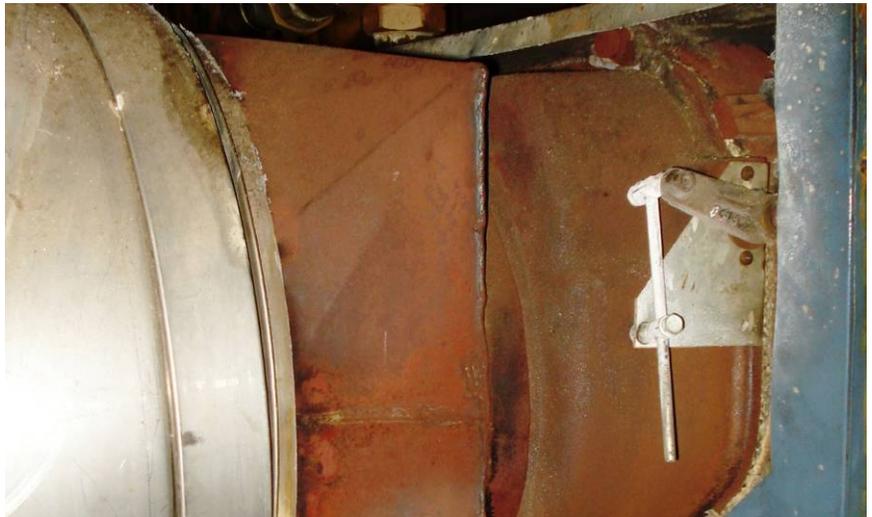
The linkage of the draft control damper at the rear of Boiler 1 is loose at the shaft of the damper. The position of the damper is unknown. Recommend the damper linkage be properly adjusted and tightened.

*Breeching Damper at Back of Boiler 1 Was Loose*

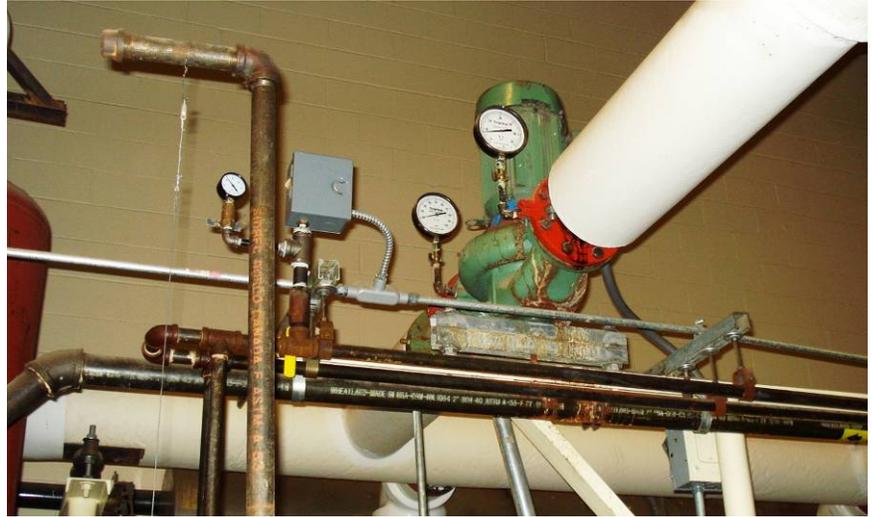
Each boiler is outfitted with an individual injection pump. The pump at Boiler 1 appears to be original and showing signs of leakage. The pump at Boiler 2 appears to be a recent replacement.

*Boiler 1 Injection Pump and Oil Pressure Gauge and Transmitter*

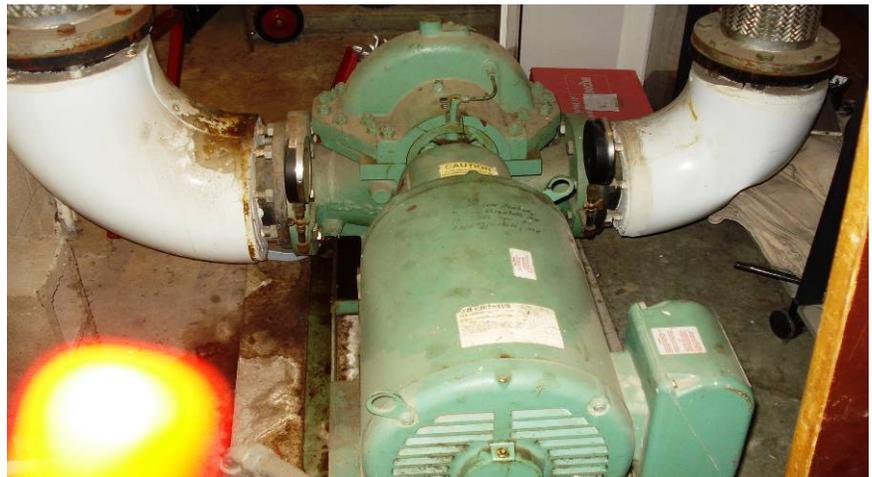
*Heating Hot Water Pump*

The heating hot water is circulated through the building by Taco 30 HP, 800 gpm constant volume split-case base-mounted pumps. The pumps were provided as part of the 1994 renovation project and are showing their age.

We would recommend upgrading the heating system hot water pump motors to high efficiency type and the installation of variable frequency drives for control and vary the speed of the pump to maintain a temperature differential across the heating hot water system.

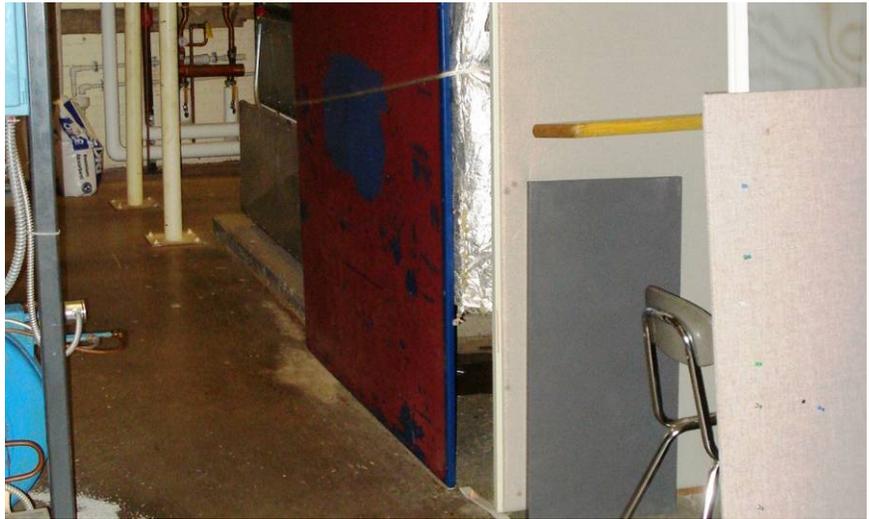
Combustion air to the boiler room is provided through the 54" x 60" insulated duct dropping down in the middle of the Boiler Room. The opening at the floor has been partially blocked off. It was reported the combustion air duct was partially blocked to help reduce the possibility of freezing the boiler(s).

*Combustion Air Duct  
Partially Blocked*

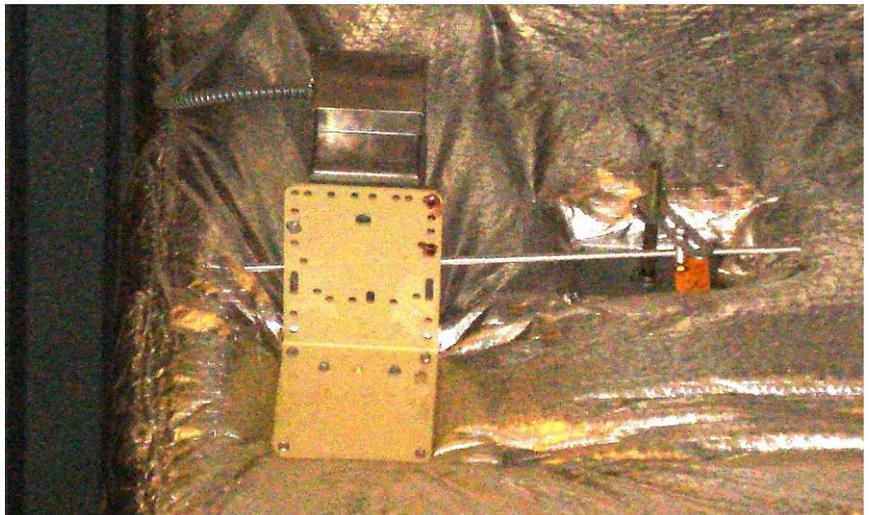
*Combustion Air Damper  
Actuator*

The damper actuator appears to be original and shows signs of oil leakage. At the time of review, the damper was open.

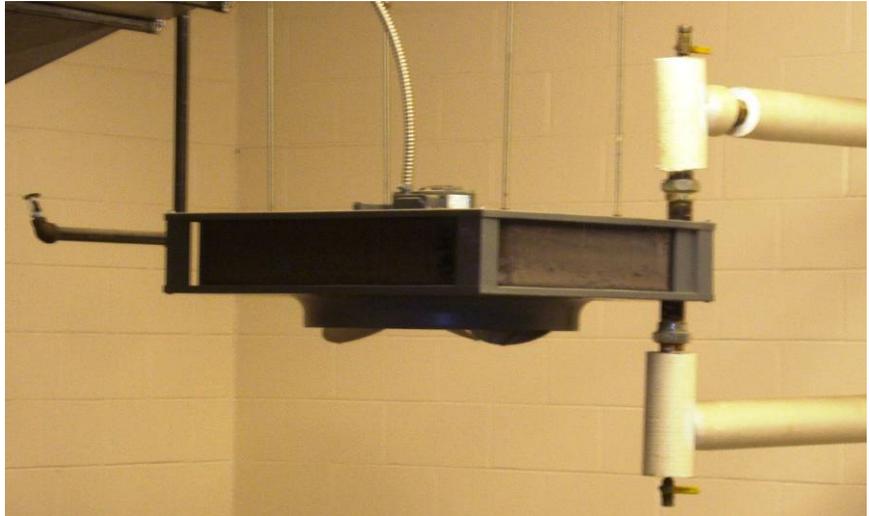
*Vertical Unit Heater in  
Boiler Room*

Heating in the Boiler Room is provided through two vertical hot water unit heaters. The coil of one of the heaters appears to be plugged.

*Coil is Plugged*

Recommend cleaning of the coils.

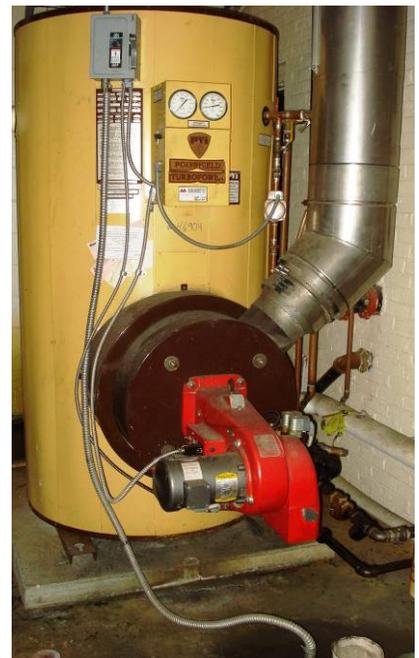
*Domestic Hot Water  
Boiler*

The domestic hot water system was upgraded during the Summer 2011. A part of the upgrade, the existing oil-fired hot water was abandoned in place. At the time of review, the oil-fired heater was turned off at the local disconnect.

We would recommend removal of the abandoned heater.

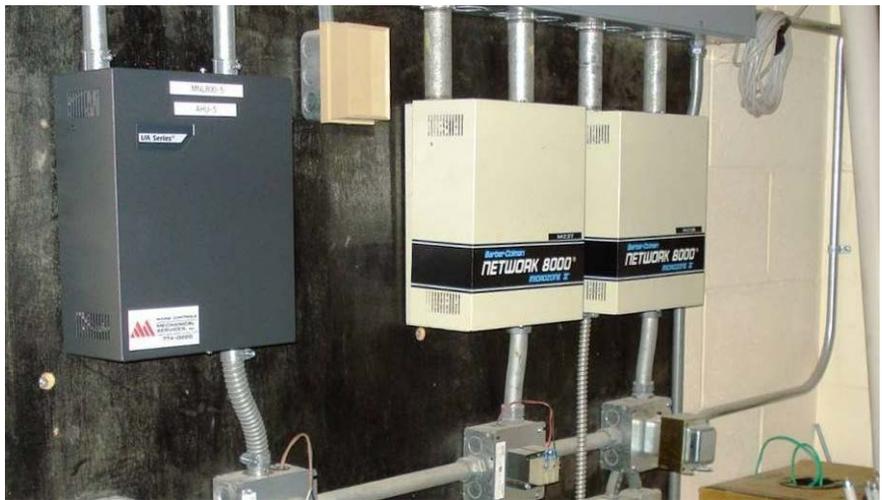
The Network 8000 Direct Digital Control (DDC) system components in the Boiler Room were provided and installed during the 1994 renovation project. The I/A Series Micronet components, pictured at the left of the panel, were provided and installed during the 2011 Boiler Room Upgrade project. The Network 8000 components are monitored through the original Signal graphics software package and the upgraded I/A Series components are accessed through the web-based Enterprise Server software package. We recommend upgrading the Network 8000 components to the I/A Series system components.

*Direct Digital Control System in Boiler Room*

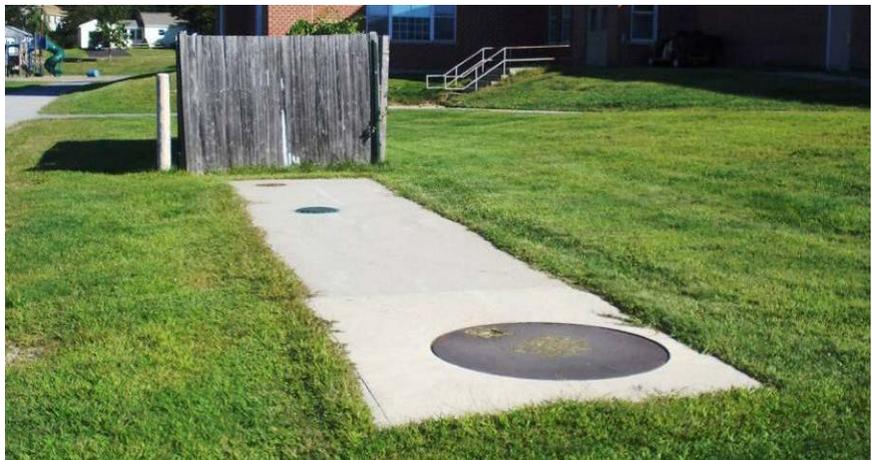
The #2 fuel oil is stored in the underground tank. Liquid propane gas is stored in the fenced in area. The International Fire Code provides a minimum distance between an LP gas container and fuel oil tank. As a noted exception, horizontal separation is not required between above-ground L-gas containers and underground flammable and combustible tanks. It would appear the tanks at the school are in compliance.

*Underground Fuel Oil Storage Tank and Above Ground Propane Storage Tanks*

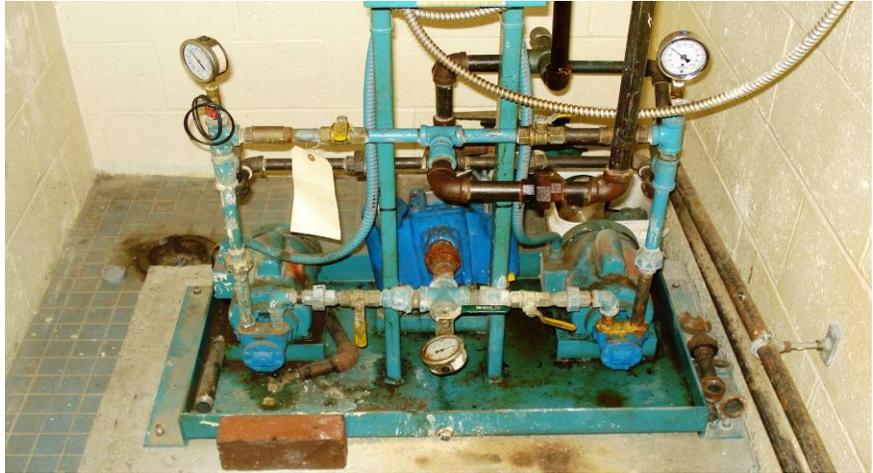
Fuel oil is provided to the boiler room through a duplex pump set located in the “E” wing janitor’s closet. The pump set is showing signs of leakage.

*Fuel Oil Pump Set*

We would recommend the pump set be replaced in accordance with NFPA 31 code requirements.

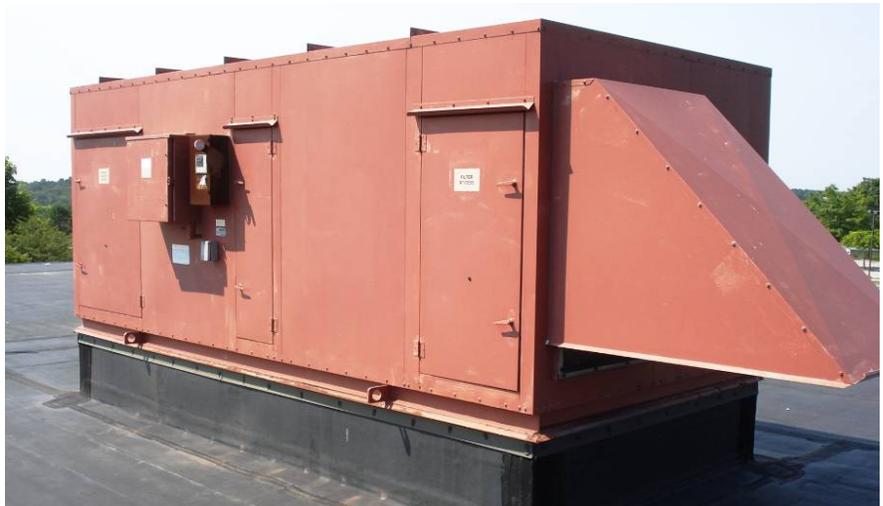
The rooftop air handling units and heat recovery units were provided and installed as part of the 1994 Additions and Renovations project making them approximately 18 years old and nearing the end of their expected service. Many of the units are showing signs of their age. At the time of review, the heat recovery units were not operating. Possibly down for the summer.

*Typical Des Champs  
Rooftop Heat Recovery  
Unit (HRU-5)*

We would recommend replacement of the rooftop units.

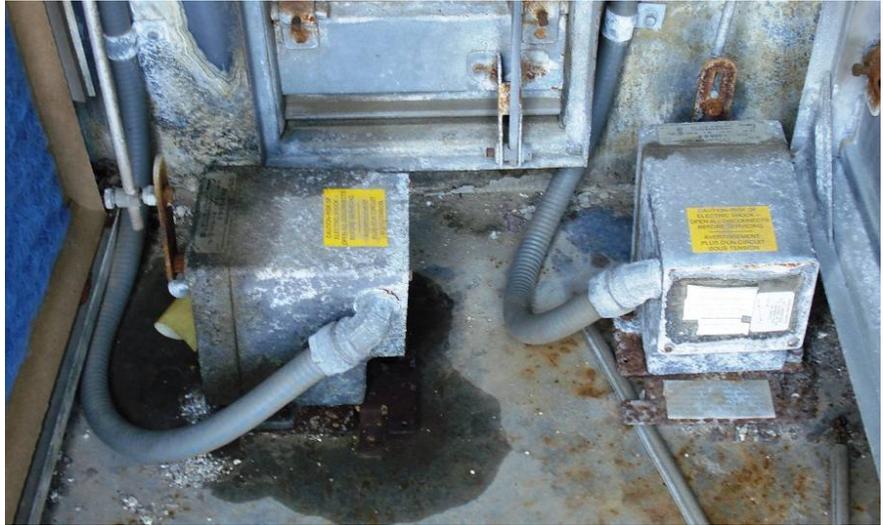
The outside air intake and bypass damper actuators, located within the outside air intake plenum, are original to the unit and are showing signs of oil leakage.

*HRU-5 Intake and Bypass Damper Actuators*

The condition of the interior surfaces of the rooftop units supports our recommend to replace the units. We would recommend replacement of the damper actuators as a short term correction.

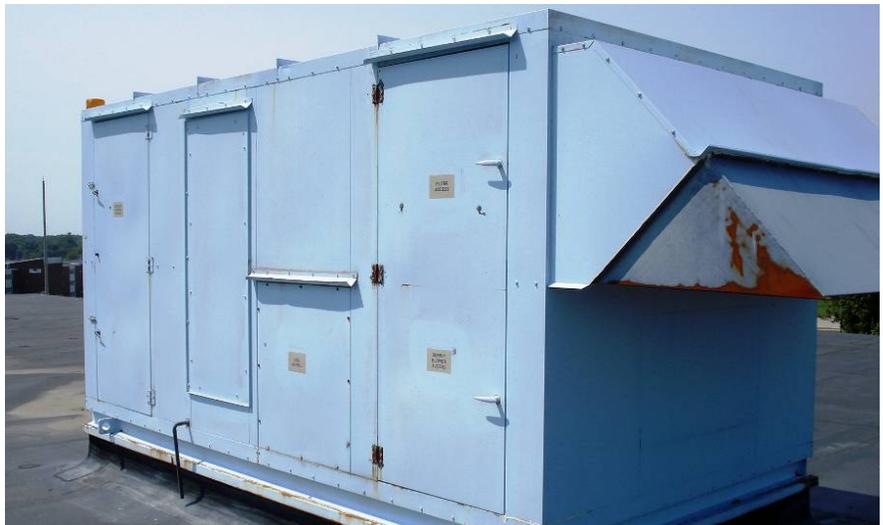
On a number of the units, additional sections of sheet metal were added to a number of the heat recovery units to help reduce the infiltration of snow into the unit. The filters in HRU-4 are noted as replaced in March 2012. On the filter it is also noted the plenum was very warm and the there was no snow.

*HRU-4 with Additional Intake Hood Section (right side of photo)*

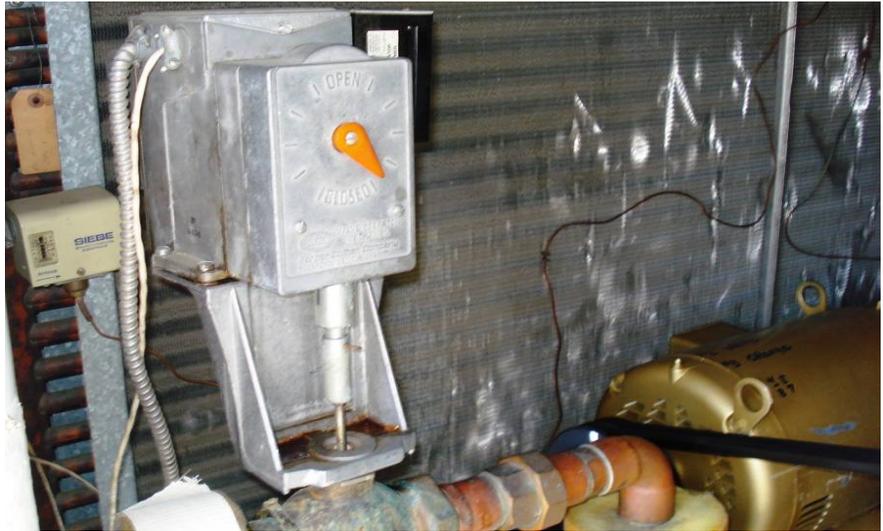
On HRU-4, the heating coil valve actuator appears to be original to the unit and is showing signs of oil leakage. The pointer on the front of the actuator indicates the valve is partially open possibly indicating the actuator has failed partially open.

*HRU-4 Heating Coil Valve Gear-Train Actuator*

We would recommend replacement of the valve actuator as a short term correction.

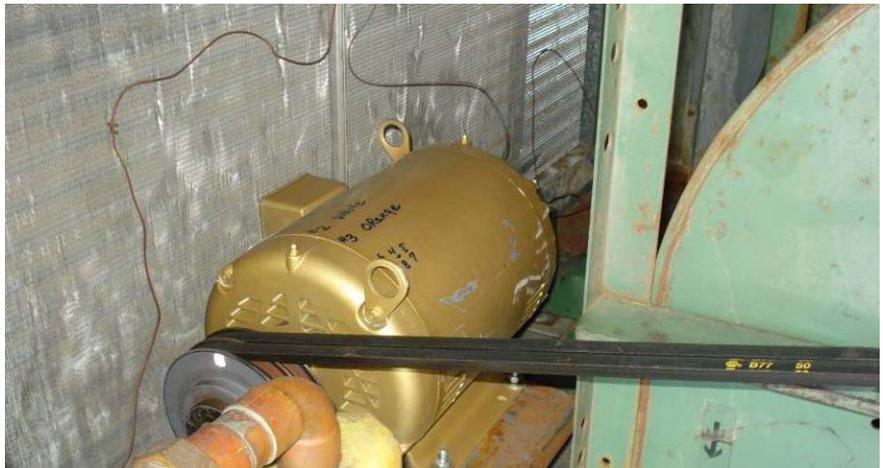
The HRU-4 supply fan motor appears to be a recent replacement. The heating coil low limit thermostat capillary has been partially removed from the heating coil fins and the fins have been bent over. The return air side of the heat recovery coil is very dirty.

*HRU-4 Supply Fan Motor, Heating Coil, and Low Limit Coil Capillary*

We would recommend reinstallation of the capillary, combing out of the heating coil fins and cleaning all rooftop heat recovery and heating coils.

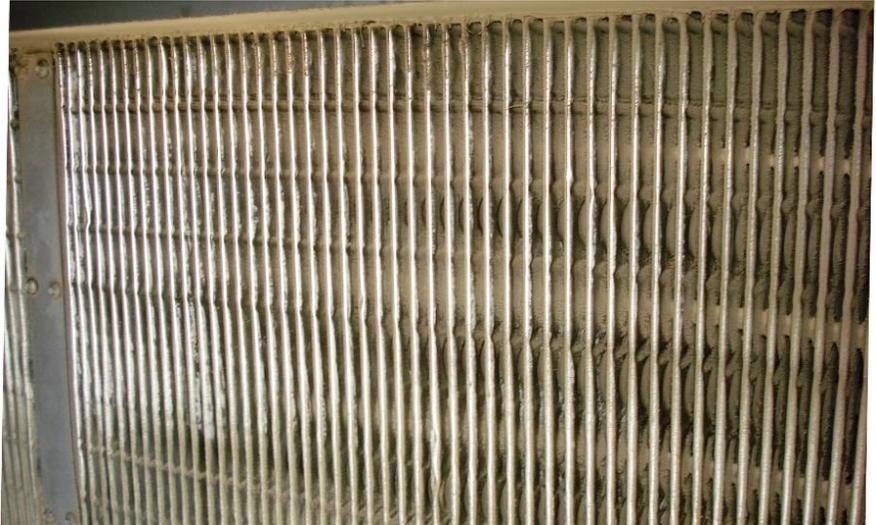
The return air side of the heat recovery coil is very dirty.

*HRU-4 Dirty Heat Recovery Coil (Return Air Side)*

We would recommend cleaning of all rooftop heat recovery and heating coils

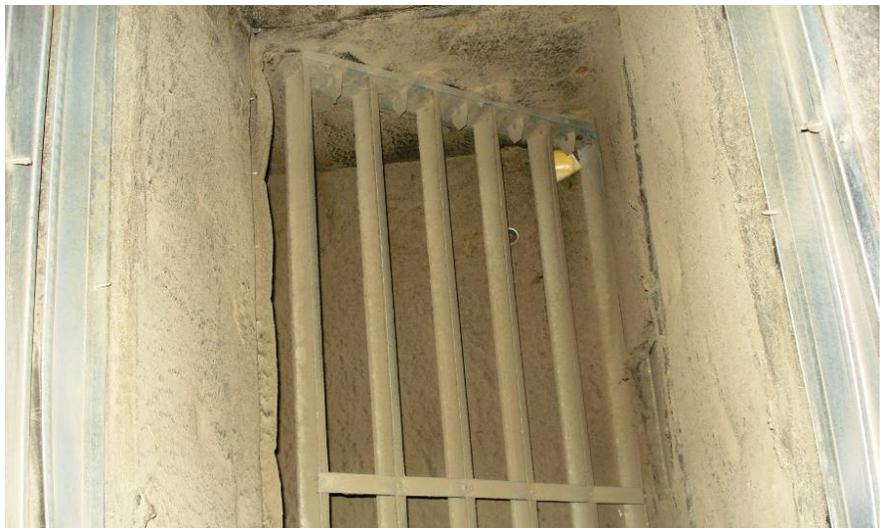
The acoustically lined return air plenum of HRU-4 is very dirty. This is typical of all units.

*HRU-4 Dirty Return Air Plenum Duct Connection*

We would recommend cleaning of all return and supply duct systems.

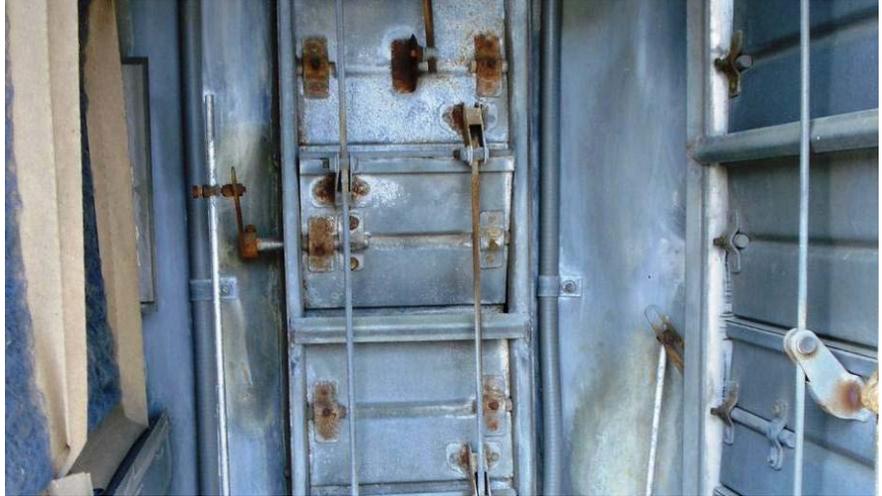
The bypass damper in HRU-3 is partially open indicating the linkage requires adjustment of the damper, original damper actuator has failed.

*HRU-3 Partially Open  
Bypass Damper*

We would recommend checking and repairing the damper as needed.

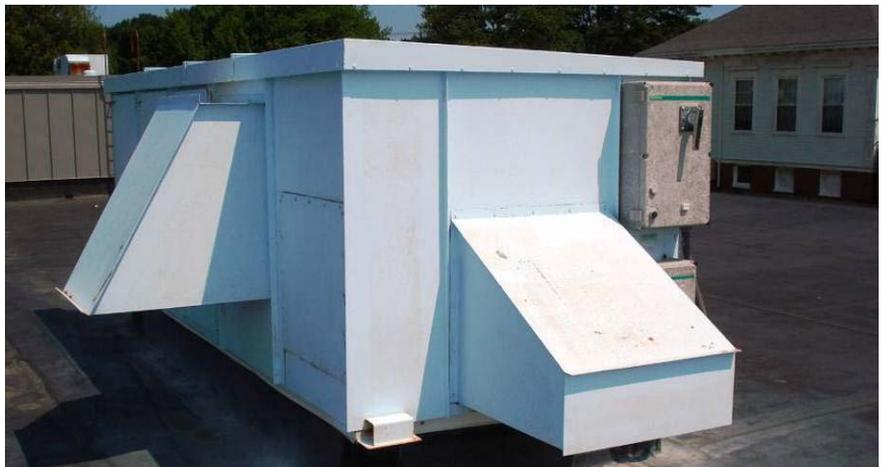
The Trane rooftop air handling unit AHU-1 serves the Variable Air Volume (VAV) system in Elementary School Media Center and adjacent Office Areas. The unit was installed as part of the 1994 Addition and Renovations project. The unit will vary the amount of air provided for the variable air volume system by opening and closing the inlet vanes at the constant speed fans. A more efficient method of varying the airflow would be to vary the speed of the fans through the use of variable speed drives (VFD).

*AHU-1 Trane Air  
Handling Unit*

We would recommend removing the inlet vanes, verify the motors are suitable for use with variable speed drives, and provide and install new VFDs.

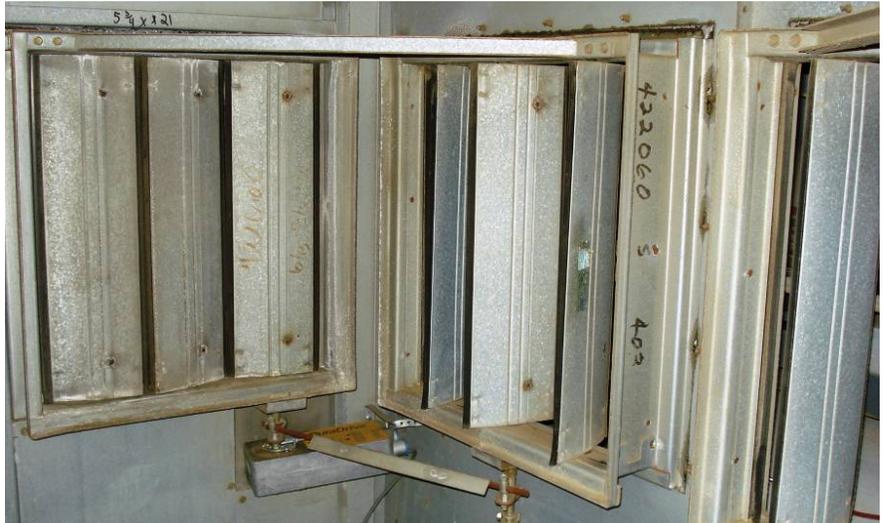
The outside air portion of the mixed air dampers (shown to the left of the photo above) were not completely closed allowing for a small amount of infiltration of outside air when the unit is off. Recommend adjustment of the damper linkage to allow the dampers to close fully.

*AHU-1 Mixed Air Dampers*

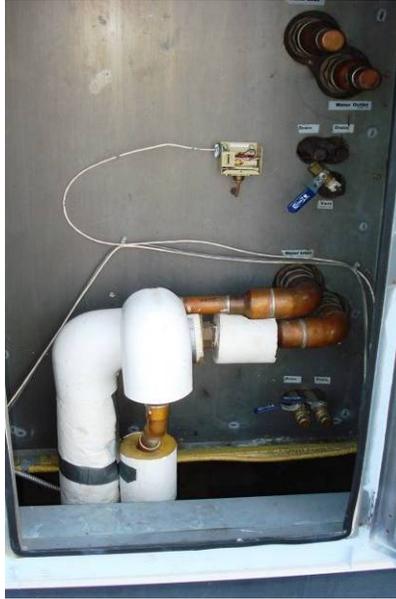
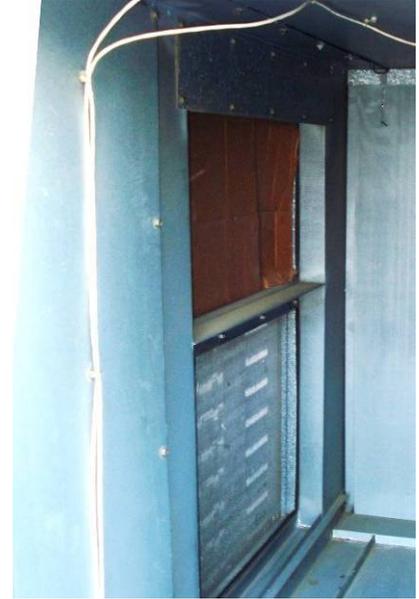
The upper portion of the coil section is not connected. The photo below on the right shows a piece of cardboard covering the cooling coil. According to the design documents, the upper coil was provided for future chilled water cooling. As a temporary measure, the upper coil was blocked off to prevent airflow from bypassing the heating coil.

*AHU-1 Coil Connections and Cardboard Covering Portion of Coil*

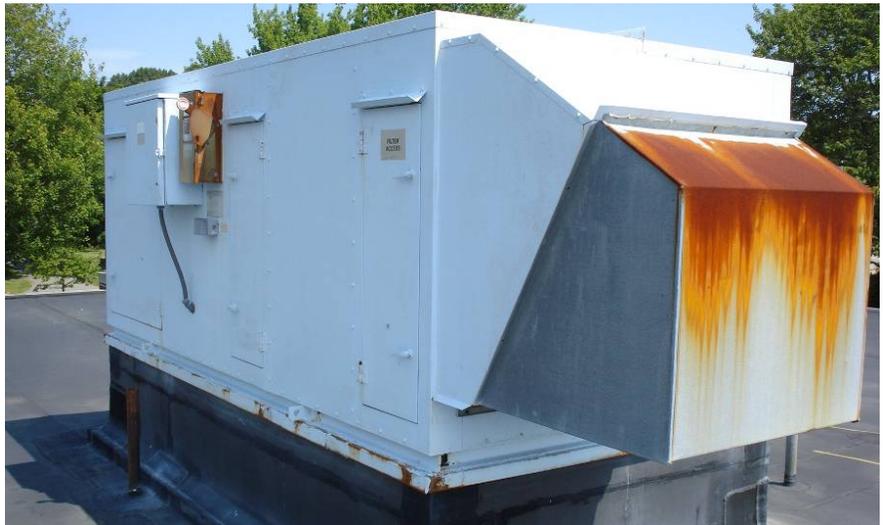
*HRU-1*

On HRU-1, additional sheet metal has been added to the outside air intake hood to help prevent snow from entering the intake. In many of the rooftop units, there are signs a corrosion between the sections of the HRU. Note the rusty areas shown in the photo below.

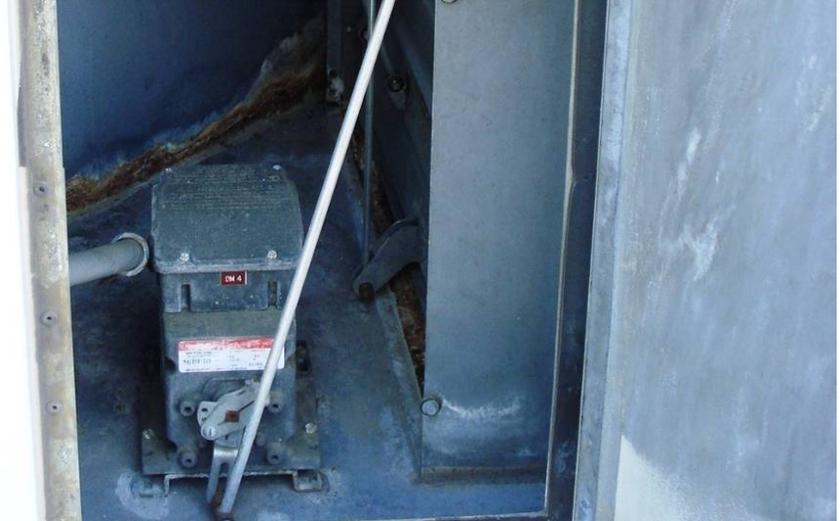
*HRU-1 Rusty Areas  
Within Unit*
