**Town of Cape Elizabeth**  
Seven Building Facility Study  
*Cape Elizabeth, Maine*

**Introduction****Town of Cape Elizabeth Facilities Study**

*Facility Study Process*

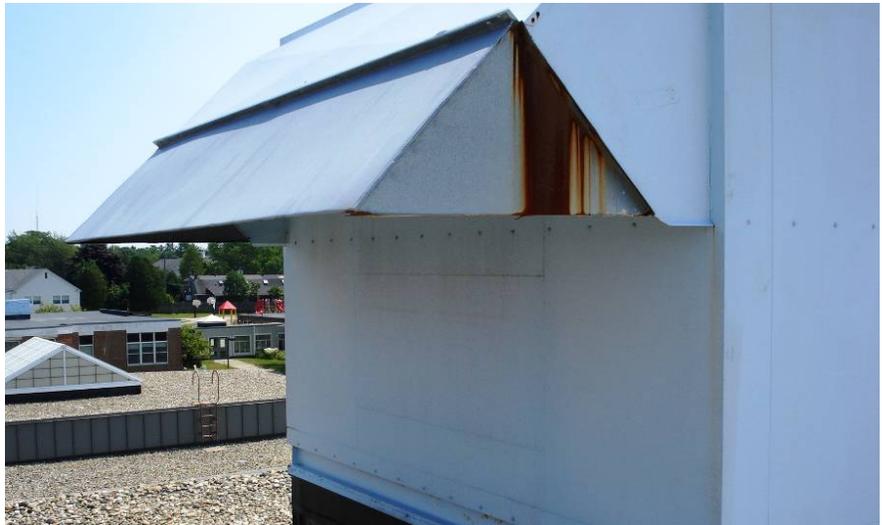
Additional sheet metal has been added to HRU-8 intake hood.

*HRU-8 Intake Hood*

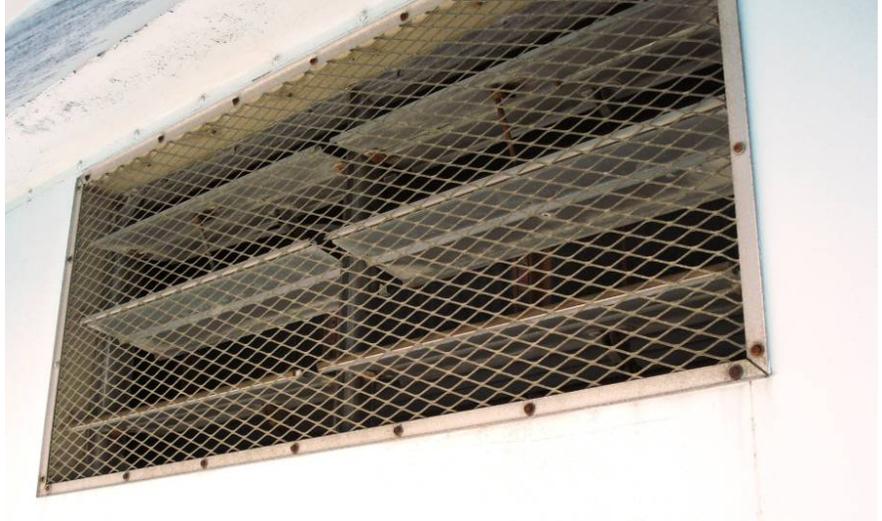
At the time of review, the unit was not operating but the intake closure damper was open possibly indicating the damper actuator has failed in the open position or the damper linkage is disconnected.

*HRU-8 Intake Closure Damper*

As an immediate action, we would recommend servicing the intake damper. As a future action, we would recommend replacement of the unit.

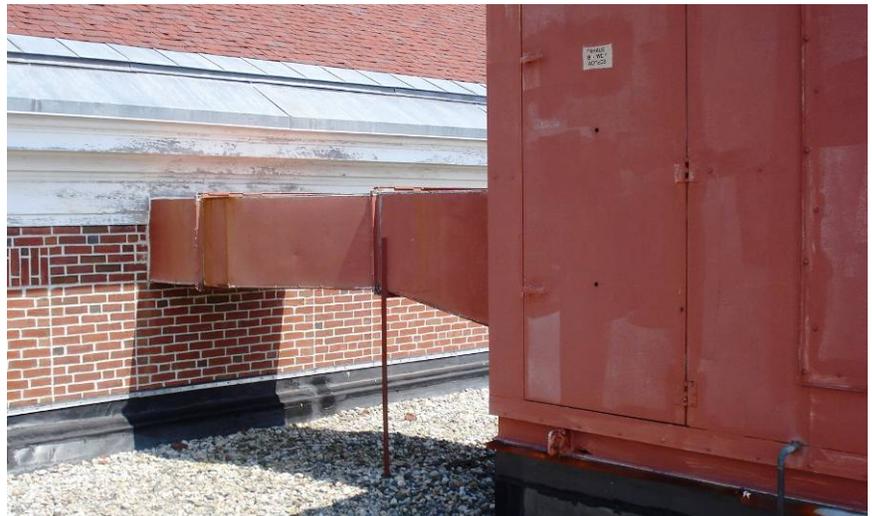
HRU-9 serves the 1930s “G” Building. The unit supply is provided out of the unit and through the exterior of the building. The wall penetration appears to be in good condition. The supply duct is not insulated on the outside but may internally lined. The return to the unit is installed up through the roof curb from the ceiling space below.

*HRU-9 Supply Duct*

We would recommend replacement of the unit and insulating the supply duct to reduce heat loss.

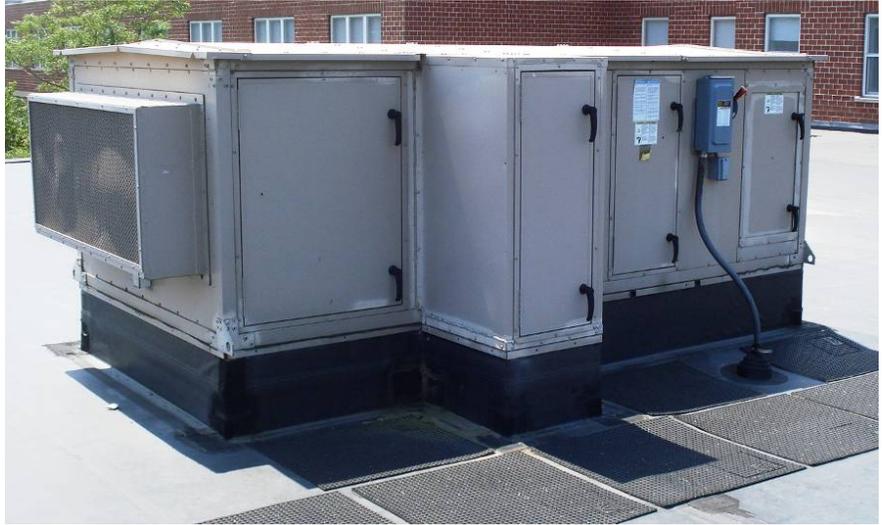
The newer York Solution AHU-1 (duplicate numbering) was provided and installed as part of the 2004 Pond Cove Elementary Addition project. The unit appears to be in good condition.

*Newer York Solution  
AHU-1*

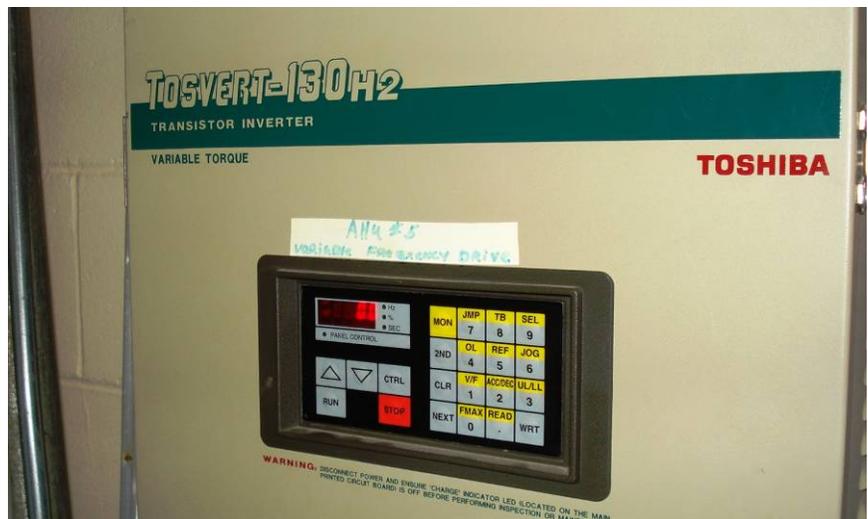
Three air handling units (AHU-5, 6, 7) are located in the Boiler Room/Mechanical Room. This is a code violation. The units serve the Cafetorium, Middle School Gym, and Middle School offices respectfully. These air handling units were installed during the 1994 addition and renovations project.

AHU-5 fan speed is controlled through the DDC system and the Toshiba VFD. The system monitors the return air carbon dioxide (CO2).

*AHU-5 Variable  
Frequency Drive*

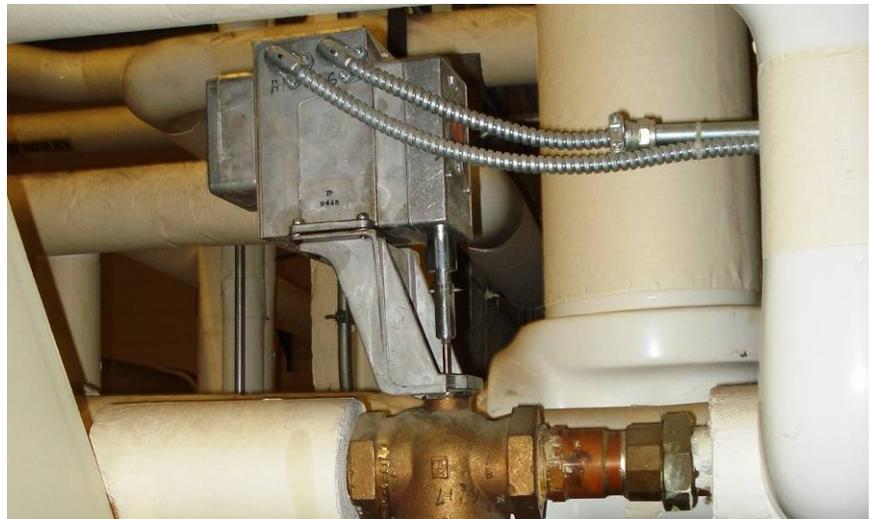
AHU-6 heating coil valve actuator is the original gear train actuator and is showing signs of oil leakage. At the time of review, the unit was off. The mixed air dampers partially open and showing signs of their age. One of the filters has been pulled of the frame.

*View of AHU-6 Heating  
Coil Valve*

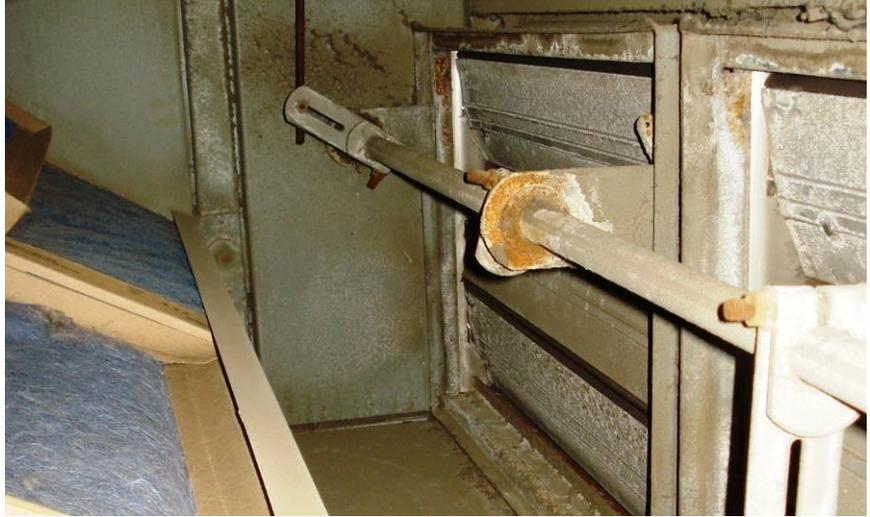
*AHU-6 Mixed Air  
Dampers and Filter*

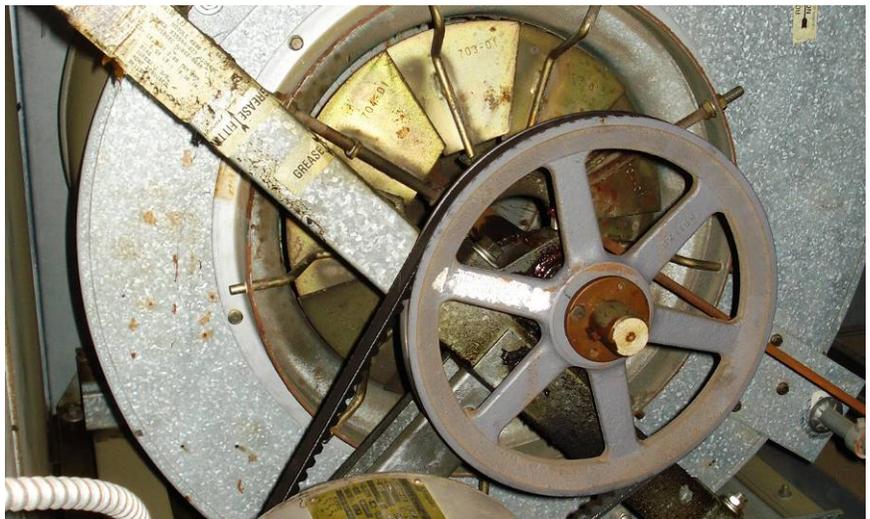
AHU-7 supply air is controlled by opening and closing the fan inlet vanes. This was a common practice before the introduction of variable frequency drives to control the speed of the fans.

*AHU-7 Adjustable Inlet  
Vanes in Supply Fan*

We would recommend the removal of the inlet vanes, verification of motor and VFD compatibility and the installation of a variable frequency drive.

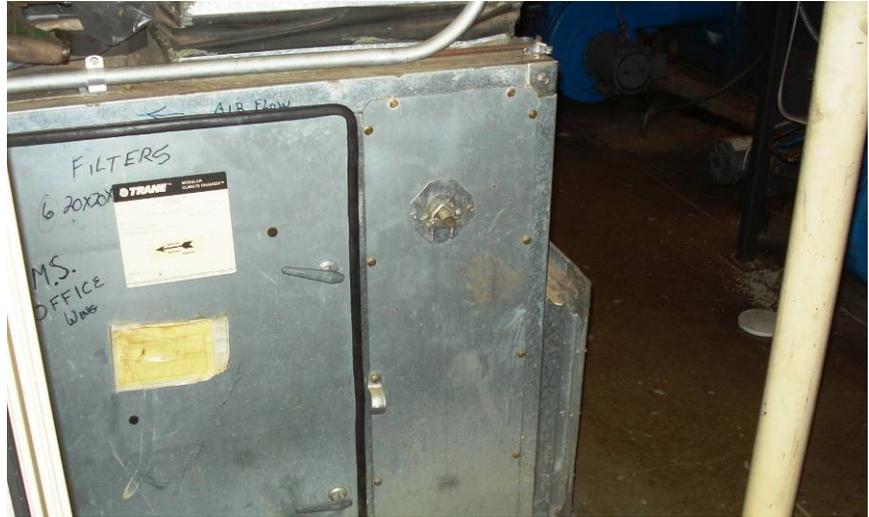
The damper at the end of the unit was blanked off during the construction. The unit was provided with mixed air dampers. Due to room constraints, changes were made to mix the return (return fan RF-4) and outside air in the ductwork above the unit and provide the mixed air to the unit through the top damper. The top damper was locked open and the damper at the end of the unit was blocked off.

*AHU-7 Blanked-off Damper at the End of Unit*

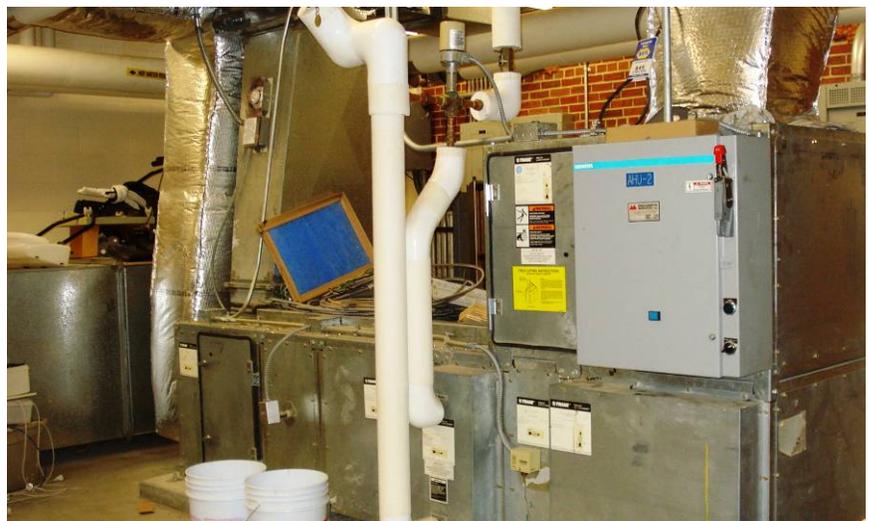
AHU-2 is a variable air volume unit and serves the Administration Offices on the ground floor (Area "C") of the Elementary School. At the time of review, the return fan (RF-3) associated with AHU-2 was operating but the AHU-2 supply fan was off on reset. Depressing the reset button caused the fan to operate.

*AHU-2 Side View*

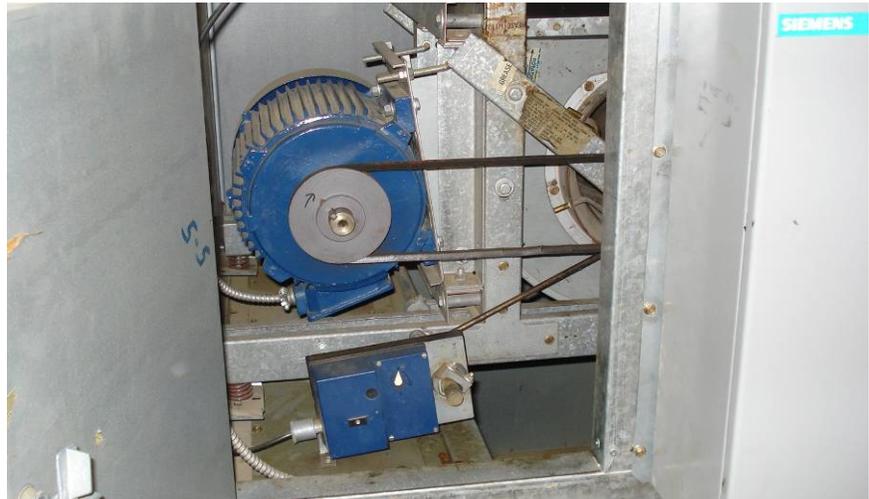
*AHU-2 Supply Fan and Inlet Vane Actuator*

The air volume of AHU-2 is controlled through the fan inlet vanes. We would recommend removing the vanes, verifying the motor is compatible with a variable frequency drive (VFD), and installing a VFD to control the fan speed.

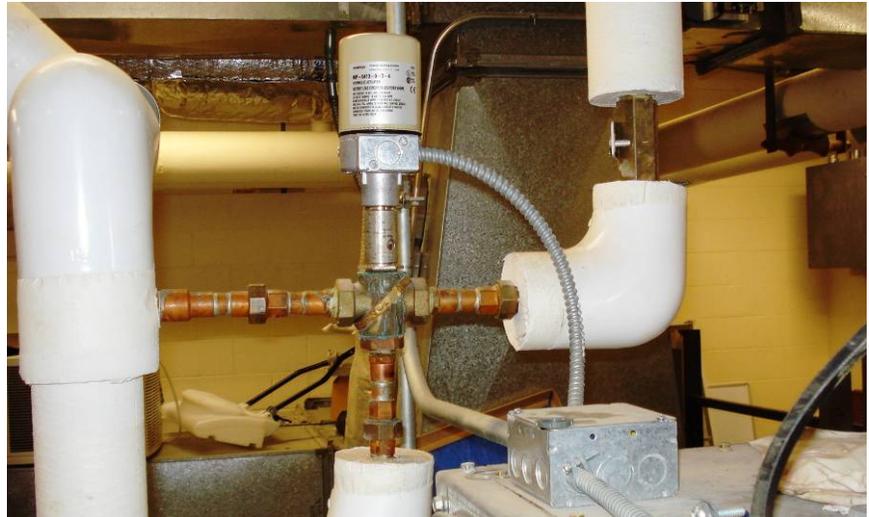
Sometime after December 2005 (date code 0551), the hydraulic actuator on the 3-way valve had been replaced. The valve appears to be original.

*AHU-2 3-way Control Valve Actuator*

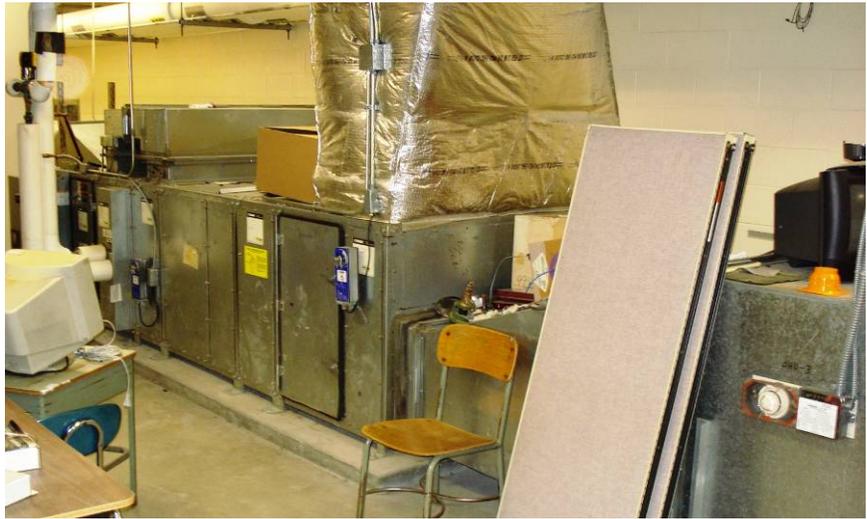
*View of AHU-3 and the Respective Duct Smoke Detector*

We would recommend the installation of access doors at all duct smoke detectors and cleaning of all smoke detector inlet tubes.

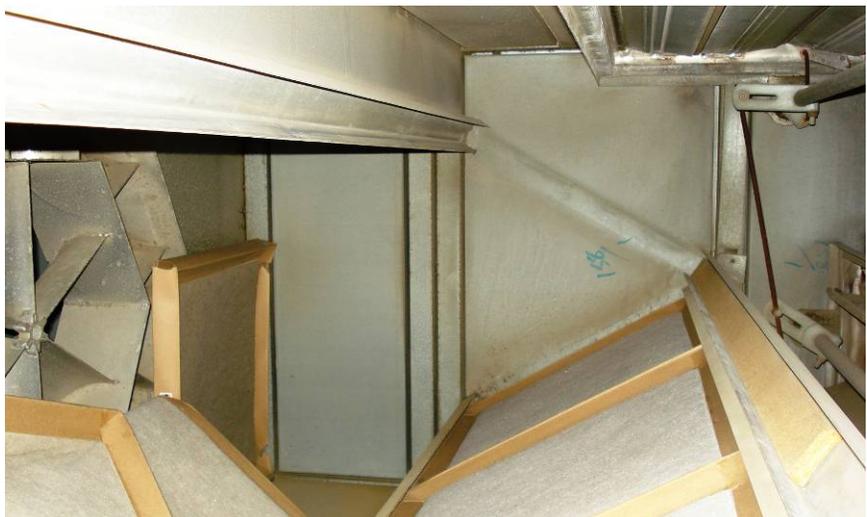
The inside of the mixed air/filter section is very dirty and the top filters have been pulled into the de-stratification device.

*AHU-3 Mixed Air and Filter Section.*

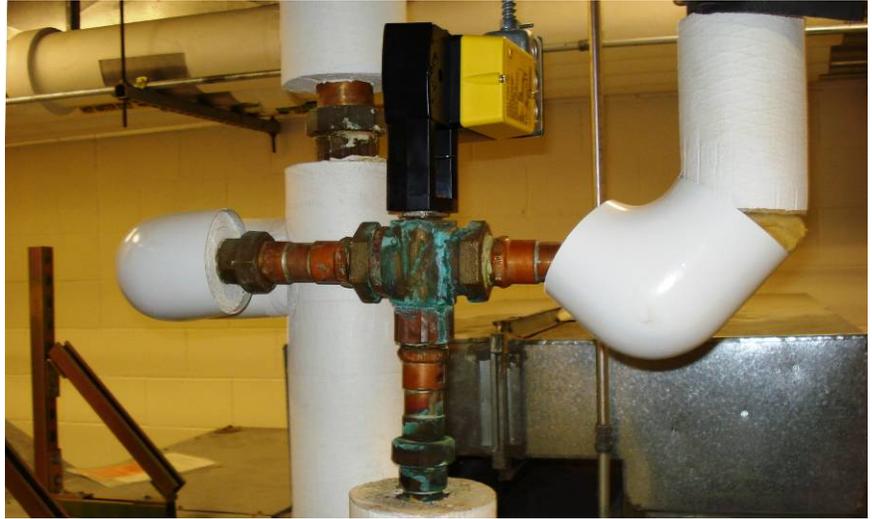
The actuator on the 3-way valve has been recently replaced. Based on the signs of leakage, it would appear the valve body may be original to the 1994 installation.

*AHU-3 3-way Control Valve*

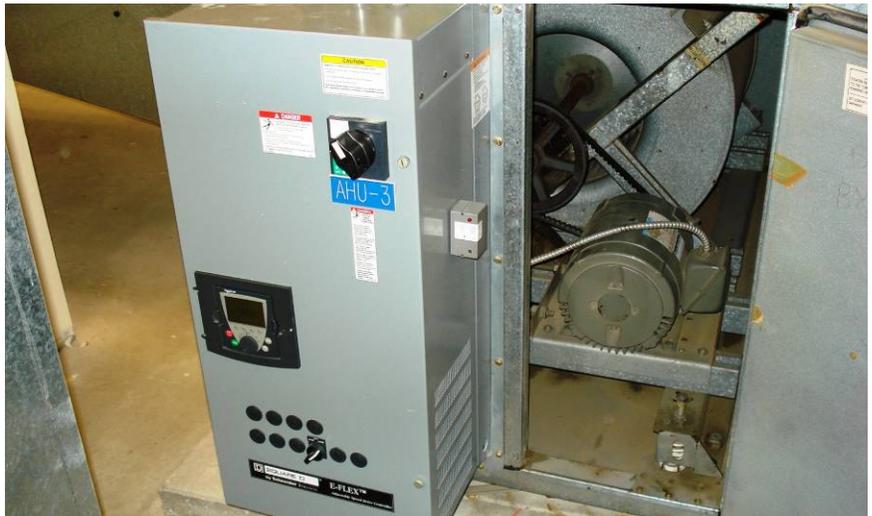
A variable frequency drive is mounted to the side of the unit. The sequence of operation for the fan is unknown.

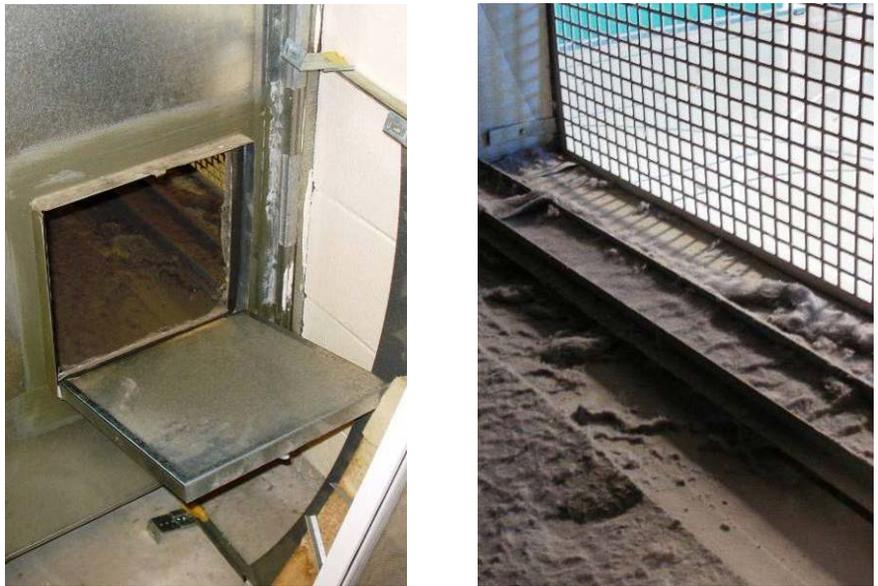
Fire dampers and access doors have been installed in the supply and return ducts at the wall between the gym and the Mechanical Room. The access doors may not be sufficient to exercise or reset the fire damper if necessary. Some of the wall penetrations have not been properly sealed. The inside of the supply and return ducts are very dirty.

*View of Access Door at Return Fire Damper and Dirty Duct*

We would recommend exercising of the fire dampers annually in accordance with NFPA providing additional access doors as necessary and sealing all wall penetrations and cleaning of all duct systems.

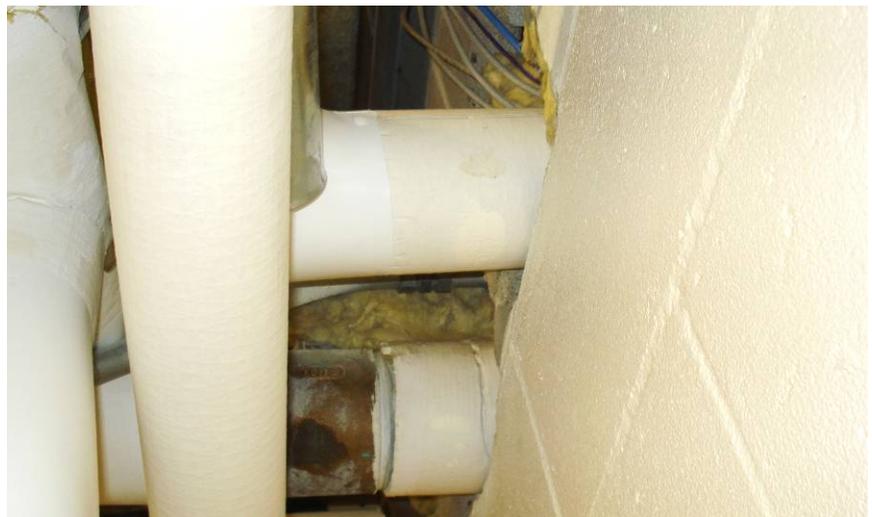
*Sample of Unsealed Wall Penetrations*

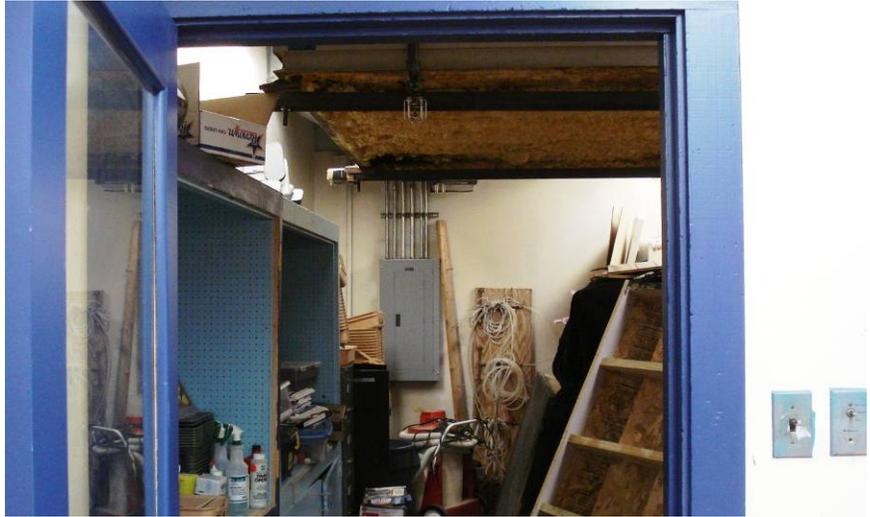
Heat Recovery Unit HRU-7 serves the “F” wing including the Band Room, Piano/Music Room, Technical and Applied Arts area and Teacher Workroom. At the time of review, the unit was turned off at the disconnect. The unit is rigidly supported directly from structure in the Storage Room F112. Spray foam has been applied to the bottom of the unit for an unknown reason. The 3-way valve hydraulic actuator is showing signs of leakage.

*View of Underside of  
HRU-7*

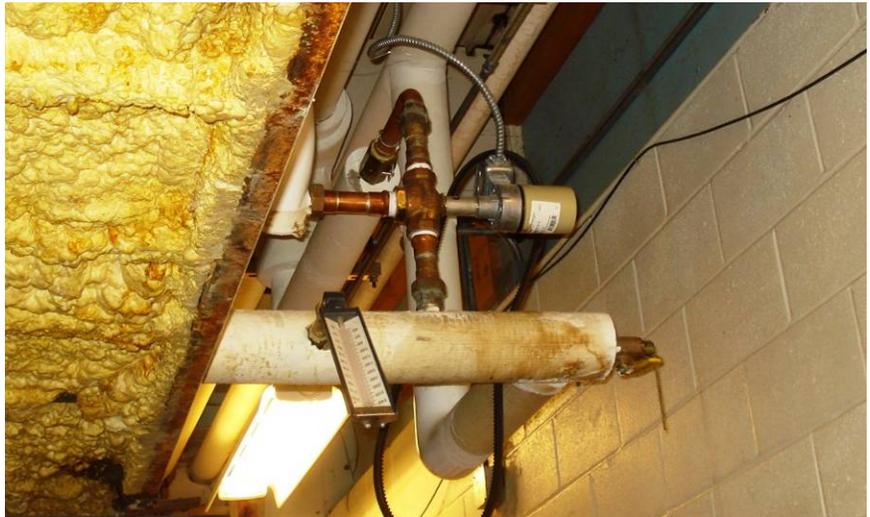
*HRU-7 3-Way Control  
Valve and Hydraulic  
Actuator*

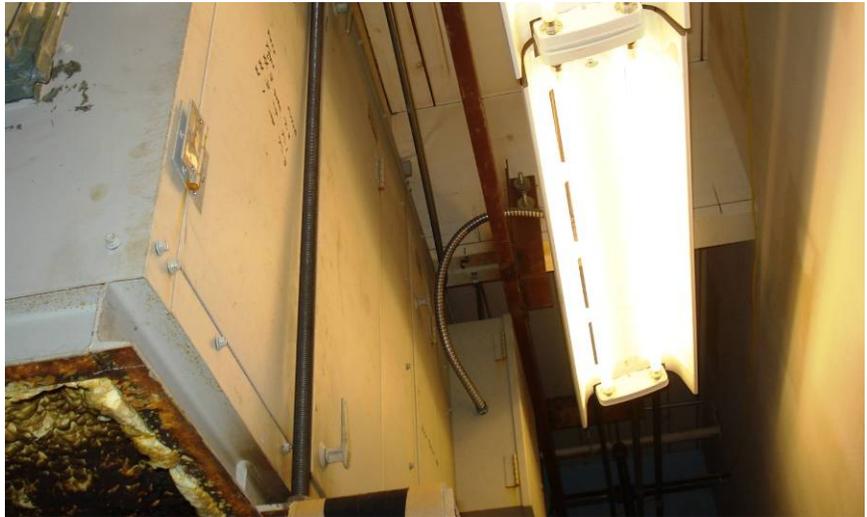
It would appear access to the HRU-7 is very limited. The hinges on the filter door appear to have been dismantled to gain access to the filters likely due to the location of the threaded rod supporting the unit.

*HRU-7 Filter Access Door*

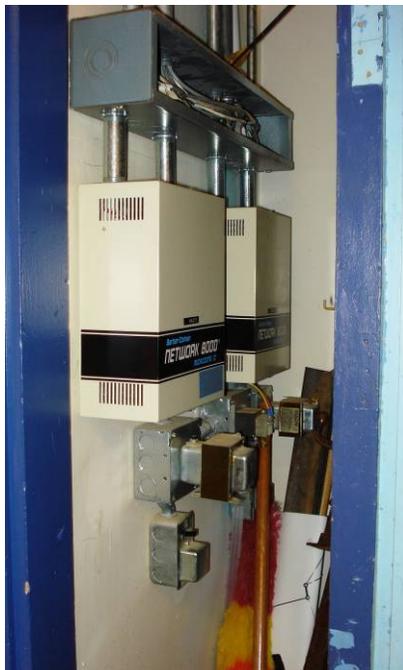
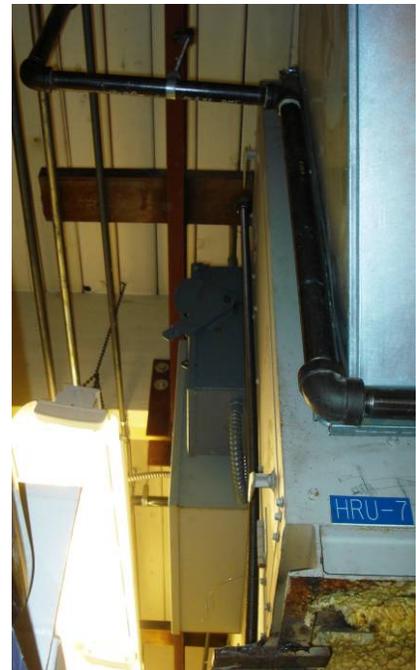
The unit-mounted electrical power disconnect and control panel are located in a very inaccessible location.

*HRU-7 DDC system Components and Unit-mounted Disconnect and Control Panel*

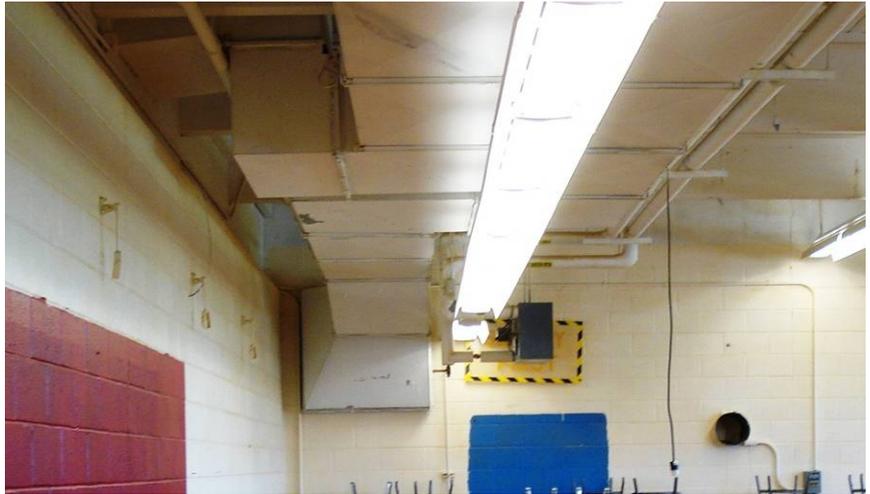
The ductwork running along the ceiling of the Shop Area is the HRU-7 outside air intake (through the further wall) and the unit exhaust (through the roof). The ductwork is un-insulated and there are no isolation dampers at the wall or ceiling. This is a tremendous heat loss.

*HRU-7 Outside Air Intake and Exhaust Ductwork*

We would recommend the installation of isolation motorized low-leak dampers at the wall and roof line and insulating the intake and exhaust duct.

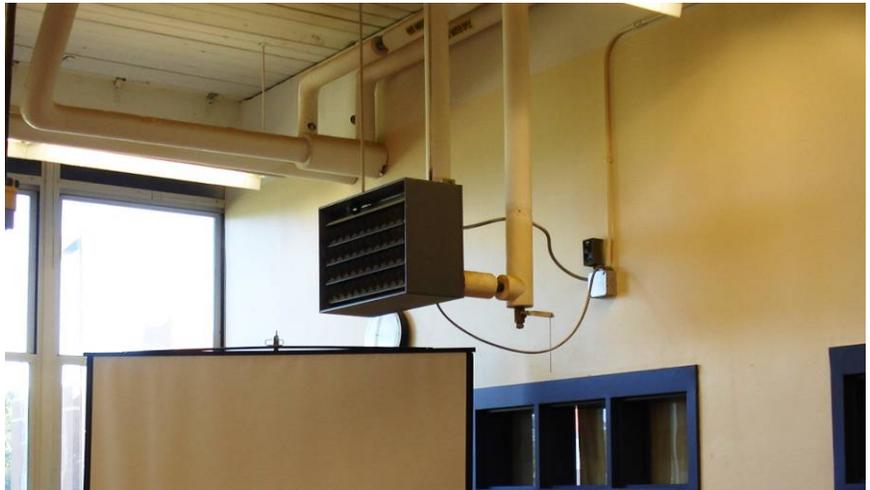
Additional heating in the technical and Applied Arts Shop area is provided through two horizontal unit heaters controlled by a local thermostat. Operation of the unit heaters is unknown. The thermostat cover is off and electrical tape is wrapped around the thermostat.

*Unit Heater in the Shop Area*

We would recommend replacing the thermostat with a DDC system space sensor and adding control of the unit heaters to the DDC system if points are available.

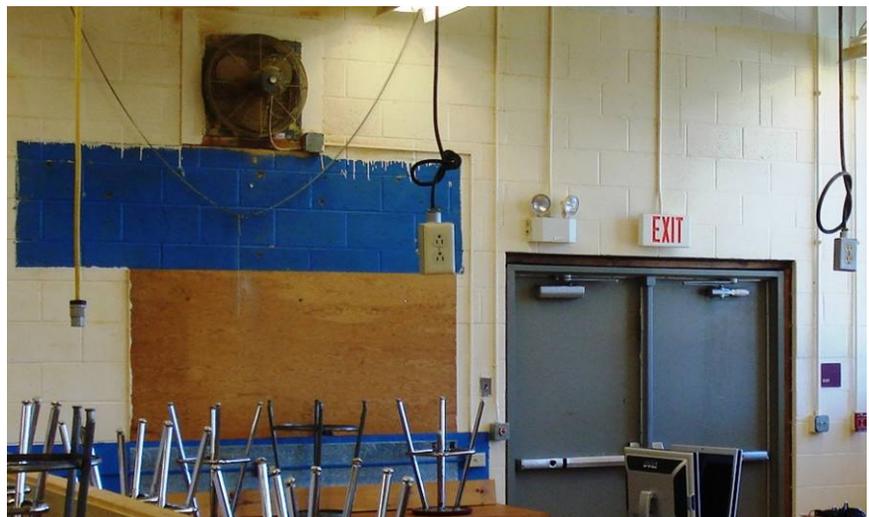
The wall-mounted exhaust fan at the back wall is controlled by the local wall switch near the door. The fan does not appear on the 1994 Addition and Renovations documents. Operation was confirmed. When the fan was turned off, the backdraft damper remained partially open after the fan stopped. After a few minutes it dropped closed.

*Wall-mounted Exhaust Fan*

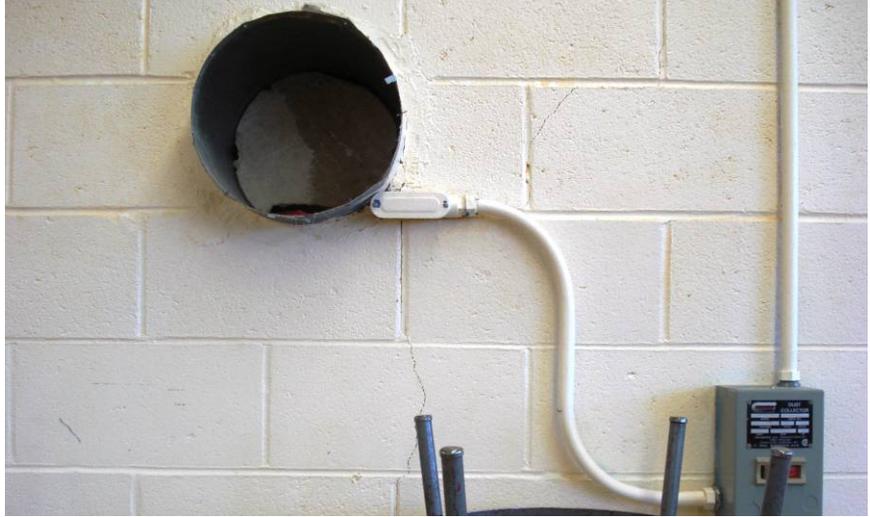
The old dust collection system has been abandoned, the ductwork removed, and the wall opening blocked.

*Abandoned Dust  
Collection System Wall  
Penetration and Switch*

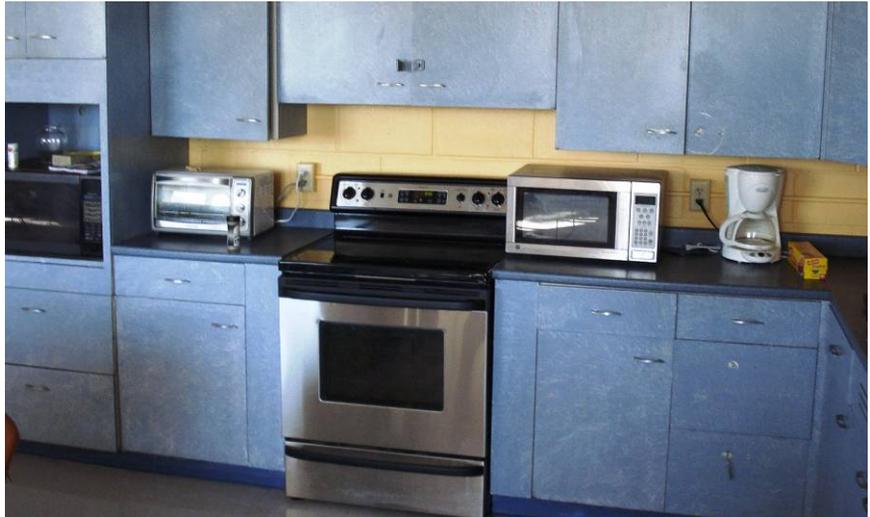
In the Teachers Workroom, a kitchen area was provided as part of the 1994 Addition and Renovations project without an exhaust hood or automatic fire suppression system above the stove.

We would recommend the installation of a hood and fire suppression system in accordance with current codes and the requirements of Fire Marshall and the Jurisdiction Having Authority.

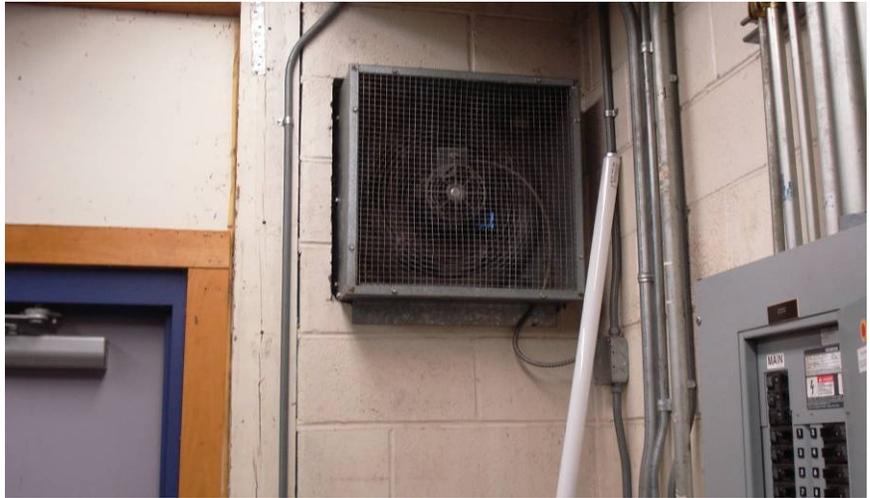
The exhaust fan (EF-14) serving the Main Switchgear Electrical Room F103 responded to the call for cooling at the local thermostat. Cycling the thermostat caused the fan to respond properly. Daylight is visible through the backdraft damper.

*Exhaust Fan in Main  
Switchgear Electrical  
Room F103*

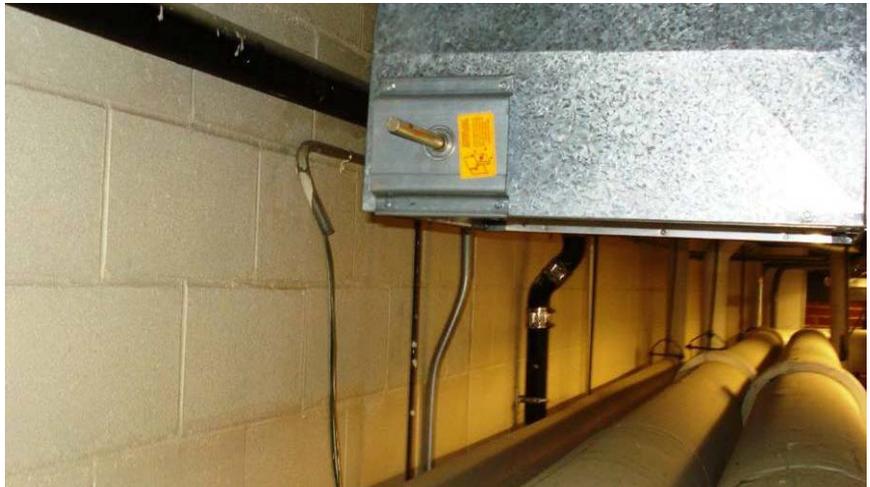
The exhaust fan (EF-17) serves the Mechanical Room C210 (near AHU-2), and, based on the contract documents, was to be interlocked with the motorized damper at the intake hood. The low-leak airfoil type damper is installed but, based on the wires hanging by the damper and the lack of screw holes in the duct, it appears the damper actuator was not installed. It is unknown whether the actuator was left off intentionally or not.

*Intake Damper Associated with Exhaust Fan EF-17*

If proper ventilation of the space has been an issue, we would recommend installation of the damper actuator and proper interlock with the exhaust fan.

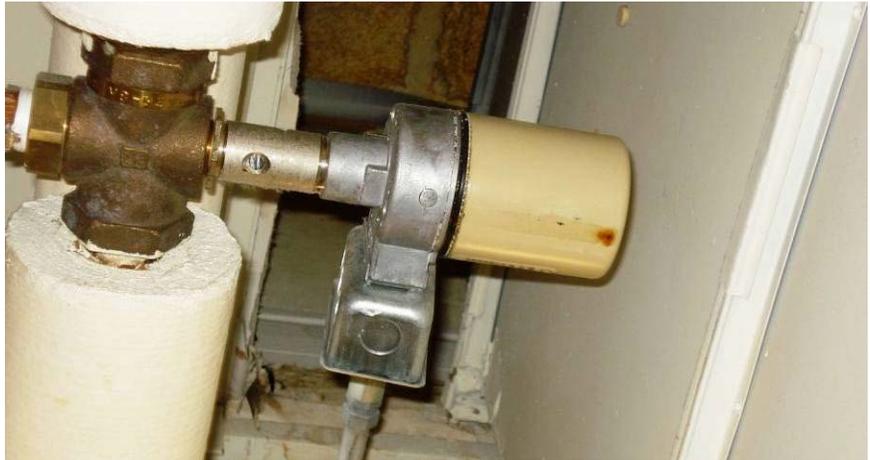
HRU-6 3-way heating control valve is located under the unit in the Laundry or Sports Storage Room E126. The MPR-5413 hydraulic valve actuator is showing signs of hydraulic fluid leakage.

*HRU-6 3-way Heating Control Valve*

We would recommend replacement of the control valve actuator.

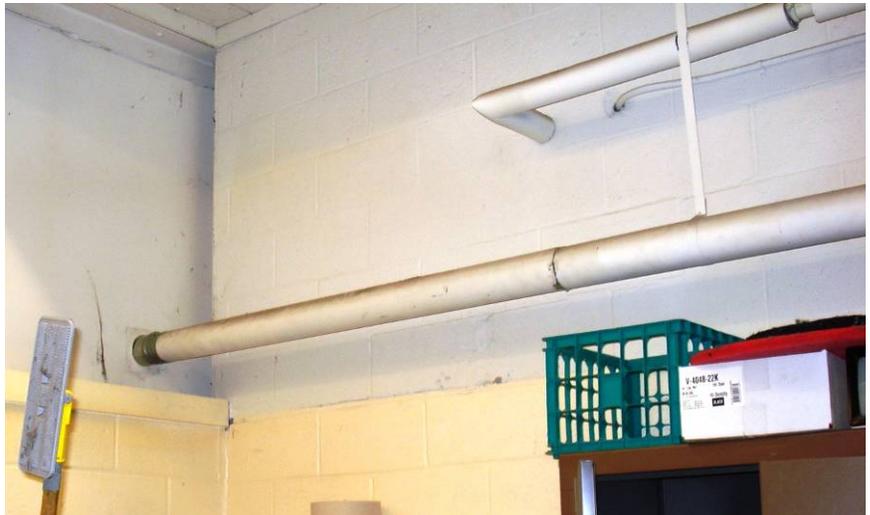
The horizontal portion of the drier vent duct, located in the janitor's closet E127 was installed as part of the 1994 addition and renovation project. The drier was installed by the school at a later date. The horizontal section is installed with screws at the joints. The duct near the drier appears to be assembled with duct tape; screws are unknown. Lint traps are not installed.

*Drier Vent Duct in the Janitor's Closet.*

We would recommend reinstalling the duct with lint traps as required in accordance with current codes.

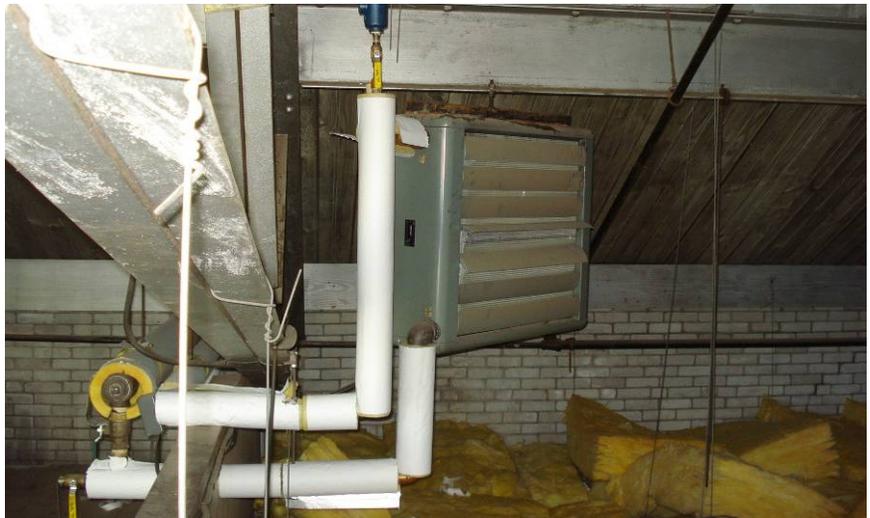
The ventilation of the 1930s Building is provided from the roof-mounted heat recovery unit HRU-9 (rooftop unit shown above). The attic space is heated by two horizontal unit heaters located at each end of the attic. Operation of the unit heaters is unknown and the fins are mostly closed.

*Unit Heater Located In Attic Space of 1930s Building*

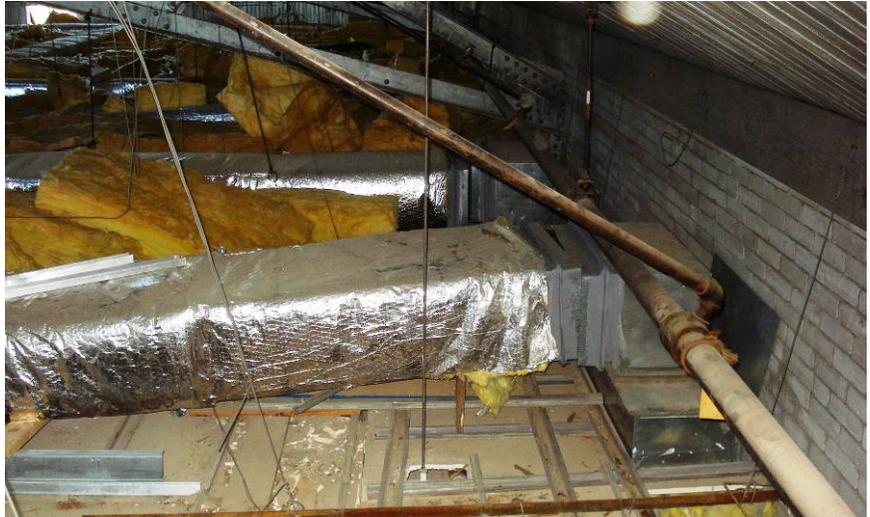
The supply and return from HRU-9 is ducted through out the building. The ventilation system appears to be well insulated but the piping and duct components do not appear to properly suspended.

*Supply (far duct) and Return Ducts located in the Attic Space of the 1930s Building*

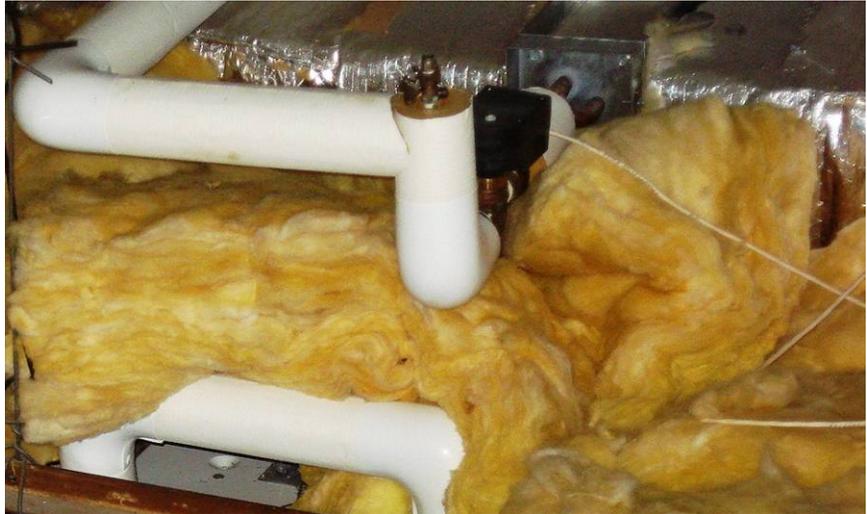
The heating control valves appear to be as installed during the 1994 Addition and Renovation project, nearing the end of their life expectancy, and may require replacement.

*Reheat Control Valve*

We would recommend a complete review and verification of proper operation of all reheat control valves.

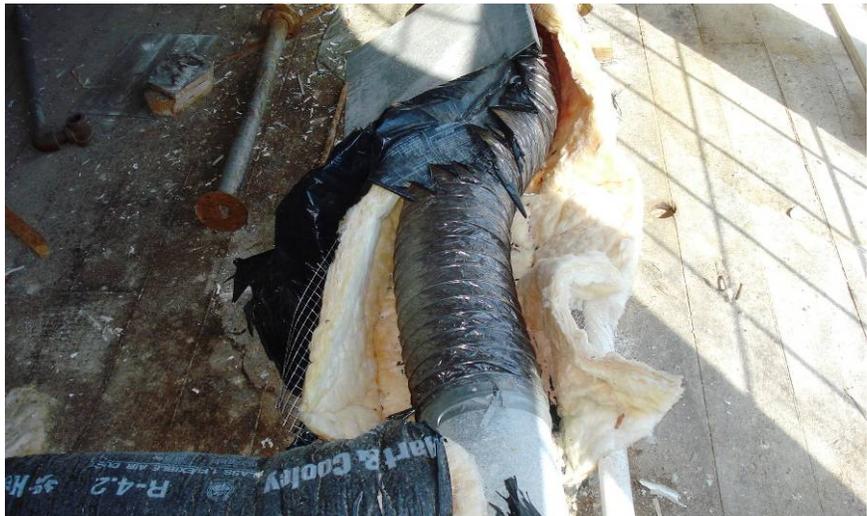
Where the branch flex duct is located in the line of traffic, some of the insulation has been damaged and the thin inner liner is exposed. Many of the metal branch tees are not insulated.

*Failed Insulation on Branch Flex Duct*

*Branch Tee is Not Insulated*

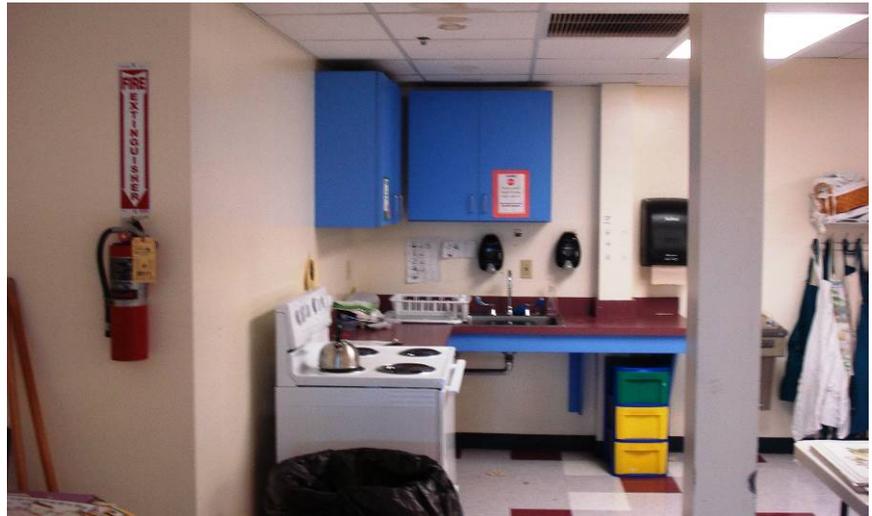
In the ground level of the 1930s building, a kitchen area has been installed without an exhaust hood or fire suppression system above the stove.

We would recommend the installation of a hood and fire suppression system in accordance with current codes and the requirements of Fire Marshall and the Jurisdiction Having Authority. Another option may be to remove the stove.

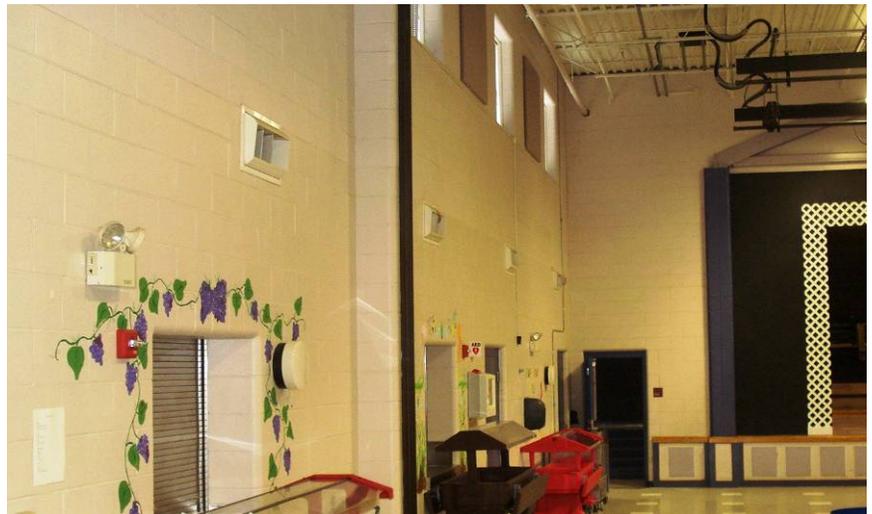
Ventilation for the Cafetorium is provided from AHU-5 located in the Boiler Room. The supply is installed along the north wall (kitchen side) and supplies air to the full length of the Cafetorium, including the stage, and both sides of the moveable wall. The return is installed along the south wall (corridor side) but does not provide for return from the west end of the café when the moveable wall is closed.

*View of North Side of Cafetorium Wall showing Supply Outlets*

We would recommend the return air system be revised to allow for return air from the west end of the café.

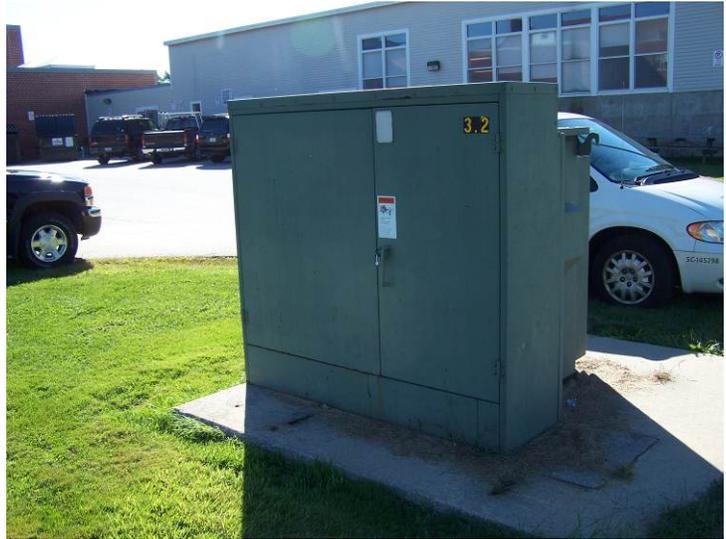
The Middle School pad mounted transformer is a 500kVA three phase transformer. Secondary service voltage is supplied at 277/480 volts. There is no peak demand data for this service as there is one primary meter for the High School and Middle / Pond Cove Elementary Schools; however, the 500kVA transformer appears undersized for the square footage of the building.  $500,000\text{VA} \div 163,110 \text{ sq ft} = 3.1\text{VA/sq ft}$  (typical design  $\text{VA/sq ft} \approx 8\text{VA/sq ft}$ ). As technology requirements increase it is likely that energy usage will increase also.

*Primary Service  
Transformer*

It is recommended that as building loads increase special attention be given to the primary service transformer and ultimately be replaced for a more appropriately sized unit.

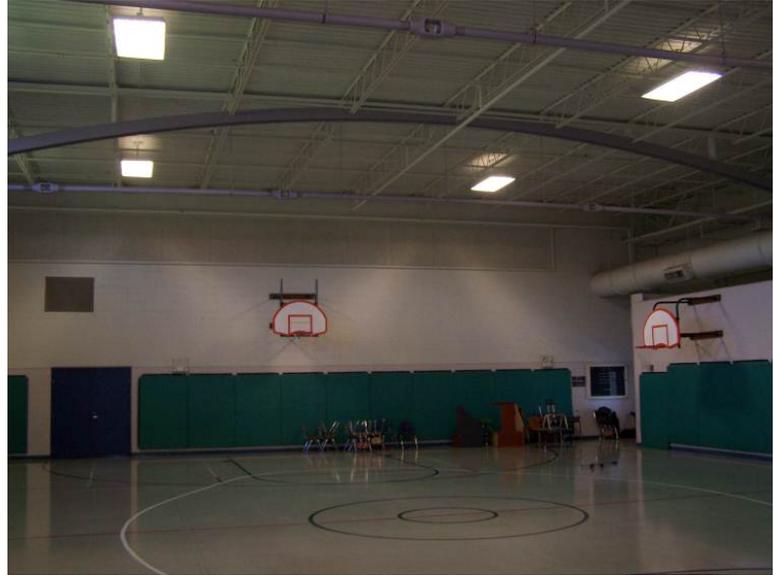
Pond Cove School Gym lights consist of two rows of three, 6-lamp T5 high bay fixtures. Fixtures are in good condition. Lighting levels are fair. Further investigation into the use of this space and its required lighting levels is recommended

*Pond Cove School Gym Lighting*

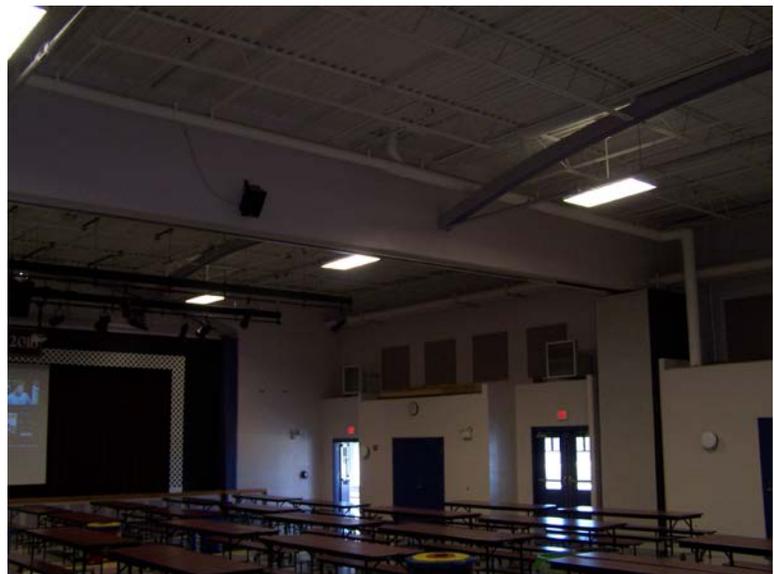
*Cafetorium Lighting*

Combination of two rows of four, 6-lamp T5 high bay fixtures, and incandescent wall mounted fixtures. Lighting is in good condition. Lighting levels are low for a multi-use space. Further investigation into the use of this space and its required lighting levels is recommended

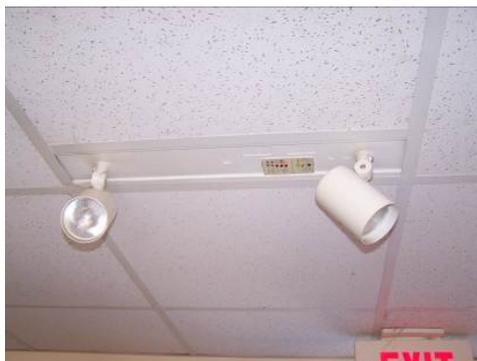
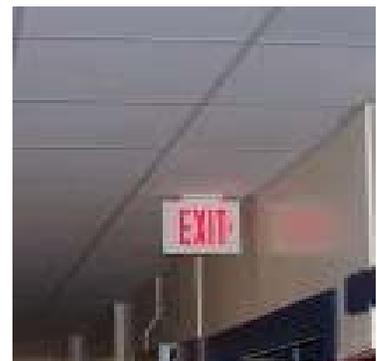
*Typical Emergency Lighting and Exit Signs*

Most emergency lights are surface wall mounted or ceiling recessed self-contained battery units with remote heads (EBUs). EBUs were generally in serviceable condition. Middle School Gym units were damaged and should be replaced. Generally emergency lighting coverage is good.

Exit signs observed are internally illuminated units with integral battery. Most signs are in good condition; however several areas including the Health/Tech Lab need supplemental exit signage to meet NFPA 101 requirements.

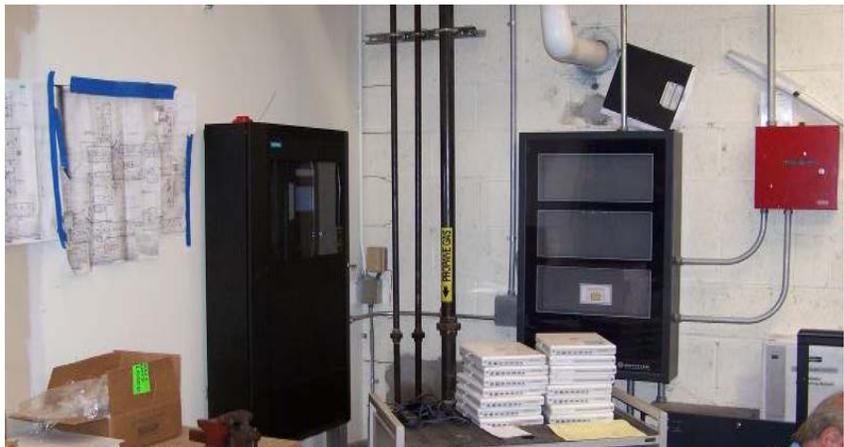
*Fire Alarm System*

Fire alarm system is a Siemens FireFinder XLS. The system was recently upgraded from an older Notifier installed during the 1994 renovation. The system is in good condition and no trouble was reported. In the event of an alarm, the system reports directly to Portland monitoring / dispatch facility. Several areas need additional notification appliances including the classrooms on the second floor of Area G.
