**Town of Cape Elizabeth**  
Seven Building Facility Study  
*Cape Elizabeth, Maine*

**Introduction****Town of Cape Elizabeth Facilities Study**

*Facility Study Process*

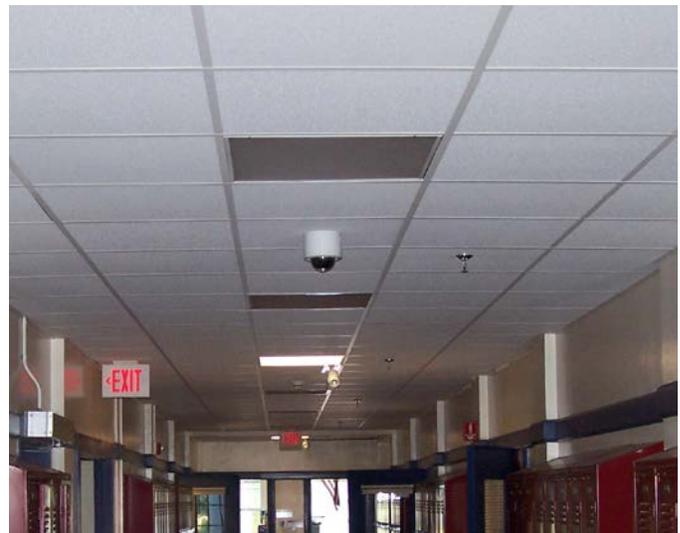
*Typical Camera*

The School is served by a video surveillance system with cameras at various locations throughout the building, mainly at building entrances. The system is an Integral Technologies system with a mixture of legacy and upgraded video platforms. The main server is based in the High School but also serves the Middle School, Pond Cove Elementary School, Police Department and Fire Department. Advance Technology is responsible for maintaining the system, and reports multiple failures of the system, with frequent database corruption and loss of camera function.

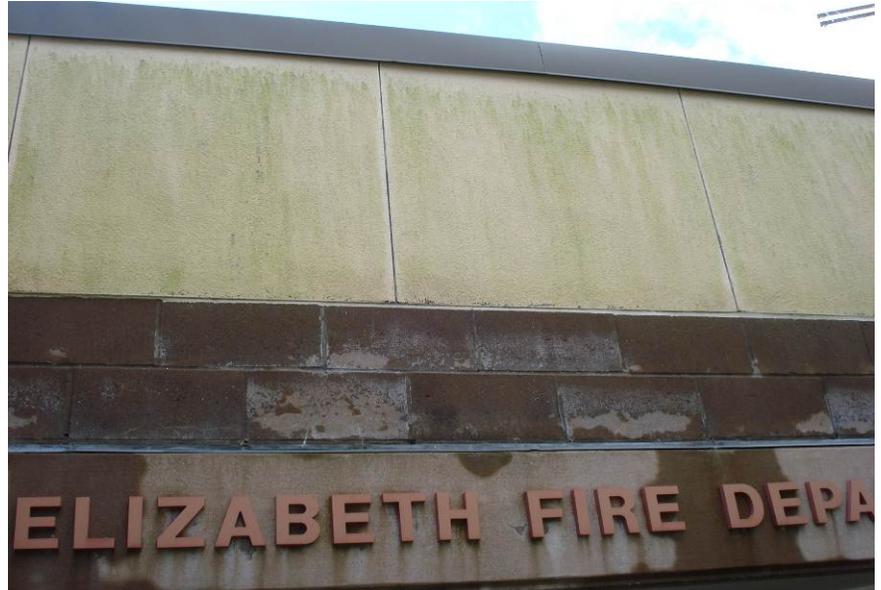
*Wet Masonry Surface*

The front entrance shows the block surface with a lot of moisture permeating the block from inside. These types of masonry units should be specified with a Dry Block ingredient so as to not allow moisture to permeate into the cell of the block through a rain event. The moisture is being drawn back through the block surface and joints causing this wet appearance. The moisture is also being drawn through the mortar joints and has caused an efflorescence to all sides of the block veneer. The white blotchy surface is a sign that the moisture being drawn from inside the block through the mortar is allowing the alkalines within the mortar to bleed out. This chemical reaction will lead to premature cracking and spalling of the mortar joints.

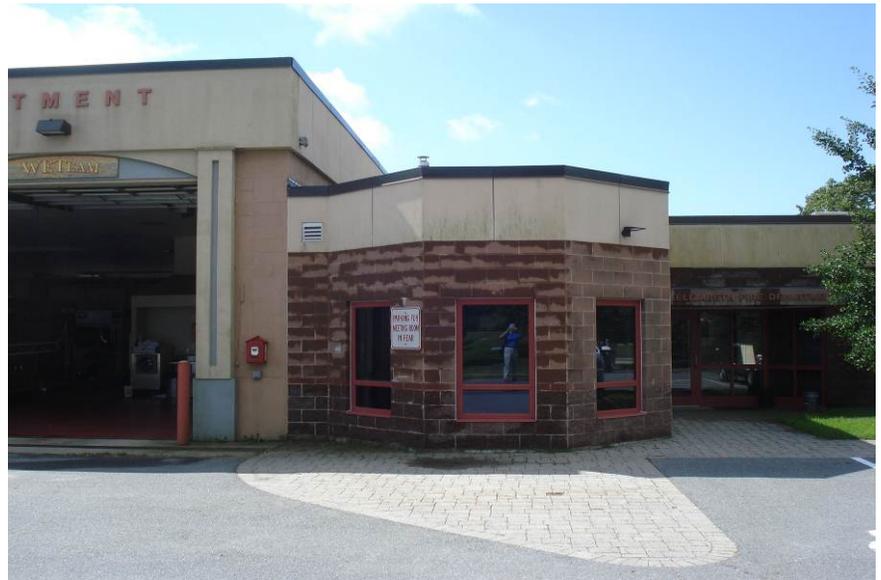
*Wet Masonry Surface*

The exterior wall system is a combination of pre-colored concrete masonry units, EIFS on steel studs and a durable paint system on regular block. The building was surveyed the day after a rain event. The pre-colored cmu veneer system had a surface wetness common with this type of masonry unit. Even though the system is cavity back with the proper flashing and drainage the presence of the moisture remaining in the block will be problematic over a very short term and will lead to a premature failure of the block system.

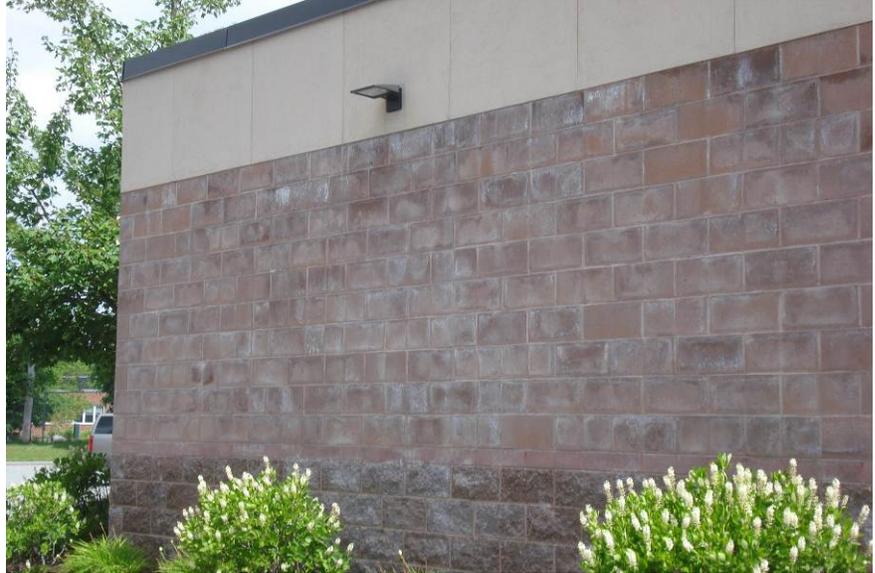
*Rear Wall – Moisture  
in Wall Has Discolored  
Pre-Colored Masonry  
Units*

*Rear Wall -  
Efflorescence*

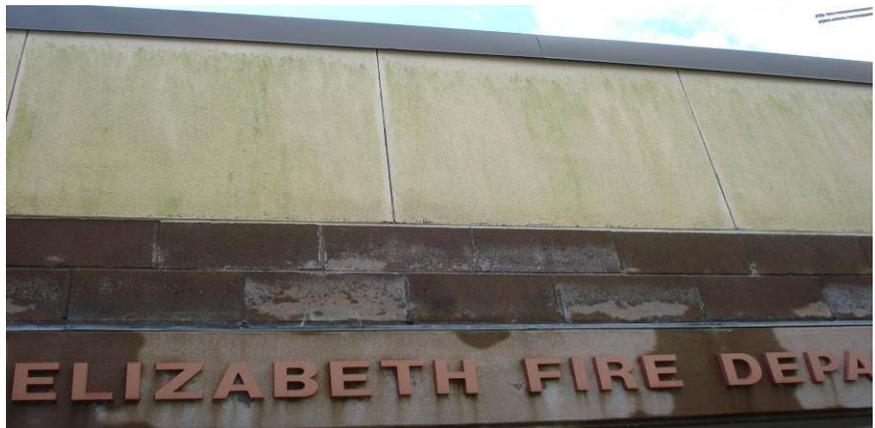
*Exterior EIFS Panel*

The EIFS panels on the office and meeting room areas are showing mold and mildew on the surface and the bottom edge is showing that parts of the finish has chipped off due to moisture.

*Mold and Mildew on  
Panel Surface*

Recommend cleaning of these panels with a strong bleach component building wash product to remove the mold and maintain the surface finish.

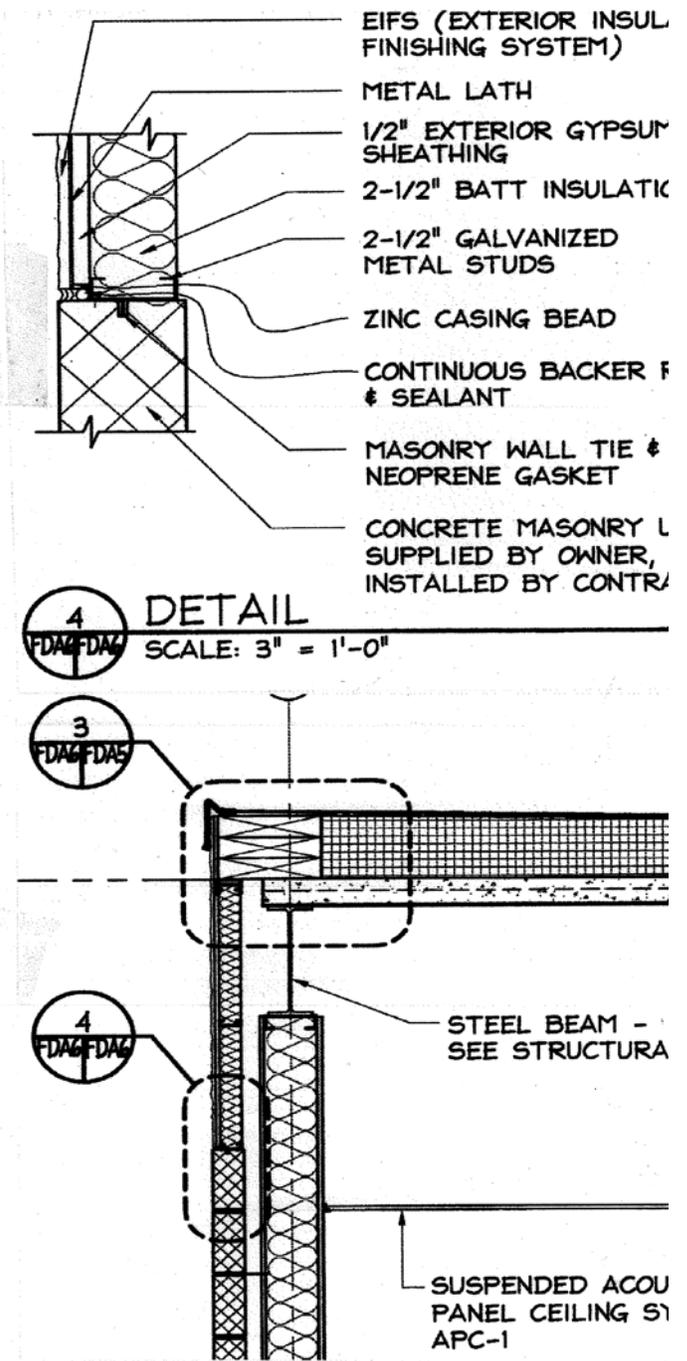
Fire Station – Top of Wall

The detail for the exterior panel, per the construction documents, is a very poor installation method. The detail shows a steel stud sitting directly on top of the block veneer and attached directly to the wood blocking at the roof line. The detail is showing a caulk joint between the panel and the top of the block. At a number of locations no caulking was installed which provides a location for water entry.

The detail of this installation should be checked to verify if indeed it was constructed in this manner. The lack of sheathing and moisture protection to the roof line from inside the cavity will cause long term issues with steel and stud connection as well as a non-insulated barrier to the inside.

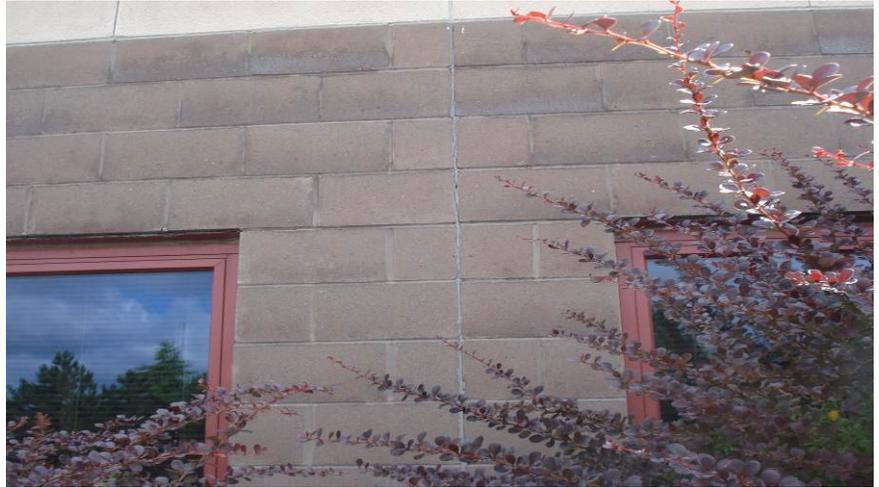
The new pre-colored block veneer has a number of cracks in the mortar joints due to contracting and expansion of the veneer. Because of the earlier issue described relative to the amount of moisture that the block is retaining this is more than likely the cause of the numerous joint cracks found around the building. These types of systems will expand and contract more due to moisture and temperature changes and the proper location of control joints is key to maintaining the wall appearance and not lead to water entry issues.

*Control Joint Failed*

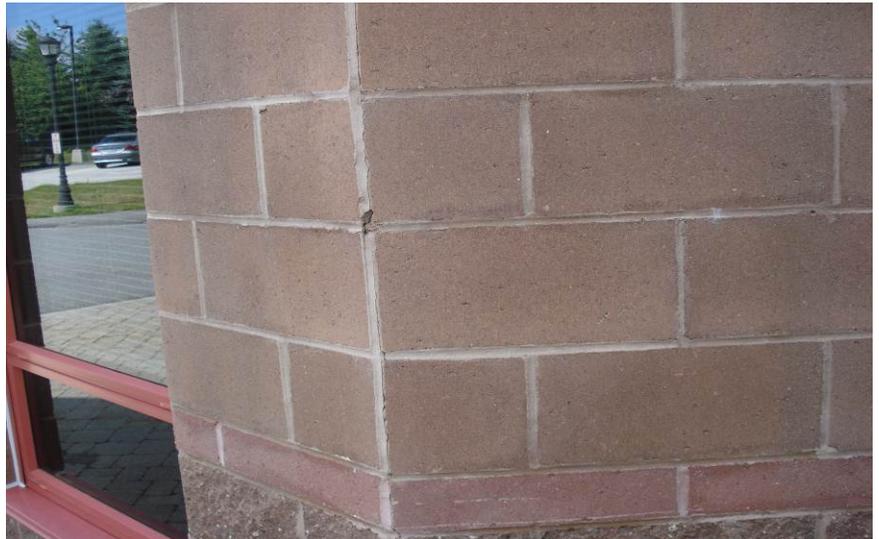
*Corner Joint Failed*

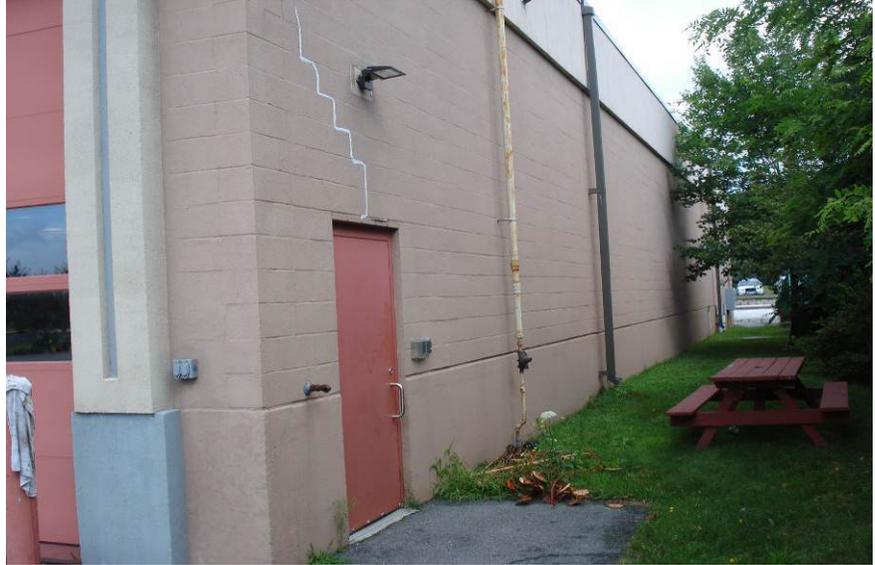
*Exterior Wall Crack  
Currently Being  
Repaired*

*Cracked Wall Being  
Repaired and Sealed*

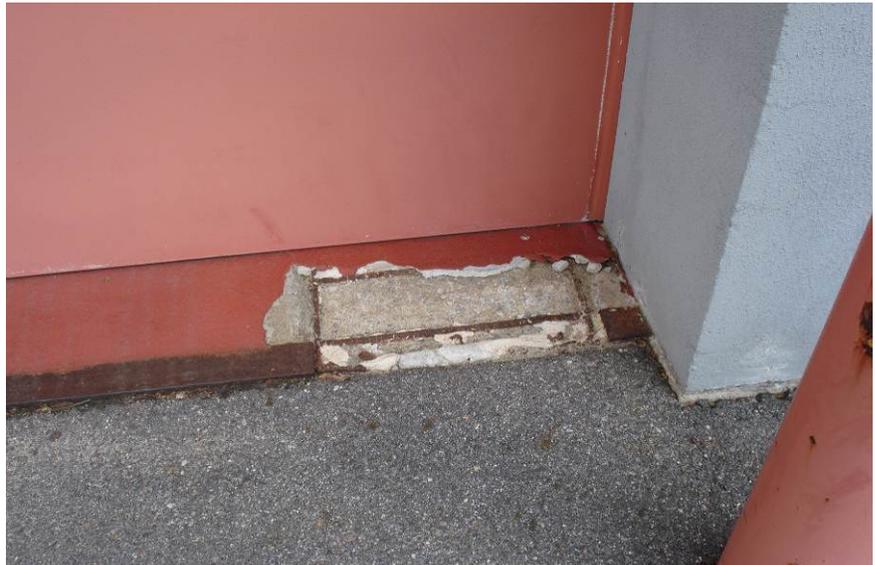
*Sill at Overhead Door to  
Garage Bay*

The concrete sill at one of the overhead doors to the garage bay is showing an area that has completely cracked and chipped off exposing the reinforcing bars to the weather. One very noticeable issue with this broken area is that the rebar within the concrete sill has been placed too close to the exterior surface. The metal angle edge is partially broken for an unknown reason. The detail, per the construction drawings, shows a thickened reinforced slab edge sitting on the foundation wall. The reinforcing from the foundation wall is dowel into the slab and it is not recommended to leave this rebar exposed to weather where, long term, this could lead to a failure of the foundation.

*Cracked and Chipped  
Sill at Overhead Door*

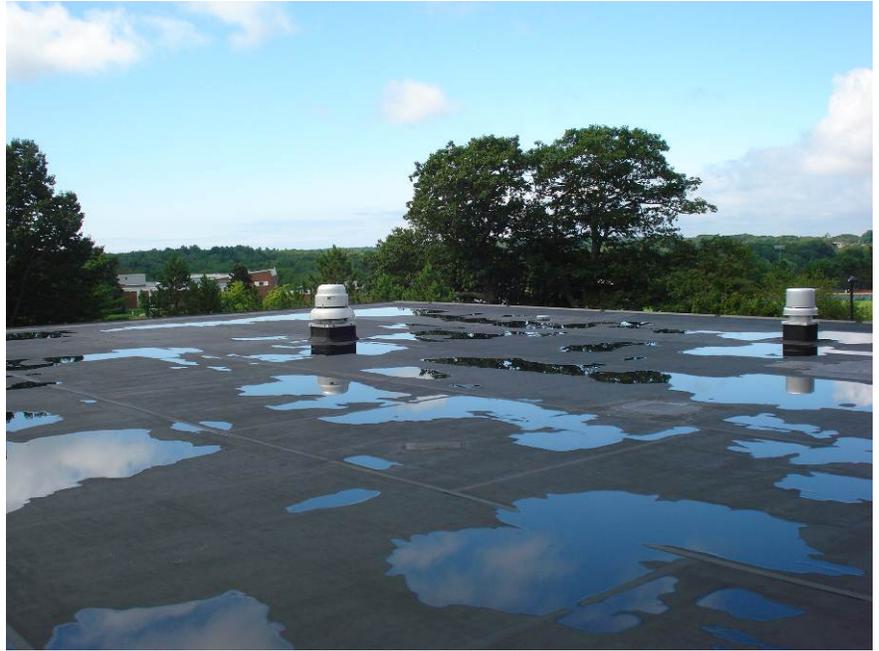
*High Garage Roof*

The main concern with the garage roof is the amount of ponding on the roof and the little or no slope to drainage locations. Since no record was found as to its replacement it is difficult to put a time period on the life of the roof. It showed no significant pitting due to UV and the seams on the low roof were in good condition. The ponding on the upper roof will be problematic to the overlap seams and will cause maintenance issues on a continuous basis over a period of time.

*Ponding on Roof –  
Drain in Background*

At the time of replacement we would recommend additional roof drains and a code compliant tapered board system be installed. Unknown if this roof is part of the town's yearly inspection and repair program.

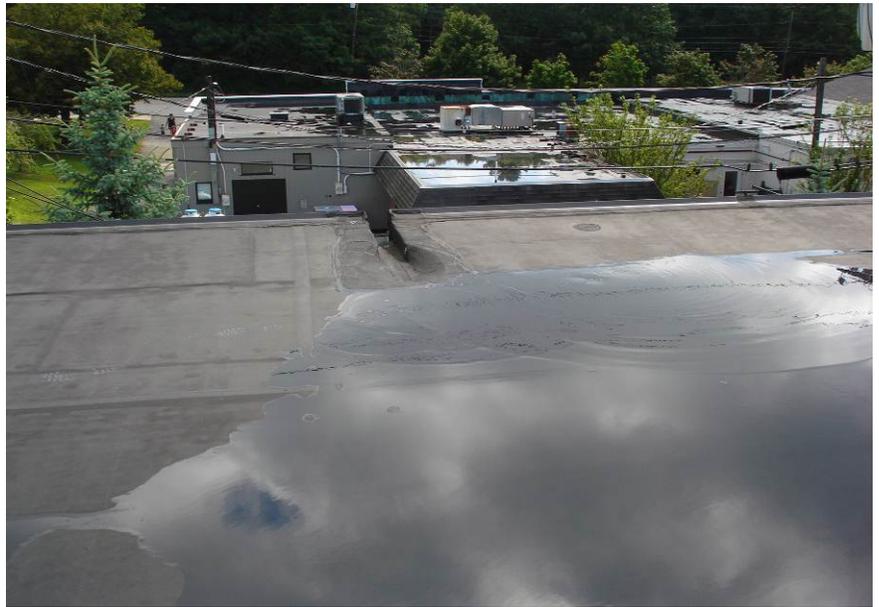
*High Garage Roof*

No record was found as to when the fully adhered membrane roofing was installed over the garage and office areas. These roof membranes were installed with a lap sealant system as evident in the pictures. There is also a number of patch / repairs that have been done to the seams. These roofs also have a mechanically fastened insulation board and fully adhered membrane fastened to the board. The high garage roof has a few roof drains off to one side and a couple of drainage slots created into the roof insulation for drainage as part of an overflow issue.

*Roof Drainage Cut Into  
Insulation with Ponding  
Nearby*

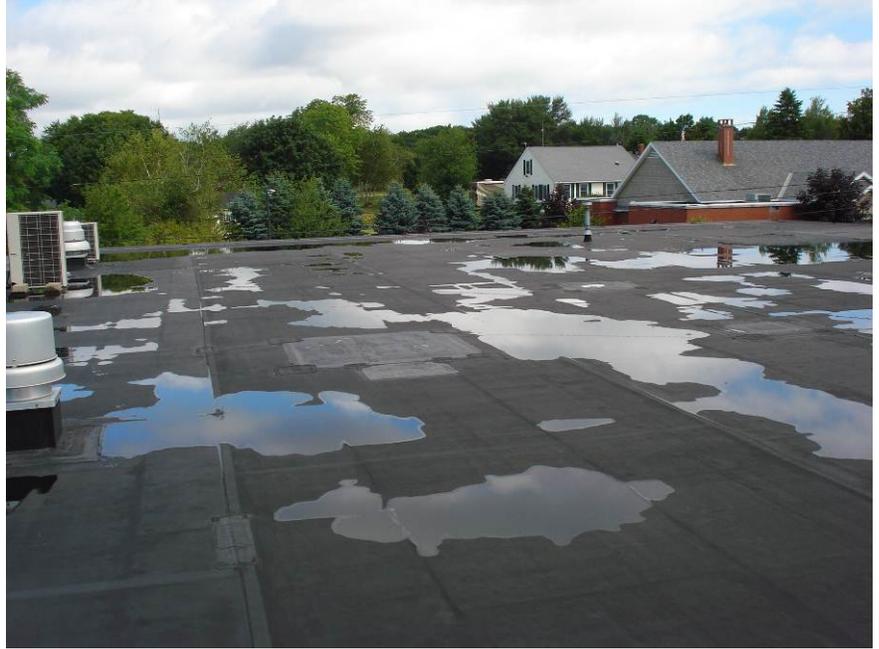
*High Garage Roof*

*Ponding Over Large  
Expanse of Roof*

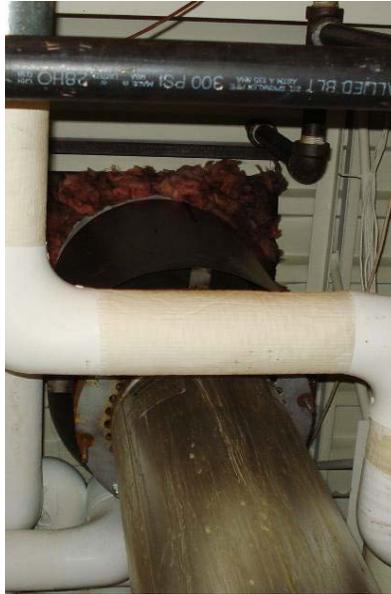
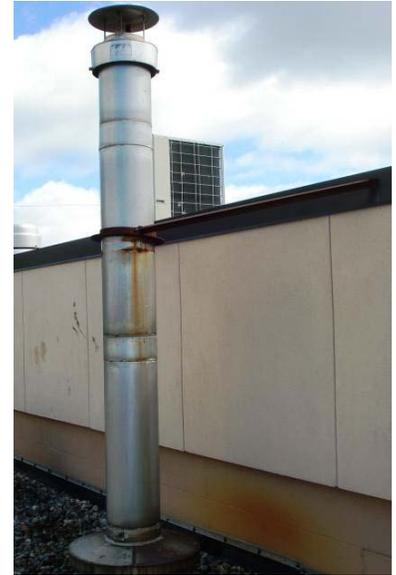
*Chimney*

The Ampco prefabricated double-wall chimney appears to be in good condition. The section of the chimney above the roof was supported off the upper roof flashing and is loose.

We would recommend the chimney be properly secured as needed.

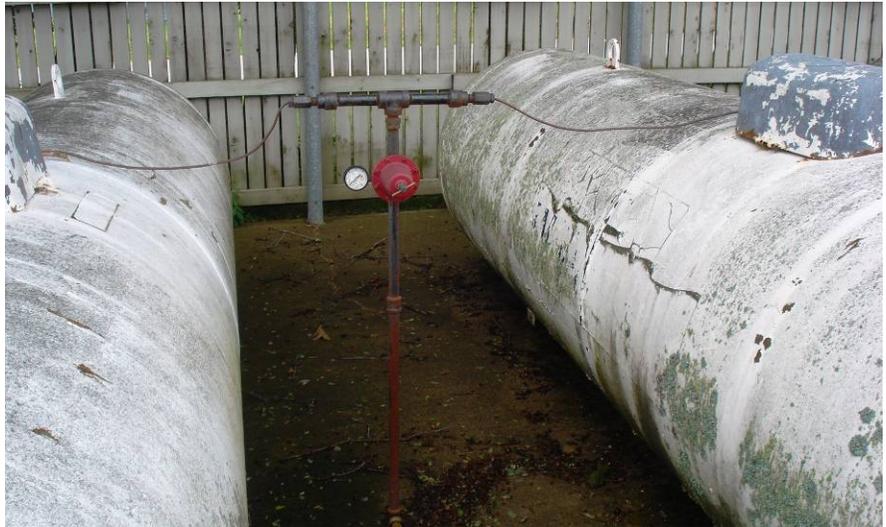
*Liquid Propane Storage Tanks*

Liquid Propane is stored in four tanks located across the back rear parking lot. The enclosure is not secured. The gas regulator and associated pipe is free standing in the middle of the tanks.

We would recommend the installation of additional support for the gas piping as needed.

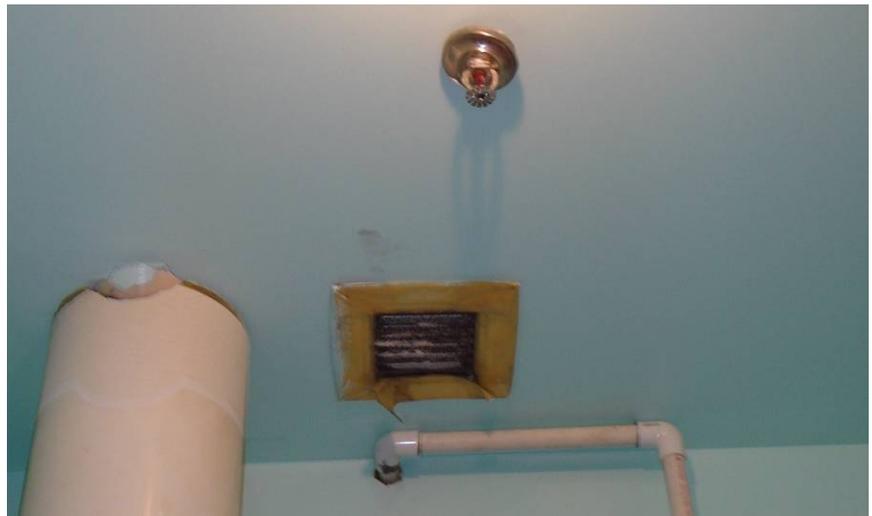
*Janitor Closet Exhaust Grille*

The exhaust grille in the janitor closet is showing signs of corrosion.

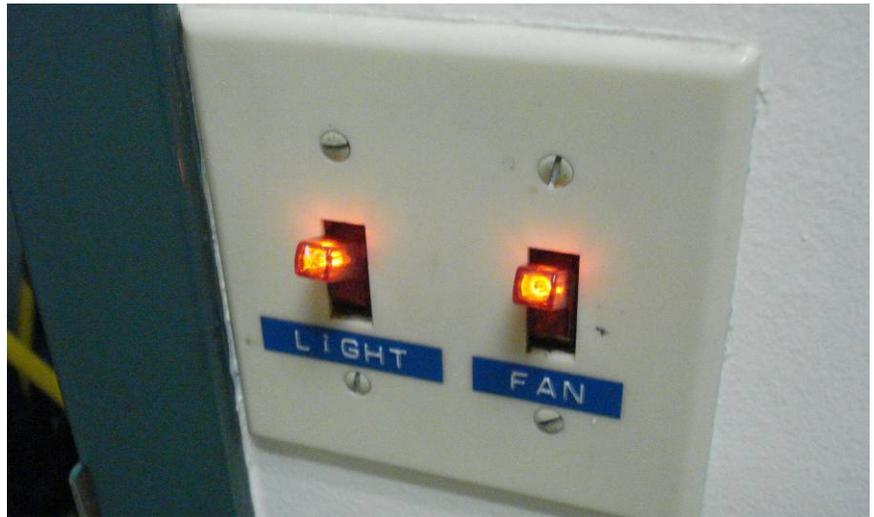
*Janitor Closet Light/Fan Switch*

The toilet and janitor closet exhaust fan is controlled by a local lighted wall switch located outside of the janitor's closet and does not meet the current code requirements. Operation of the fan was confirmed.

We would recommend interlocking the fan with the lights in each room served to operate when the lights are on and remain on for a time delay after the lights are turned off.

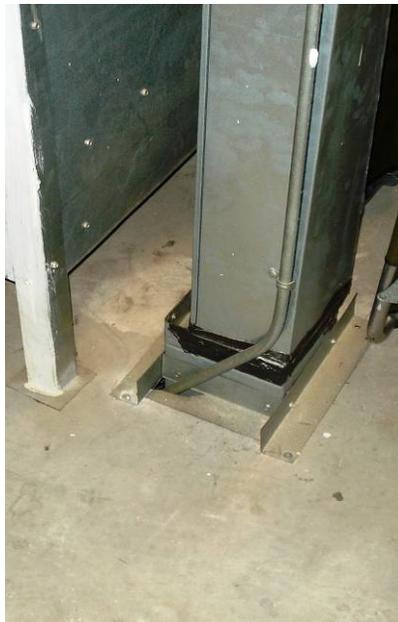
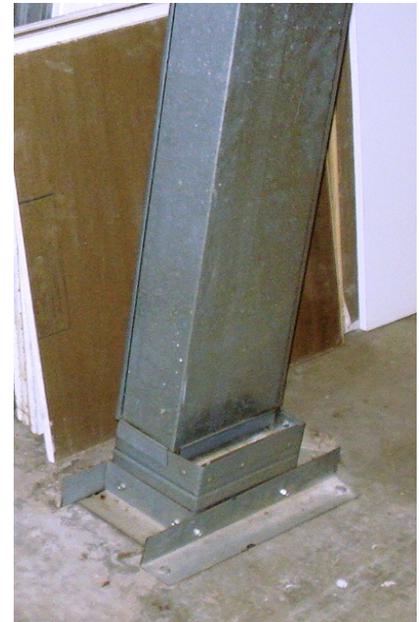
*EF-7 Duct Penetrations  
Through Mezzanine Floor*

Fire dampers have been installed at the floor level. Adjacent to one of the fire dampers (left photo below), a section of electrical pipe has penetrated the sheet metal near the fire damper. Access doors have not been installed above each fire damper. Access doors are required for annual inspection and testing of fire dampers. It would appear the mounting screws may have penetrated the damper channel.

We would recommend properly sealing the floor penetration, installing access doors, verifying proper operation of the dampers, and annually testing fire dampers in accordance with requirements outlined in NFPA 90A.

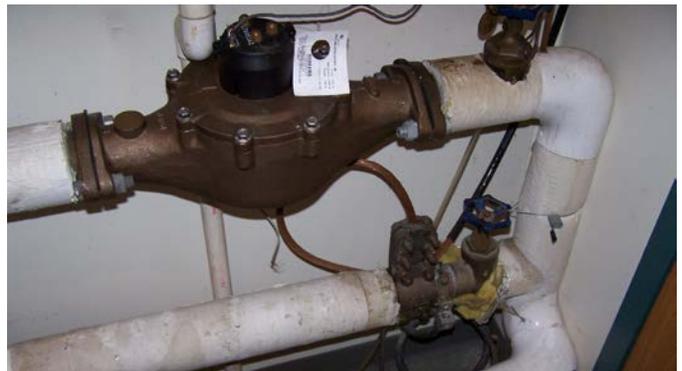
It was observed that there was no bonding jumper across the water meter in the boiler room.

*Water Meter missing bonding jumper*

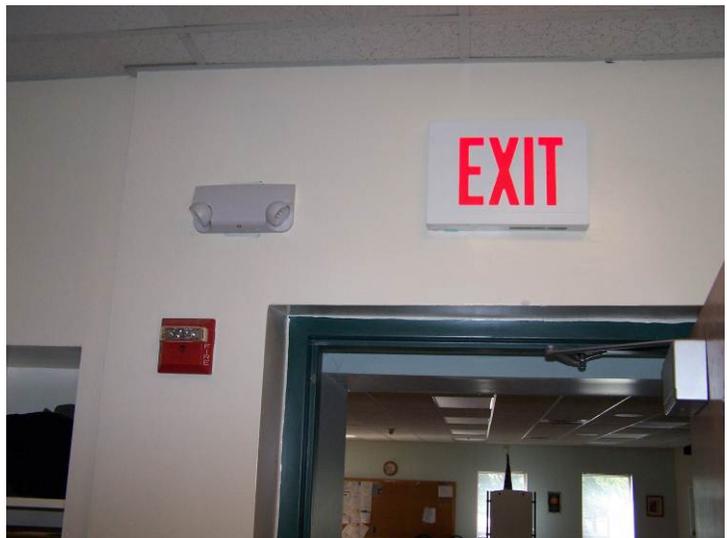
*Life Safety Lighting and  
Exit Signs*

Only a few emergency lights were observed in the corridors and restrooms. These units are surface wall mounted self-contained battery units with remote heads (EBUs). The units have been recently upgraded to an LED type. Generally EBUs are in excellent condition but coverage is limited to the restrooms and central corridor. If the occupancy of this building exceeds 50 the building is required to have full life safety lighting for all paths of egress per NFPA 101 standards.

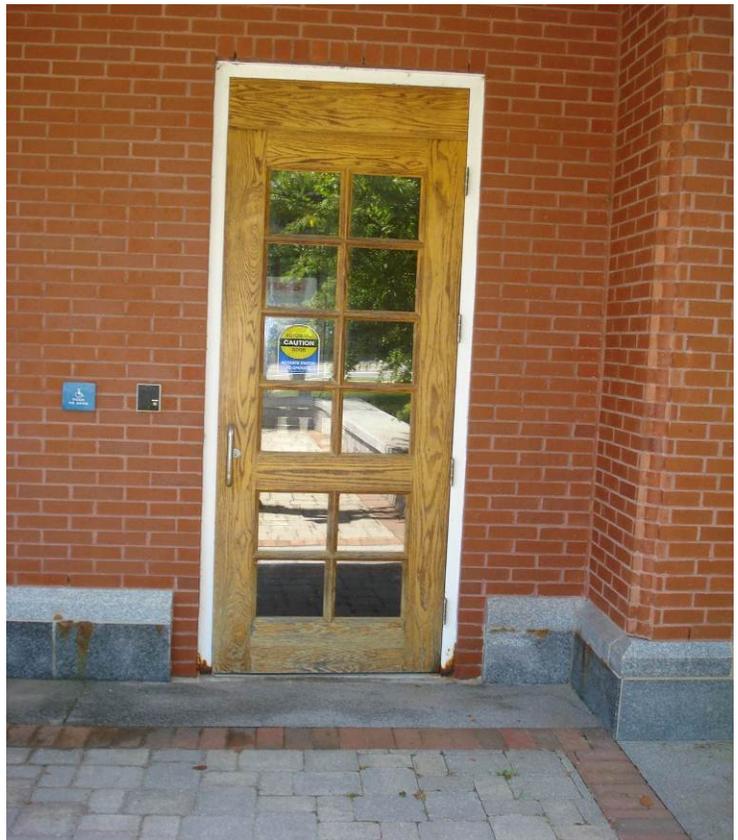
*Front Entrance – Wood Door*

The items requiring maintenance or replacement would be the exterior doors and frames. The front entry wood door needs replacement – the door is sticking to the jamb and the frame is showing rust through the bottom of the hollow metal frame.

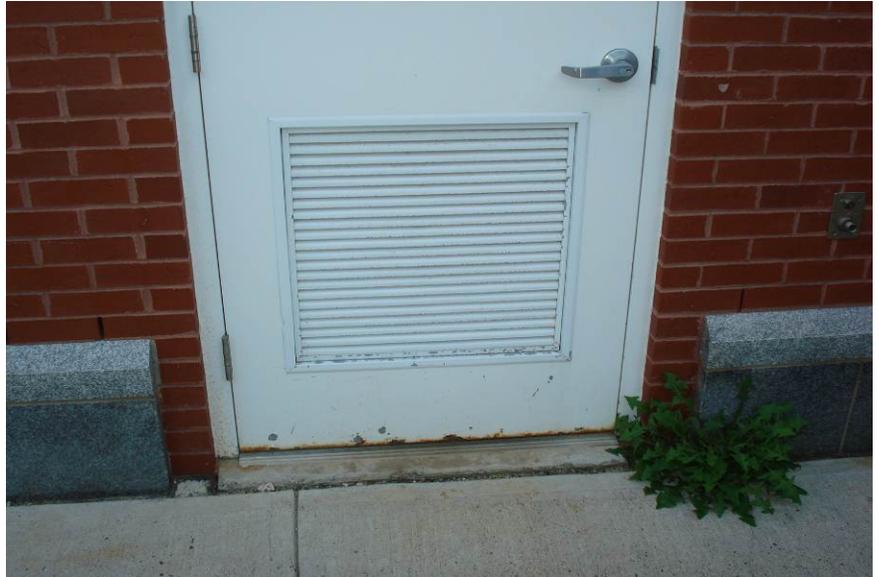
The exterior painted white doors and frames will need replacement soon as the bottom edge of the doors and frames are rusted out to the point where sanding and painting will be ineffective.

*Painted Doors Bottom  
Edge Rusted*

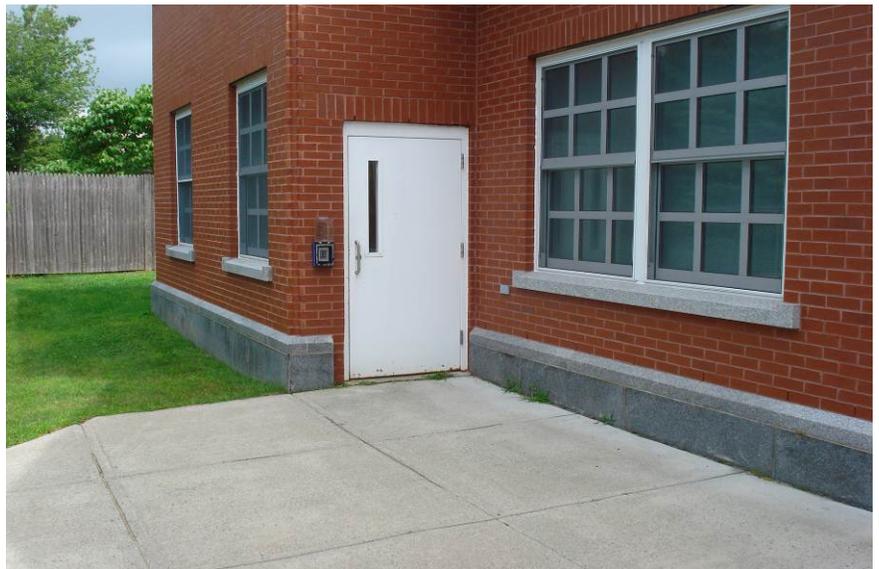
*Rusted Bottom Edge  
Door*

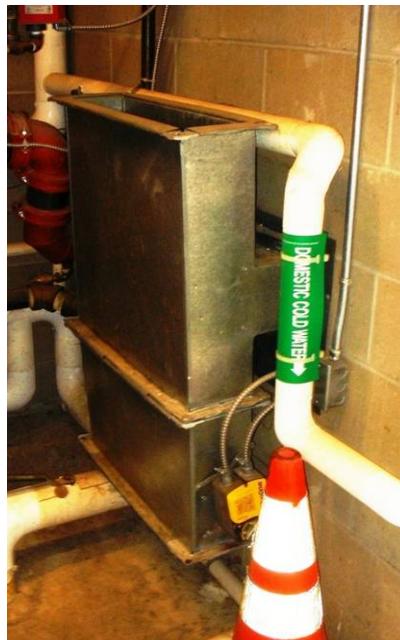
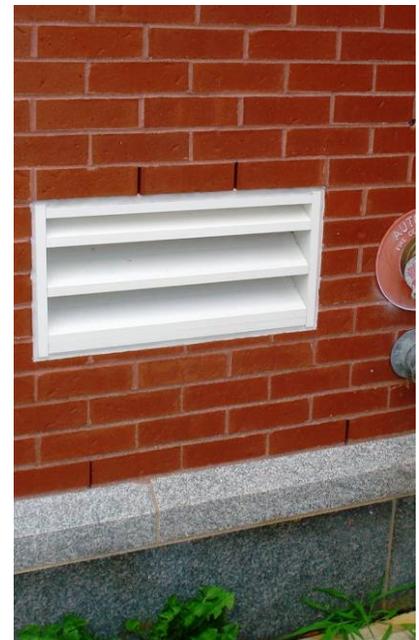
*Ducted Combustion Air*

Combustion air is provided by natural ventilation into the boiler room through two openings. The opening shown below is a dual-duct opening configuration with a combustion air damper on the lower portion. According to the original plans, each opening is 24" x 6". At the time of review, the damper was open as expected in accordance with the sequence of operations.

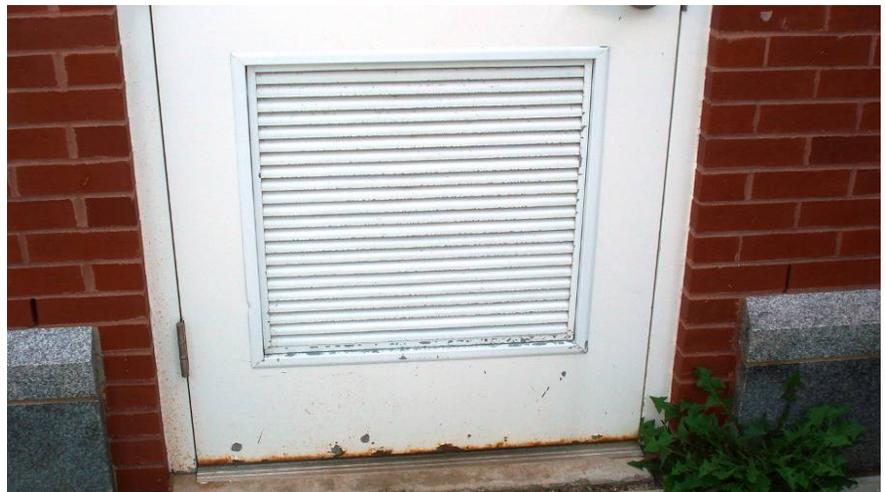
*Door-Mounted  
Combustion Air Louver*

The second combustion air opening is a louver cut into the boiler room door. Based on the duct tape around the inside of the opening, it would appear efforts have been made to reduce the infiltration through the door-mounted louver.

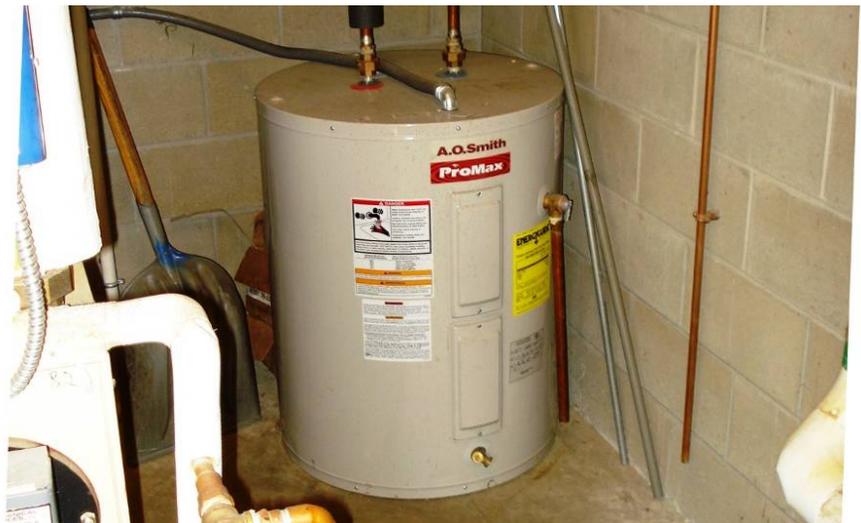
*Domestic Hot Water Heater*

The boilers are outfitted with tankless hot water connections. Based on the contract drawings and apparent piping modifications, the electric hot water heater may have been added since the time of construction.

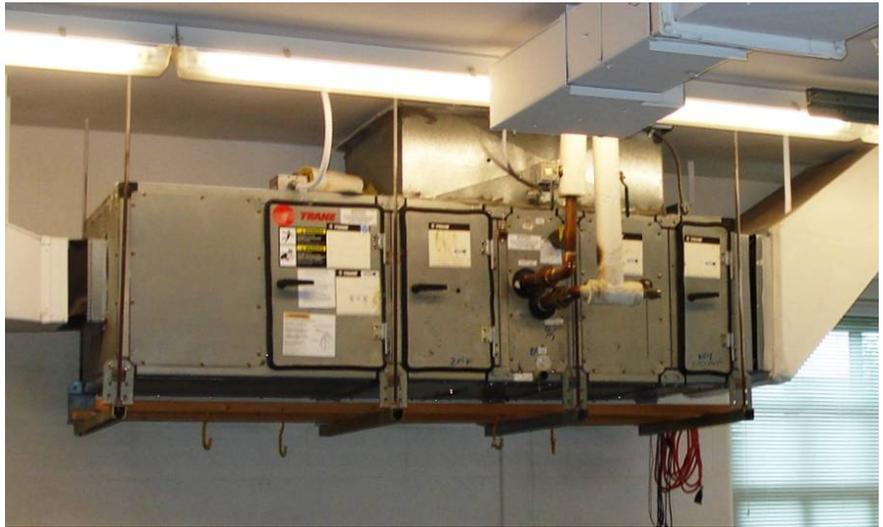
Heating and ventilation for the sally port is provided through the 1100 cfm Trane HV-1 unit suspended from the structure in the sally port. The unit appears to be in good condition. When manually commanded on, the duct-mounted intake and return dampers opened. However, the duct-mounted relief damper failed to open. As a result, the space may be improperly ventilated.

*Trane Heating and  
Ventilation Unit HV-1*

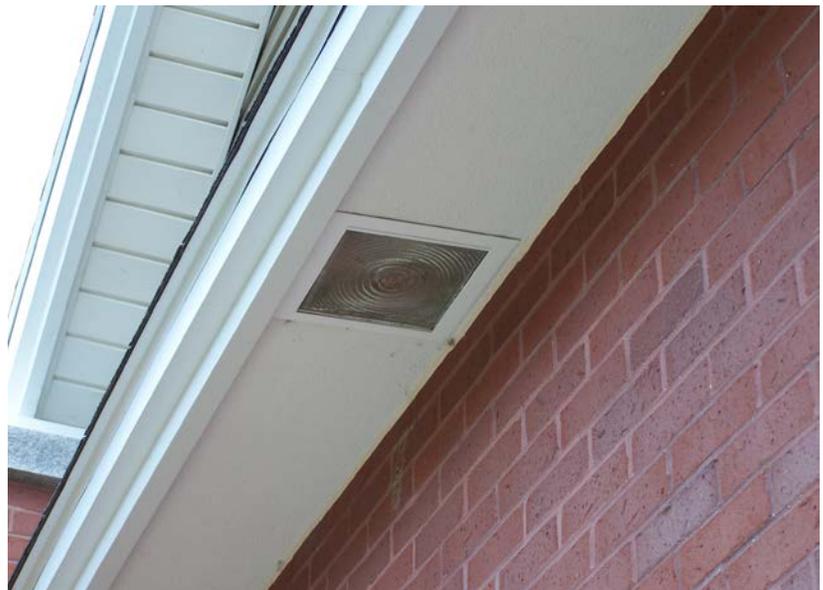
The Cape Elizabeth Police Department is served by a variety of lighting fixtures (lens troffers, parabolic troffers, compact fluorescent downlights, incandescent downlights, surface wraps, vapor-tight). Most fixtures are T8 or bent tube T8 lamps. Many spaces are switched for two levels of lighting. Occupancy sensing lighting controls were observed in some spaces. Rear exterior soffit lighting showed signs of dirt and insect infiltration.

*Rear Soffit Lights*

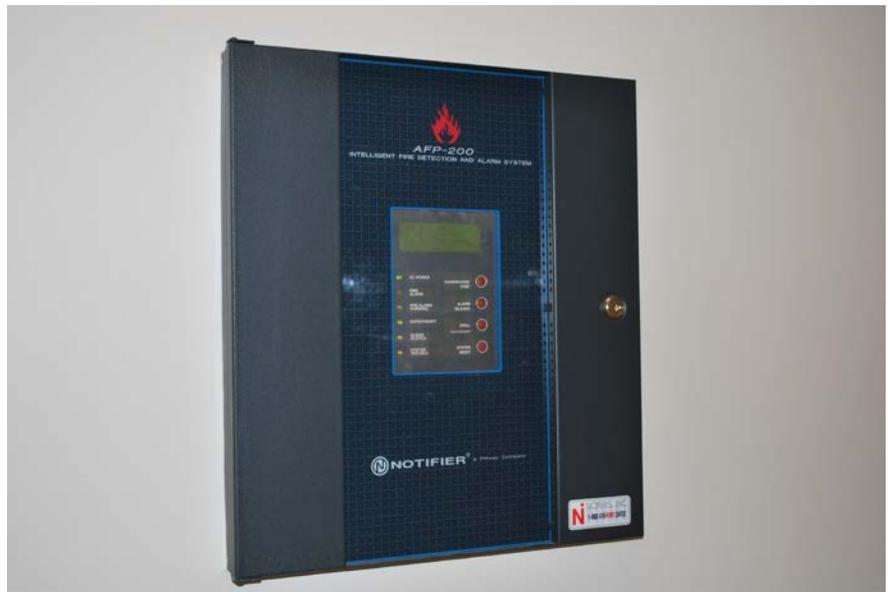
The police station is served by a fire alarm system. The system is a Notifier AFP-200. It appears that this system is original to the 2000 construction. Notification appliance, smoke detectors and pull stations are located throughout the building. In the event of an alarm, the system reports directly to Portland monitoring / dispatch facility. The police department reports no trouble with the control panel but has experienced some trouble with the dialer.

*Fire Alarm System*

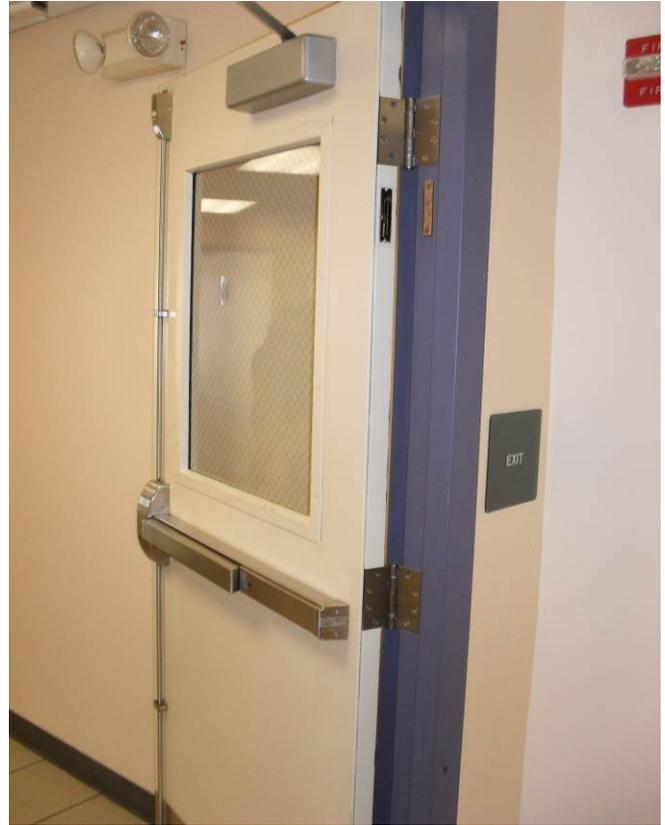
The cross corridor doors have full vertical rod panic devices which are required to latch at the top and bottom to meet code. The floor strike plate is missing at all fire rated door assemblies viewed, and should be replaced. Pairs of doors used in a fire rated assembly are required to have smoke seals at the frame and smoke resistant astragal. These items are also missing and should be corrected. The doors have glass lites with wire glass. Fire doors with wire glass are no longer allowed per code. IBC requires glazing in these doors to be of tempered fire lite.

*One Hour Rated Cross  
Corridor Door*

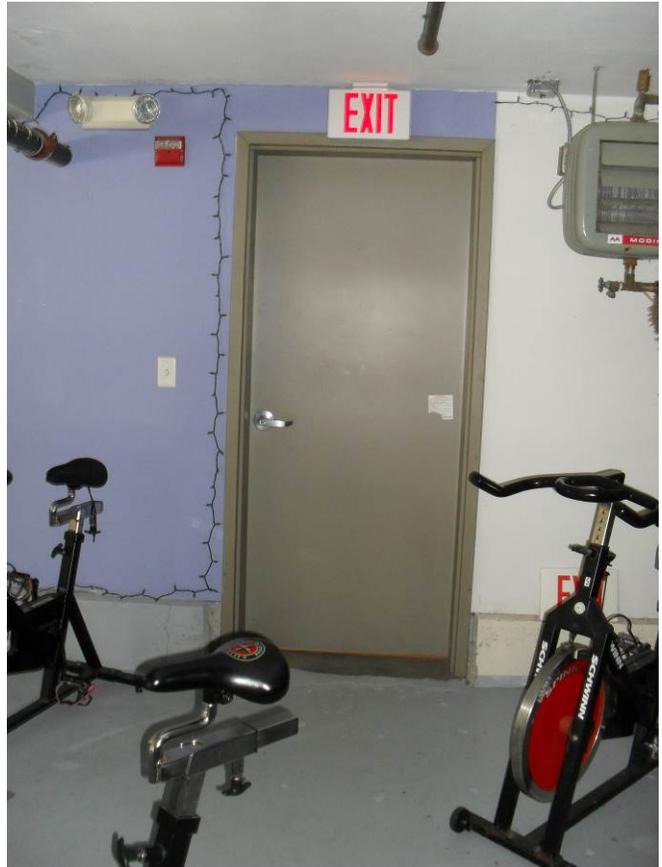
*Exit Door Enters Into a Storage Room – Code Does Not Allow Exiting Into a Higher Hazard Space*

*Means of Egress Door to Storage Room*

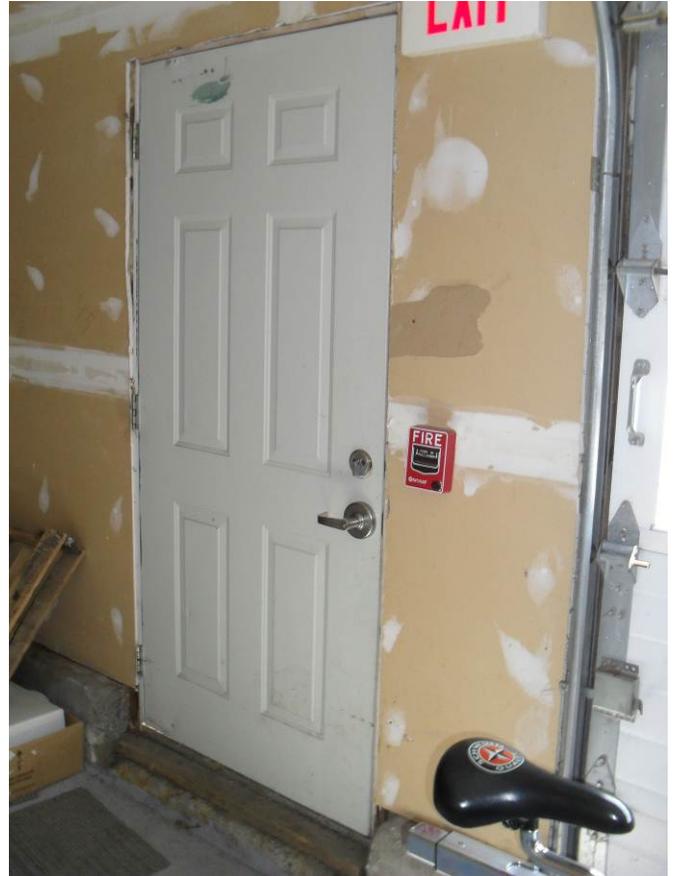
*Life Safety Code  
Requires Floor to be at  
Same Level at Each  
Side of an Exit Door*

*The levels on each side of  
the door are not the same  
height as threshold.*

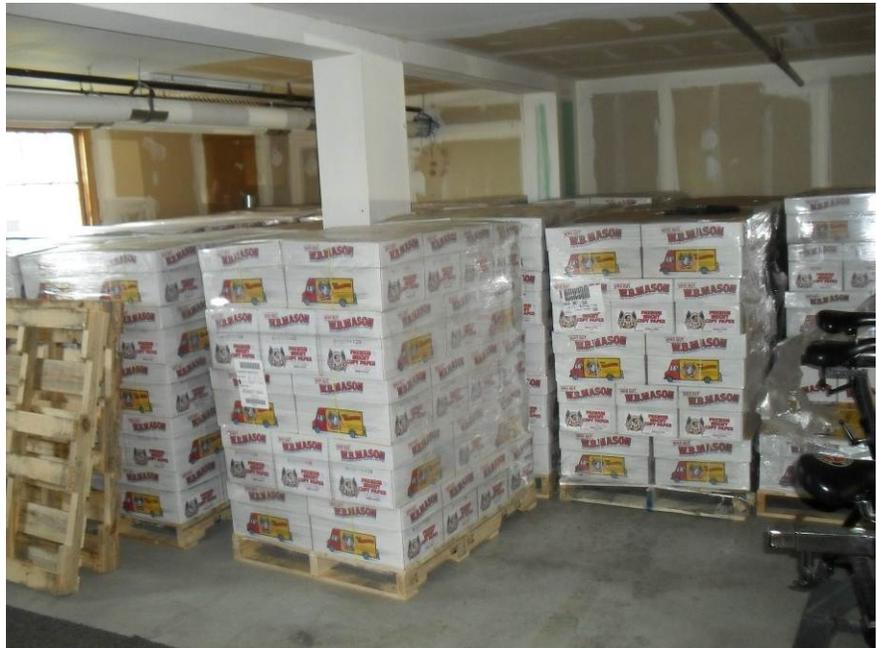
*Occupied Space with  
Combustible Materials*

*Combustible Material  
Storage*

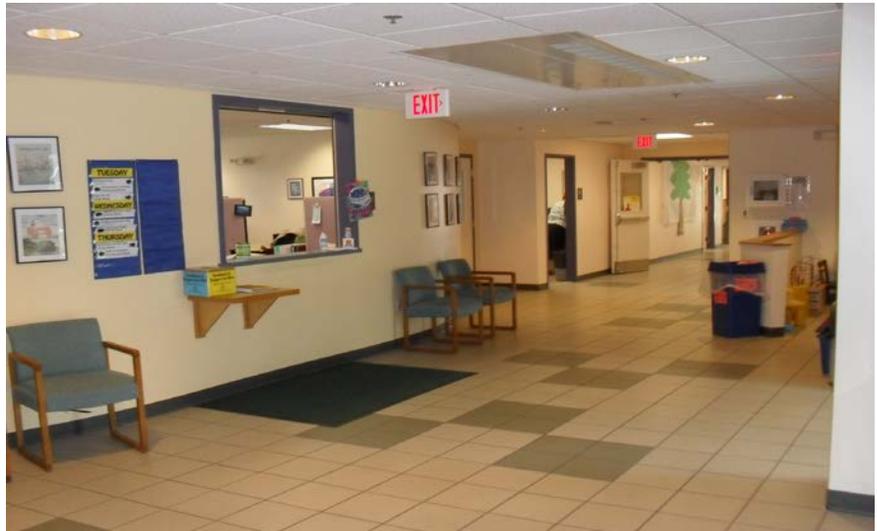
The porcelain tile lobby floor is having continuing issues with the grout joints cracking, loosening, and breaking the tile bond with the substrate below. It has been reported that a number of repairs have already been conducted to the floor system. There are a number of items connected with this floor that can produce this condition. The framing may be flexing under live load conditions or the bond or type of grout used is not bonding properly to the substrate.

*Lobby Tile Floor*

The method of correction for this floor is to remove the tile and plywood substrate and replace the underlayment with a product designed for this application.

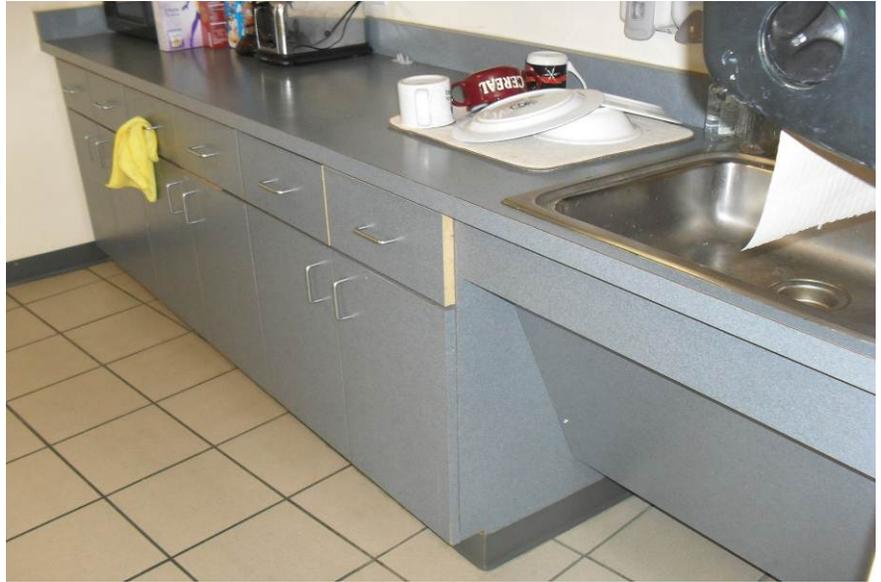
*Laminate Edge - Repair*

Recommend minor repair.
