**Town of Cape Elizabeth**  
Seven Building Facility Study  
*Cape Elizabeth, Maine*

**Introduction****Town of Cape Elizabeth Facilities Study**

*Facility Study Process*

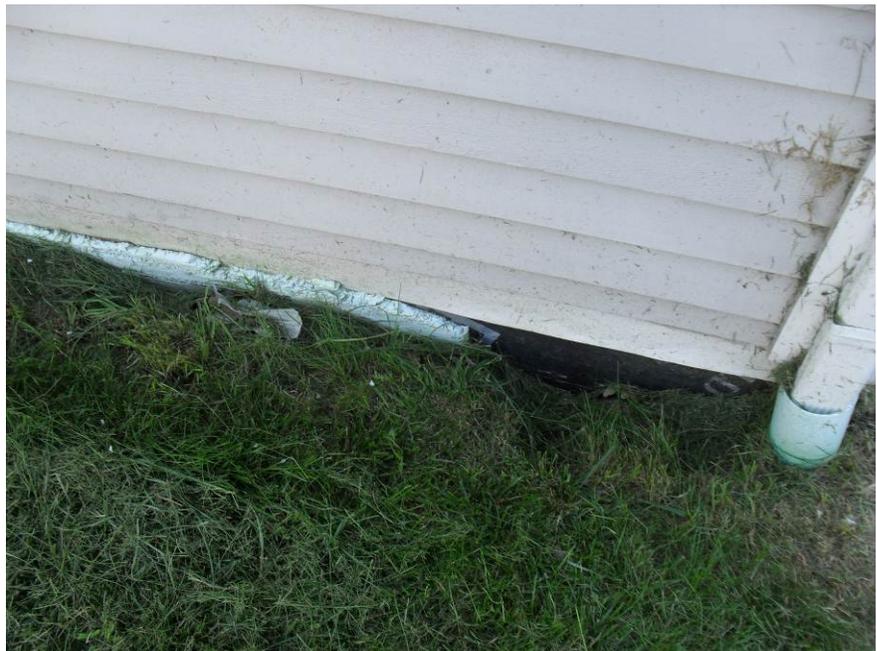
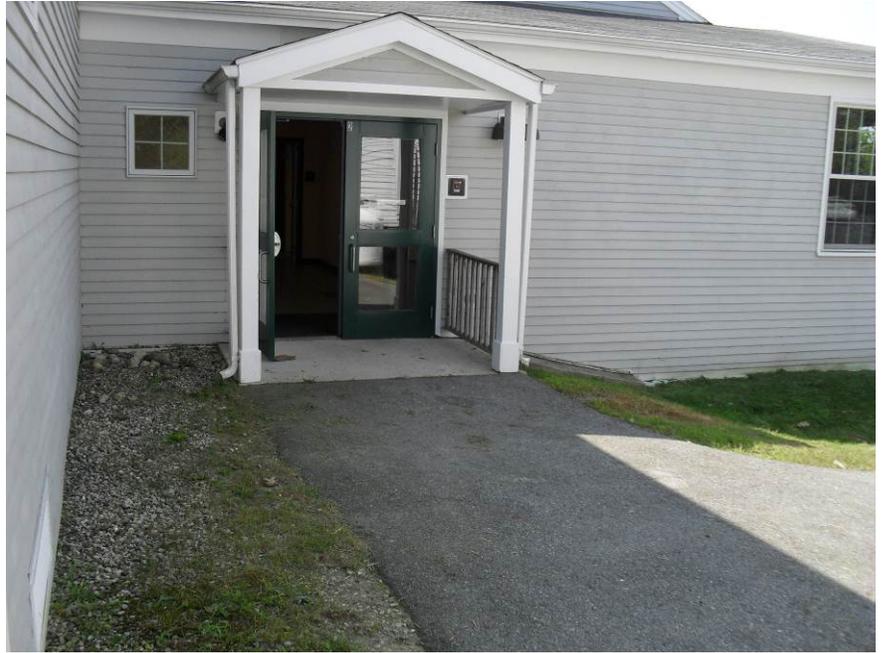
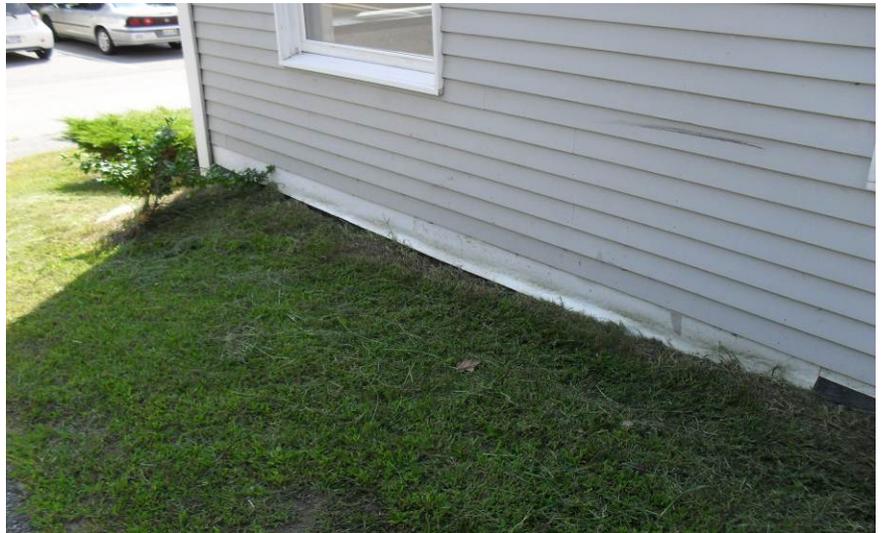
The base of the barn has a construction detail that will require attention. As part of the renovation project a series of materials was added over the existing framing system to protect it from grade. The sills were replaced with new pressure treated framing and insulated to help keep the crawl space warm. The materials used in series as sketched are not designed for this application in this particular location. Ground water and moisture in the grade will break the system down and allow moisture to get at the wood frame components and rot out even though they are noted as pressure treated products.

*Base Detail – Ice and Water Shield Exposed*

*Base Detail on These Walls*

*Base Detail – Front of Barn*

We would recommend a correction of this detail with a waterproofing product designed for this application and a new underdrain system on all sides where this detail occurs.

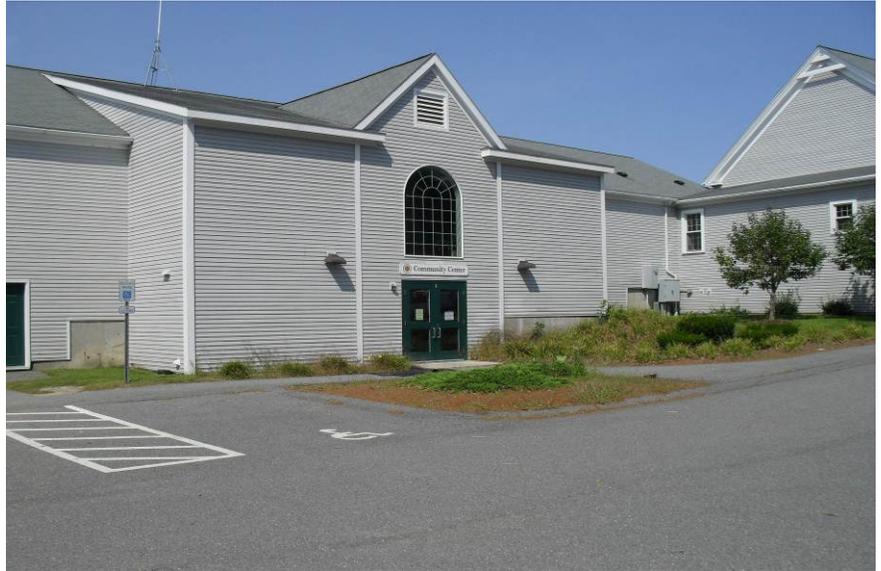
Exit doors at the side entrance cannot be fully open for exiting under freeze conditions. It has been reported that the leading edge of the door becomes stuck in a partially opened position after contacting the concrete entry slab. The entry slab is not a structural slab and is subject to ground freeze when moisture from the roof is introduced into the ground under and heaves the slab upward.

*Main Entrance Doors*

This is a Life Safety code issue that should be repaired immediately. The recommended repair is to remove the canopy and slab and replace with a structural slab and foundation and replace the canopy.

For ease of accessibility for elderly citizens who use this building we would recommend an ADA Automatic Door Opener at this entrance.

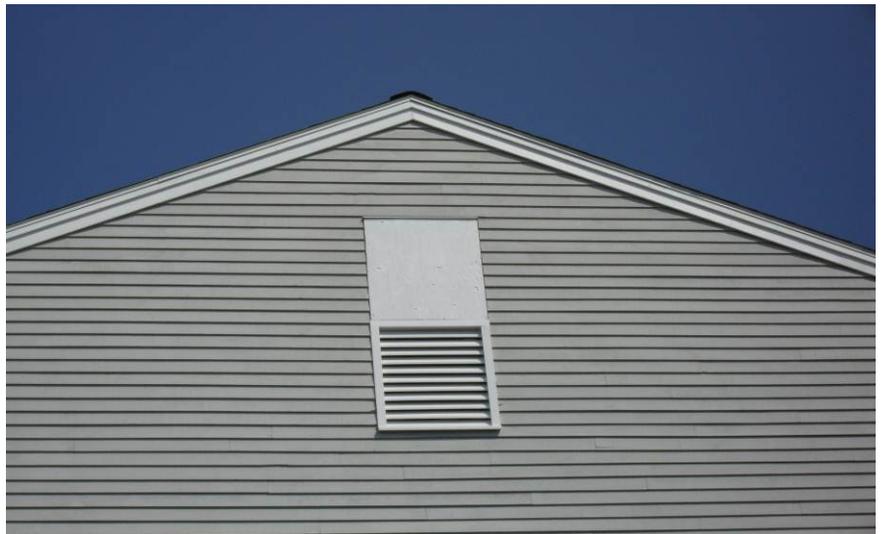
The documents did show two louvers on this gable end stacked and per the picture one has been removed and blocked up with a plywood panel. This type of gable end louvers of this size can be problematic by allowing wind-blown snow to enter the attic and pile up on top of your ceiling insulation. When the temperature rises enough to allow melting of the snow then water damage will appear on the ceilings below and may give the appearance of a roof leak.

*Blocked up Gable End  
Vent Louver*

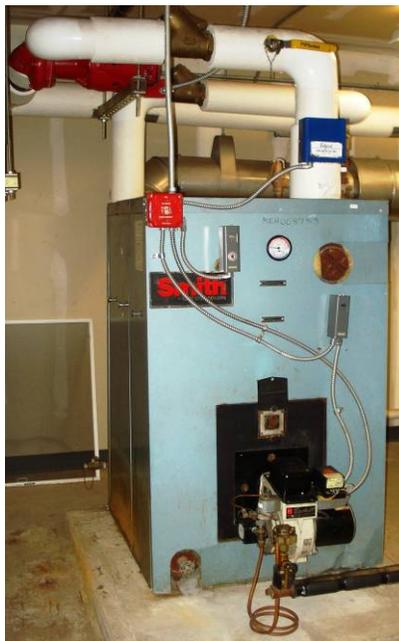
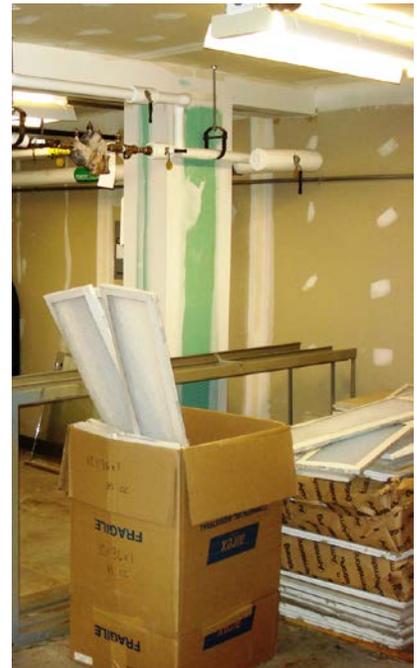
The boiler room is being used as a storage room. This is in violation of code. Combustible materials are not to be stored within the boiler room.

*View of Boiler 1*

*View of Combustible  
Materials Stored in the  
Boiler Room*

We would recommend check out of the boilers, injection pumps, and review of the boiler operating system and DDC interlocks.

We would recommend removal of all flammable and combustible materials stored in the boiler room.

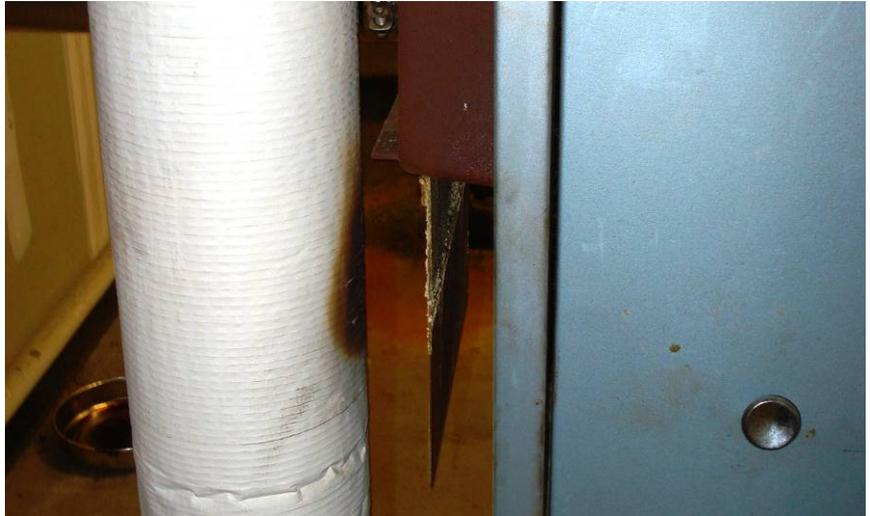
At Boiler 1, the return pipe insulation is burnt indicating a possible leak from the combustion chamber.

*Burnt Pipe Insulation at the Rear of Boiler 1*

We recommend repair of the combustion leak.

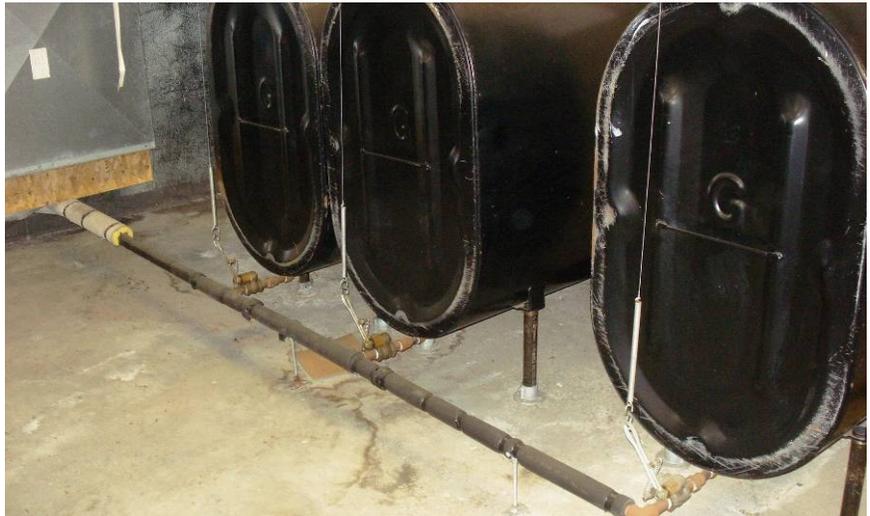
Fuel oil is stored in three tanks located in the boiler room. The fuel line is covered with insulation indicating there may have been a problem due to the location of the fuel line in relation to the combustion air opening. The fuel line installation does not meet code. The fuel line could be damaged and creates a tripping hazard.

*Oil Tanks*

We recommend reinstallation of the fuel line in accordance with code.

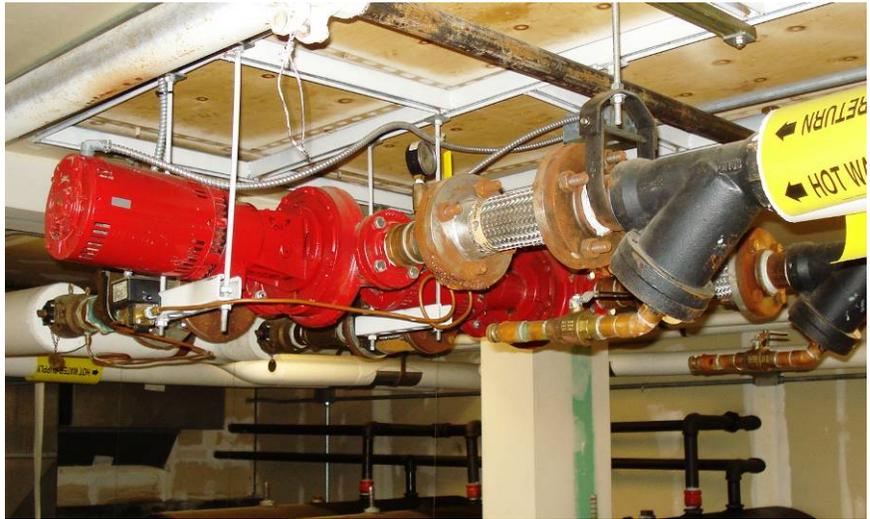
Heating hot water is circulated through the building by one of two Bell & Gossett in-line constant volume pumps and is controlled through the DDC system. The pumps are installed with threaded rods directly attached to the structure with rubber in-shear vibration isolators as specified. This may cause structural borne vibration noises to be transmitted through the building.

*Heating Hot Water Pumps*

We would recommend the installation of vibration isolation at the pump and associated supports.

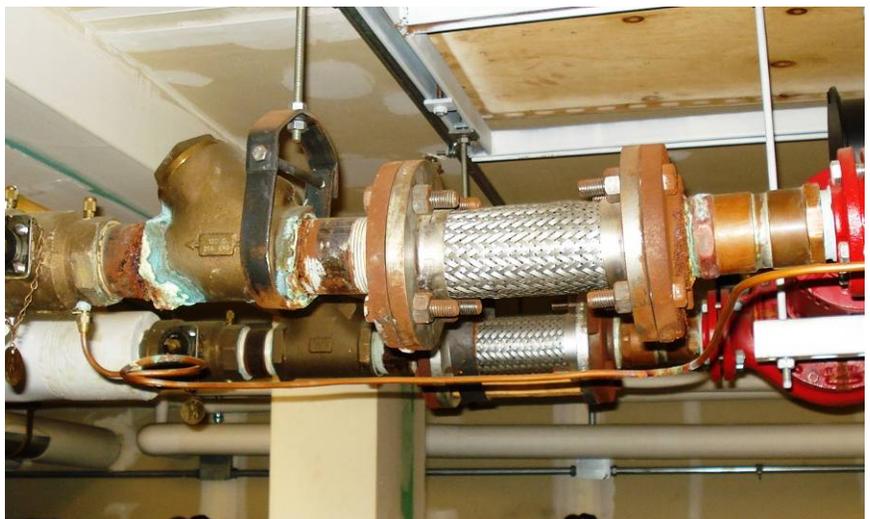
Some of the piping connections around the pumps are showing signs of excessive leakage and corrosion.

*Pipe Fittings Around Pump P-3 Showing Leakage, Corrosion*

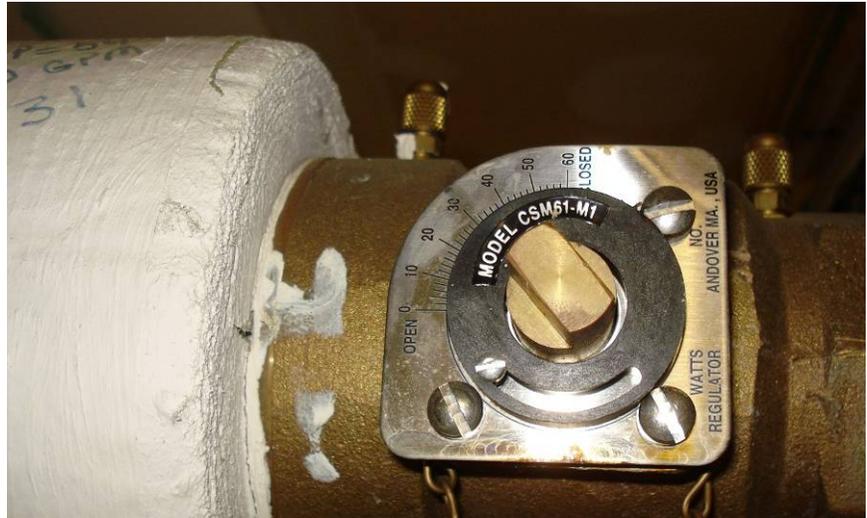
The circuit setters at each pump discharge have been set to approximately 50% open indicating the circuit setters required adjustment to restrict the flow to provide 80 gpm flow through the system (connected load is 75 gpm). According to design documents, the pumps were scheduled to provide 75 gpm. The circuit setters were not installed as noted on the design documents (length of straight pipe before and after the CS).

*Hot Water Pump Circuit  
Setter*

We would recommend opening the circuit setters to 100% open and the installation of variable frequency drives to reduce the speed of the pumps to accomplish the design water flow while reducing the energy consumption of the pumps.

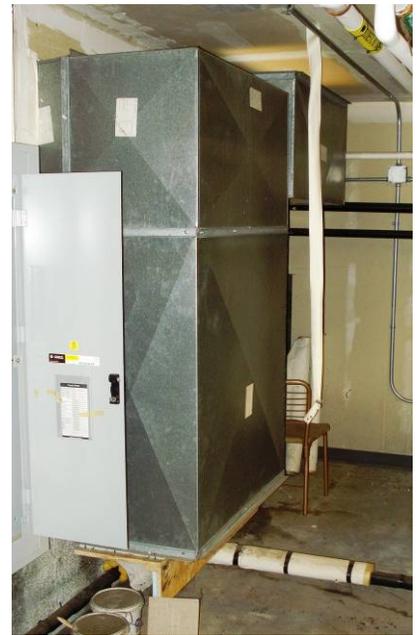
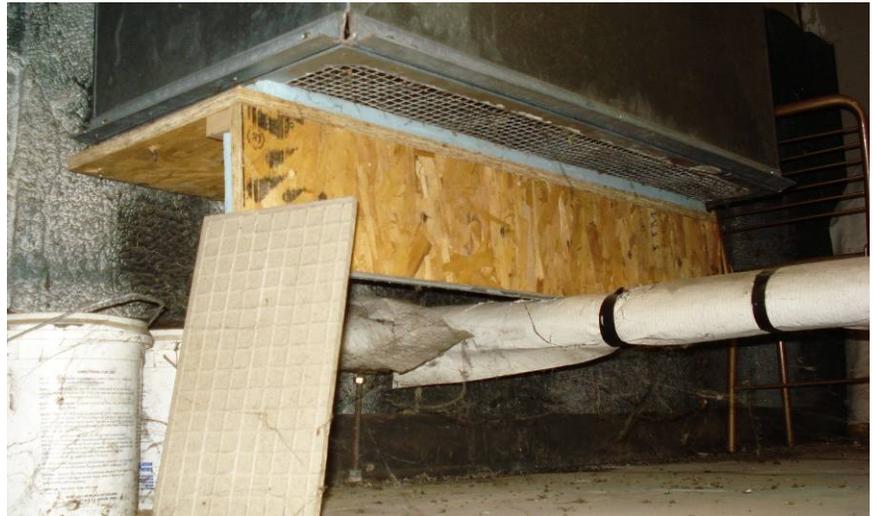
Combustion air is provided through two ducted openings; one is approximately 12” above the floor and the other is approximately 6” below the ceiling. The lower duct opening is partly blocked with insulation and plywood. It would appear the lower opening was blocked due to the location of the fuel oil piping directly under the opening. As installed, the combustion air duct system does not meet current code requirements.

*Combustion Air Ducts*

*Combustion Air Duct  
Blocked Off at Floor*

We would recommend revision of the combustion air system to meet current code requirements.

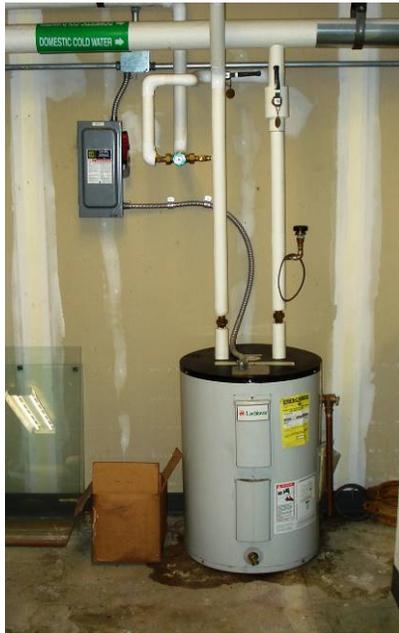
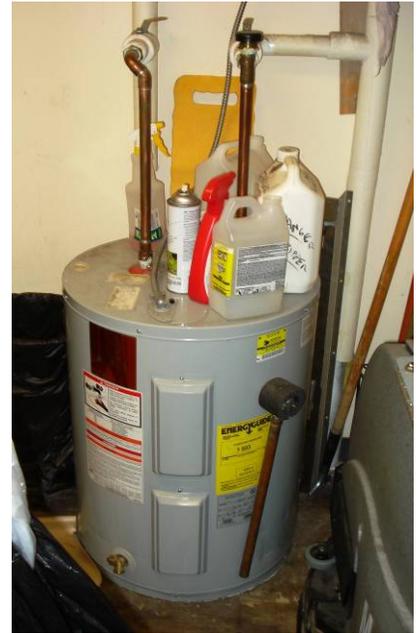
*Electric Domestic Hot Water Heater*

The heater in the boiler room appears to showing signs of leakage based on the floor stains around the heater. Both heaters appear to be resting directly on the floor without any means of leak retention.

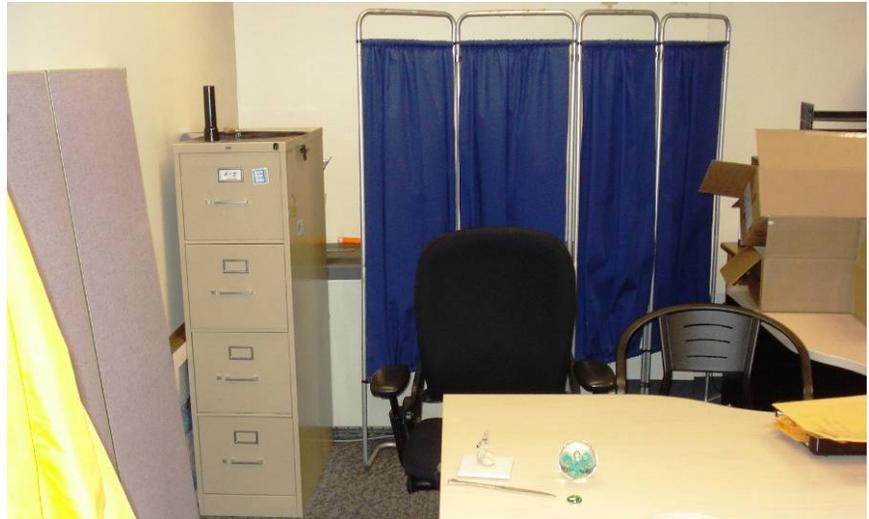
*Unit Ventilator in the  
Open Office Area*

Heating, ventilation and air conditioning is provided to the Community Services open office area through two unit ventilators (UV), provided with mechanical (DX) cooling coils, located at the outside wall. At the time of review, the left-hand unit was operating and the right-hand unit was not. According to the occupants, air flow of the left-hand unit was being deflected by the portable blind to help reduce cold drafts. It was noted that during the cooling season it is typically too cold and during the heating season it is typically cold also.

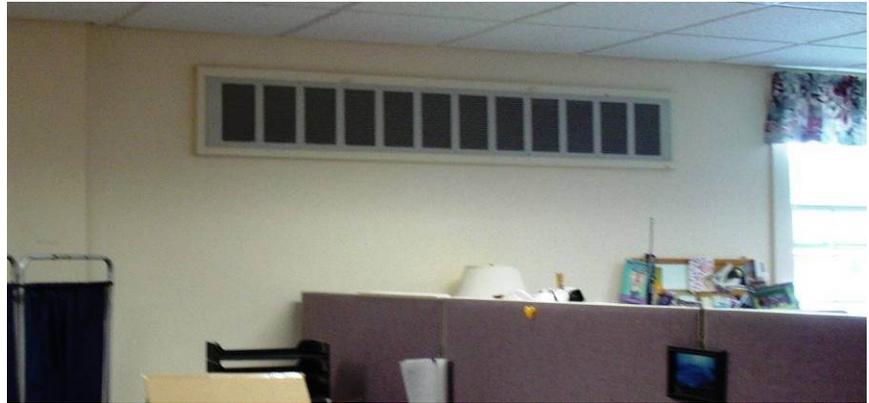
*Unit Ventilator Relief Vent*

Relief for the office area is provided through two wall-mounted vented louvers located directly above each unit ventilator. According to the contract documents, the designed was based on the Ventimatic through-wall shutter assemblies manufactured by AFF. Actual vent model is unknown. According to the occupants, during the cold weather, cold air typically drops down from these relief vents.

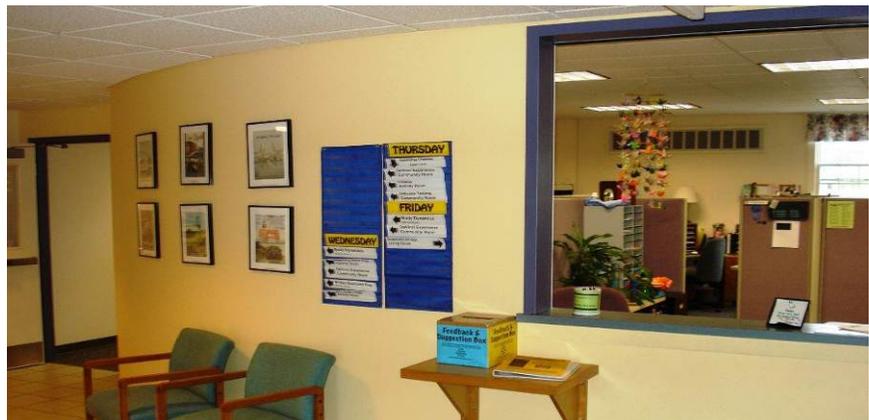
*Lobby Window*

Between the office and the lobby area is a large open window. Cooling is not provided in the lobby and adjacent corridors; heating and ventilation are provided through a ceiling-mounted unit ventilator (UV). It is unknown if the was UV was operating at full economizer ventilation or if the dampers were commanded to the minimum position.

At the time of review the spaces felt moist and cool. The outside air was warm and humid. The single UV in the office was operating at full mechanical cooling and the condensing unit was short cycling. The lobby UV was operating at perhaps full ventilation or economizer. As a result, unconditioned air from the lobby may have been adversely affecting the air conditioned air in the office.

We would recommend further in-depth review of the office and lobby ventilation systems.

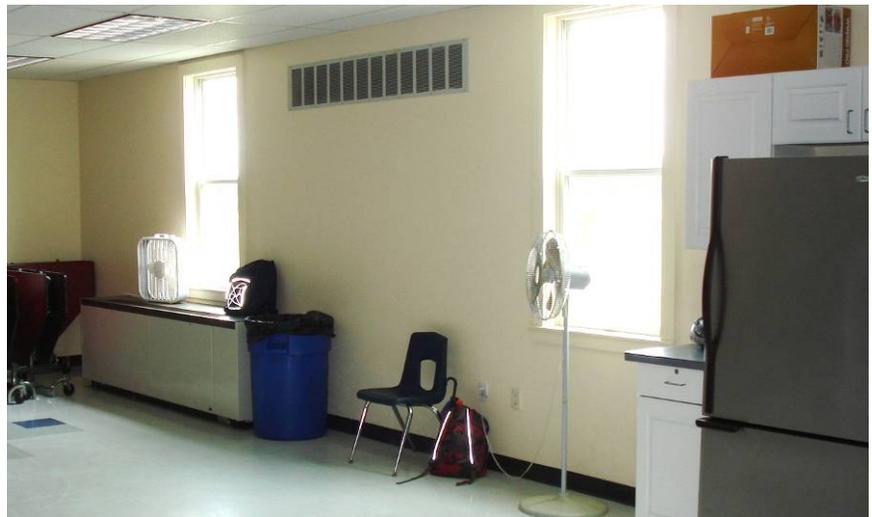
*Community Room Unit  
Ventilator and Vent*

Heating and ventilation for the community room is provided through a single unit ventilator and respective relief vent louver. Mechanical cooling is not provided. At the time of review, the UV was not operating. The window was open and a large fan was circulating air in the room.

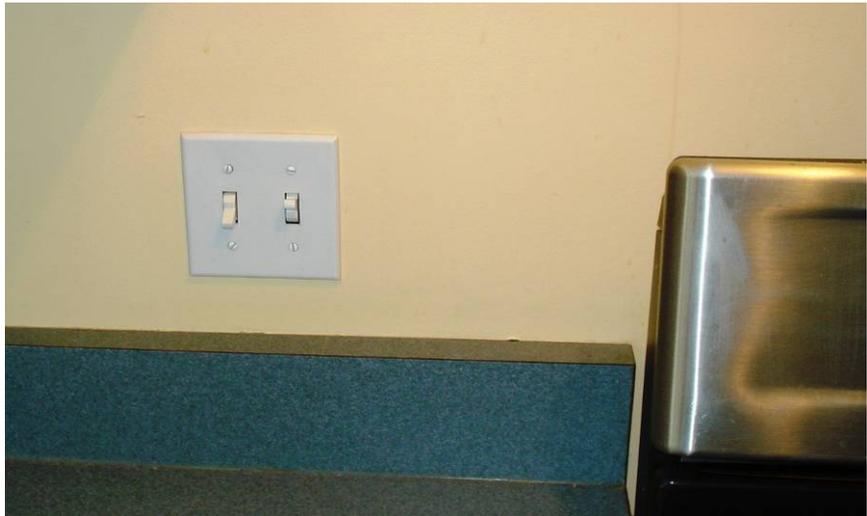
*Hood Light and Fan Switches*

*Fan switch is in the on position.*

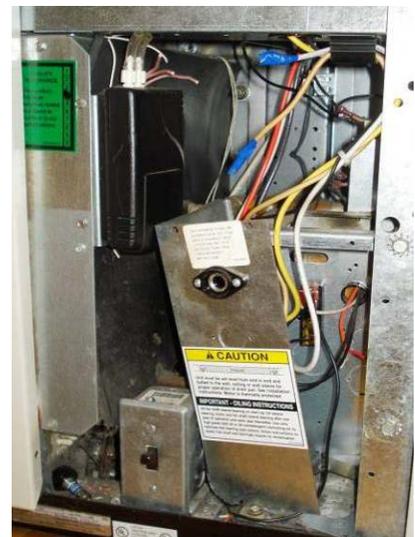
*View of Right-Hand Unit Ventilator End Panel*

The unit ventilators are controlled through the DDC system. Based on review of the right-hand UV, it would appear it is in need of repair.

The black box at the upper left corner of the photo below appears to be a gas detector; perhaps carbon dioxide. With the tubes installed as shown in the photo, it is likely the sensor does not properly monitor the level of gases in the room or the return air from the room.

We would recommend further in-depth review of both unit ventilators and the respective DDC controls.

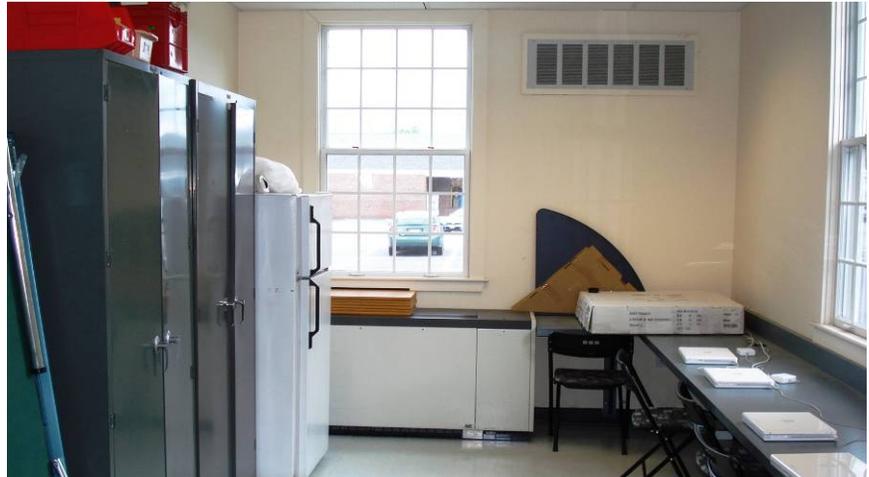
*Computer Lab*

Heating, ventilation and cooling of the computer lab is provided by a unit ventilator, provided with a mechanical (DX) cooling coil, and the respective relief vents. At the time of review, the unit was not operating and the sensor display was blank.

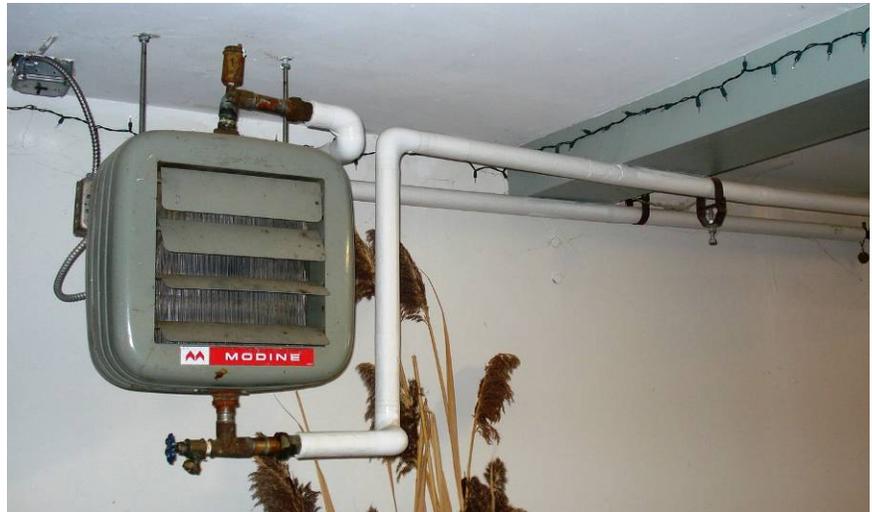
*Typical Horizontal Hot  
Water Unit Heater*

Heating is provided in the lower level spaces by a number of horizontal hot water unit heaters controlled by the respective local wall-mounted thermostats. In many locations, the piping in the lower level is not properly supported.

*Note clevis hanger upside  
down on pipe.*

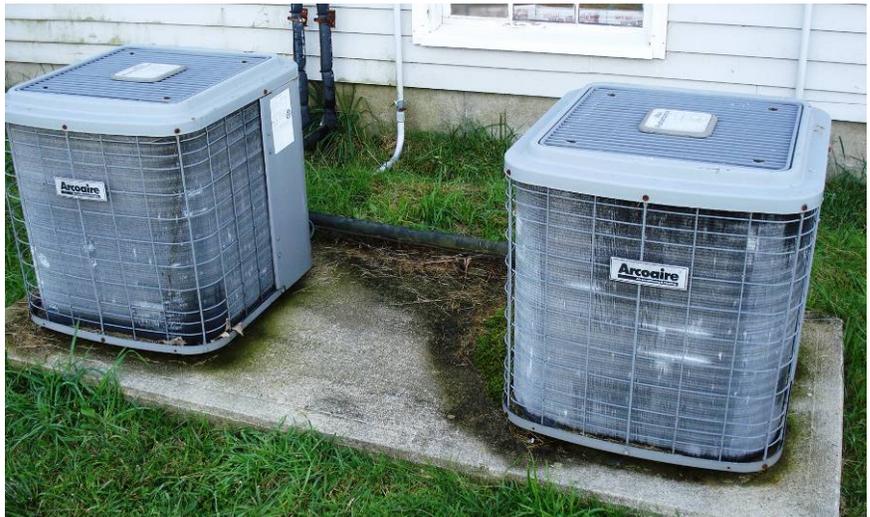
*Condensing Units for the Conference Room and Office Heat Pumps*

The condensing units for the Community Service office and computer lab unit ventilators and the conference room and office split-system heat pumps are located on the north side of the building. At each of the condensing units, the refrigerant and power piping is installed on grade and is showing signs of possible damage due to lawn care.

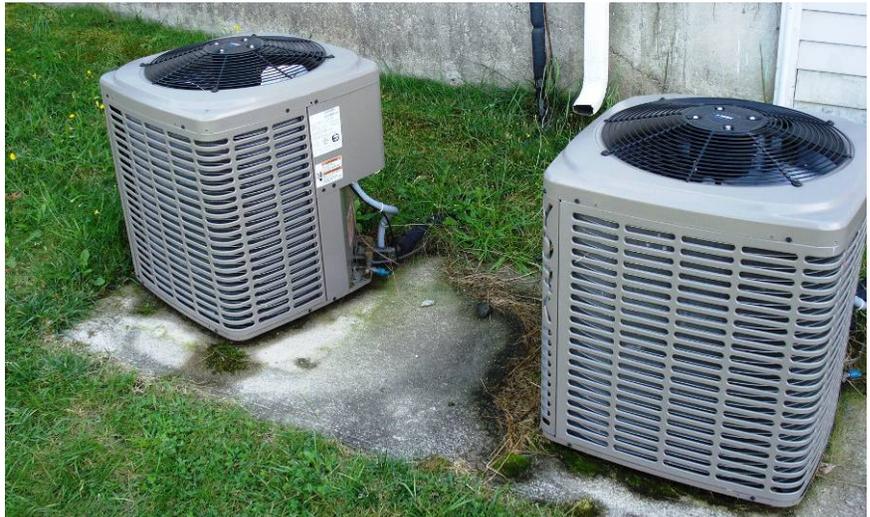
*Condensing Units for the Community Service Office Unit Ventilators*

*Note unit at left has been moved.*

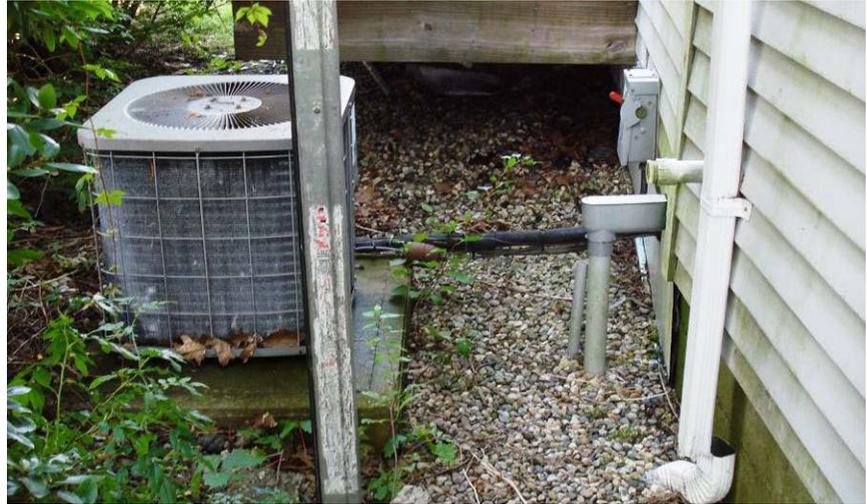
*Condensing Unit for the Computer Lab Unit Ventilator*

The condensing unit serving the computer lab UV is installed behind the trees near the corner of the building and is showing signs of deterioration and neglect. The fins of the coil are corroding and there is debris on the fan blade.

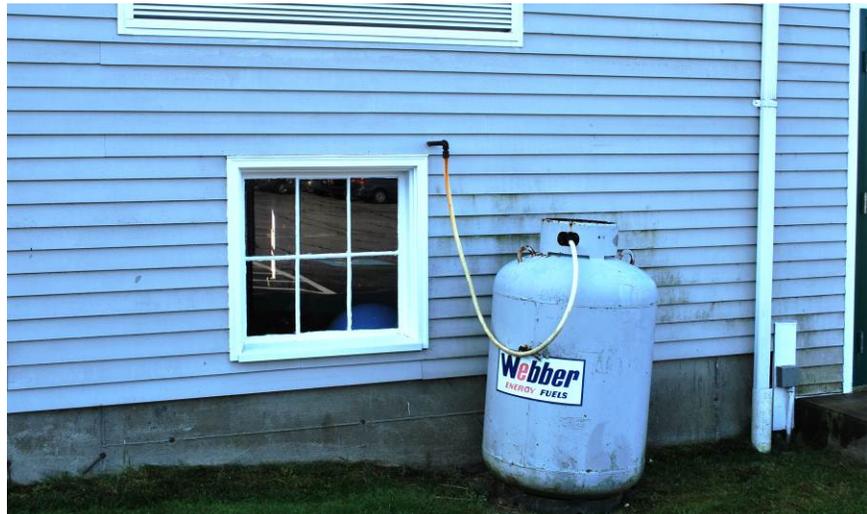
*Propane Storage Tank*

The propane storage tank for the gas range is located next to the building and within 10 feet of the adjacent window and fresh air intake louver. The tank is resting on concrete blocks below the level of the grass. The installation does not meet code.

We would recommend the relocation and installation of the propane tank in accordance with code.

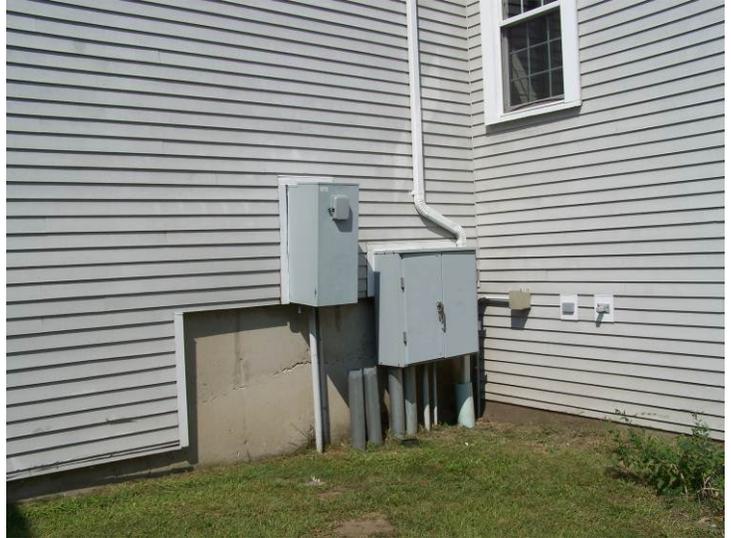
*Service Metering*

The meter enclosure was observed to have partially detached from the building wall.

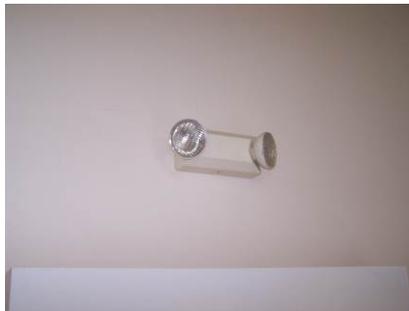
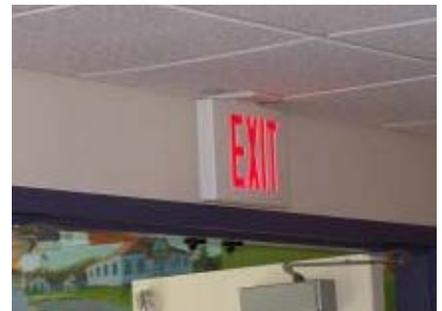
*Life Safety Lighting and Exit Signs*

Exit signs are internally illuminated. Signs are in good condition; coverage is good throughout the building. One exit sign was observed in the basement area directing emergency exit through a storage space. This is a code violation.

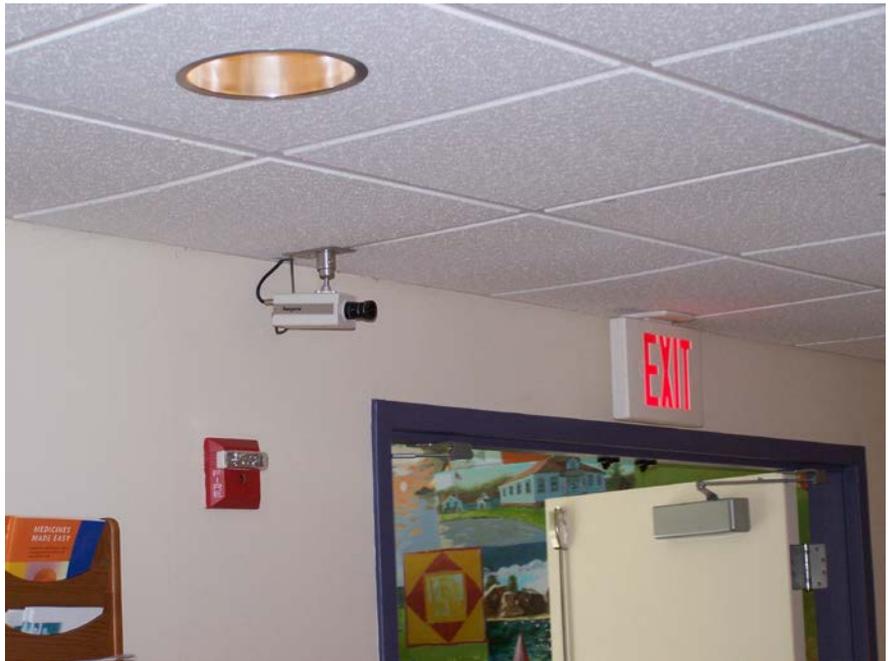
*Typical Camera*

The system is an Integral Technologies system with a mixture of legacy and upgraded video platforms. Server is based in the High School but also serves the Middle School, Pond Cove Elementary School, Police Department and Fire Department. Advance Technology is responsible for maintaining the system, and reports multiple failures of the system, with frequent database corruption and loss of camera function.

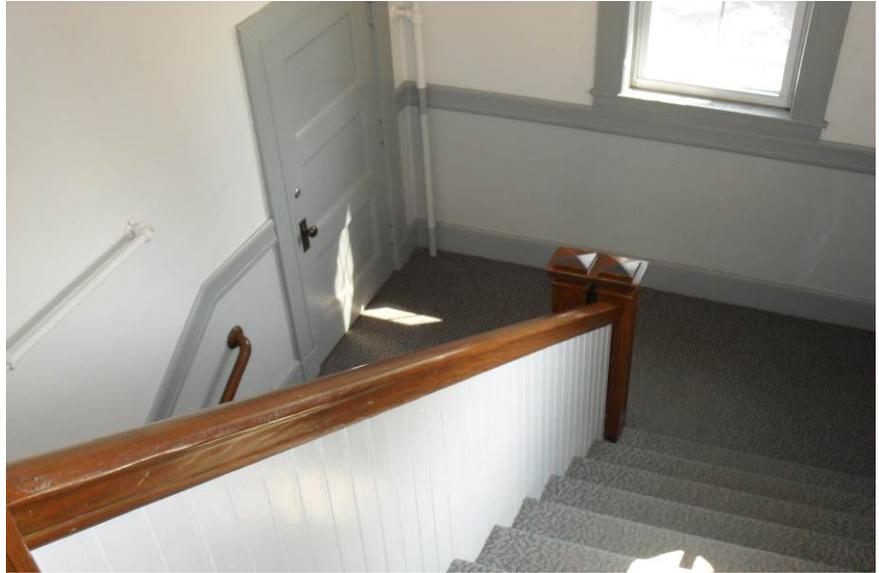
*Original Stairwell  
Construction with Door  
to Storage Room*

There are main stairwells on each side of the building that are original to the building with wood handrails, dividing wall and wood stair treads. The wood treads have been carpeted over and the carpet is worn. The stairwells have accessible rooms with doors off the stairwells.

Recommend a major upgrade to the stairwells to bring them into compliance with the life Safety Code.

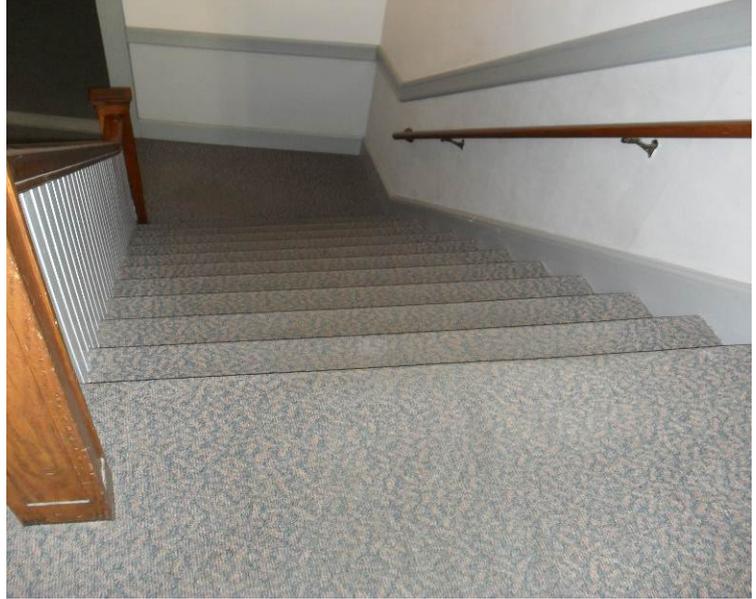
*Exit Stairwell*

*Non-Compliant Stairs*

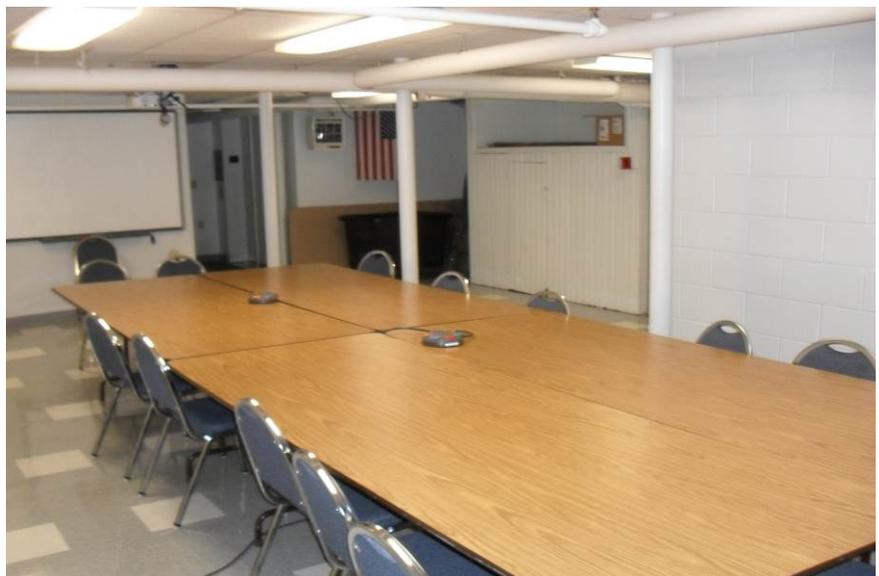
*Sub Grade Space in  
Basement*

There is a space being utilized as a conference/cafeteria area. Mounted on the wall is a sign noting a maximum capacity of 57. This space has only one means of egress to an open stairwell. This means of egress has no door separating the space from the stair. Per Life Safety Code, two means of egress are required from this sub grade level space.

Recommend consultation with the local Fire Department about the functional use of this space and the egress issues.

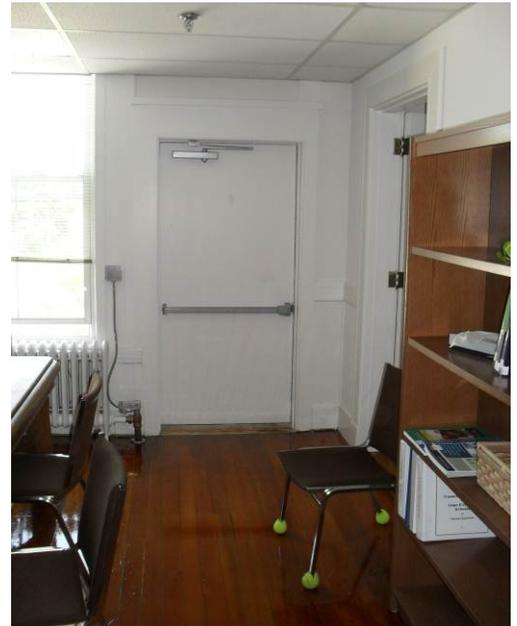
*Conference Room Exit Door*

*Exit Door*

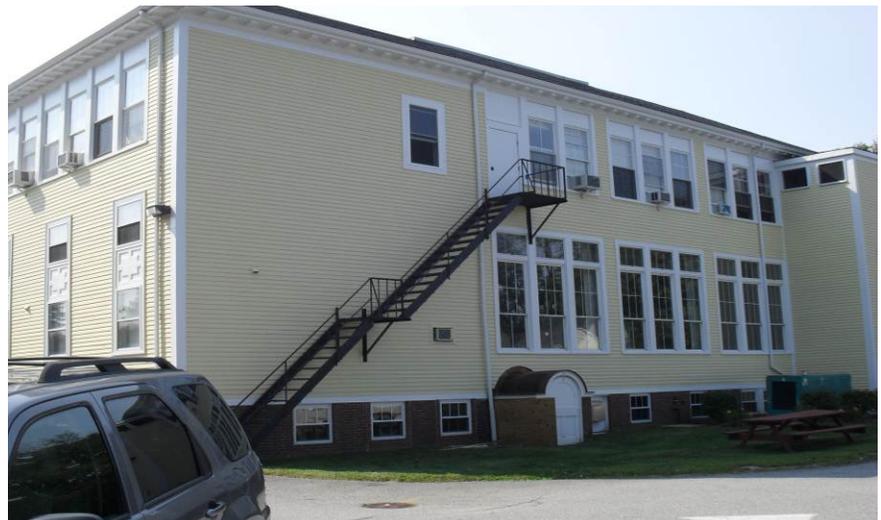
*Exterior Fire Escape*

*Exterior Fire Escape From Conference Room*

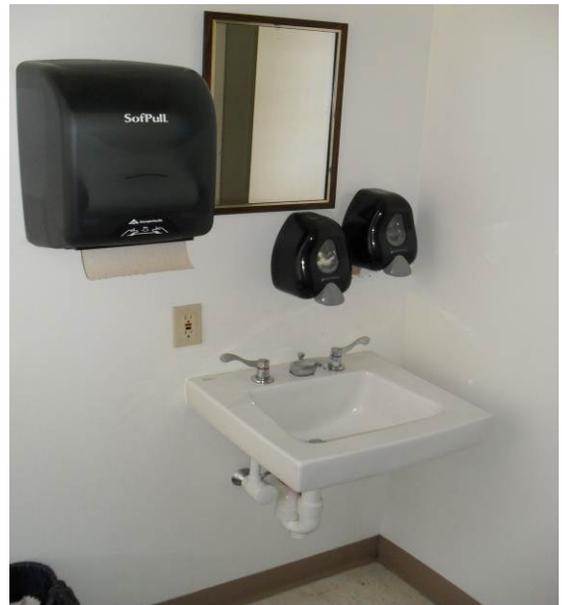
*Paper Towel Dispenser too Close to Sink*

Recommend relocation to be in compliance.

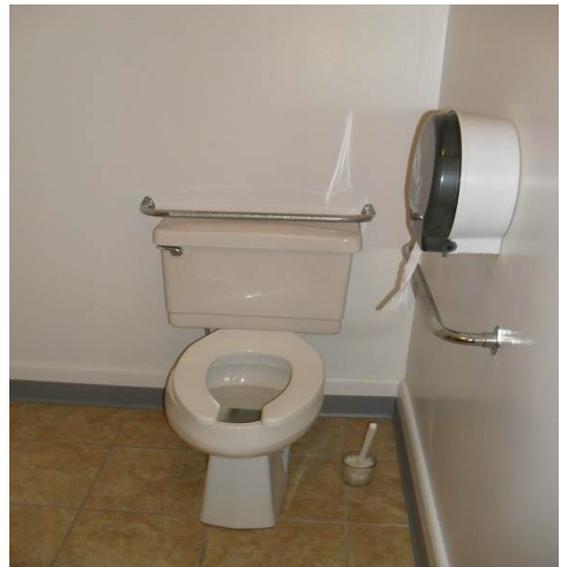
*Tissue Dispenser too High*

*Grab Bar Needs to be Higher*

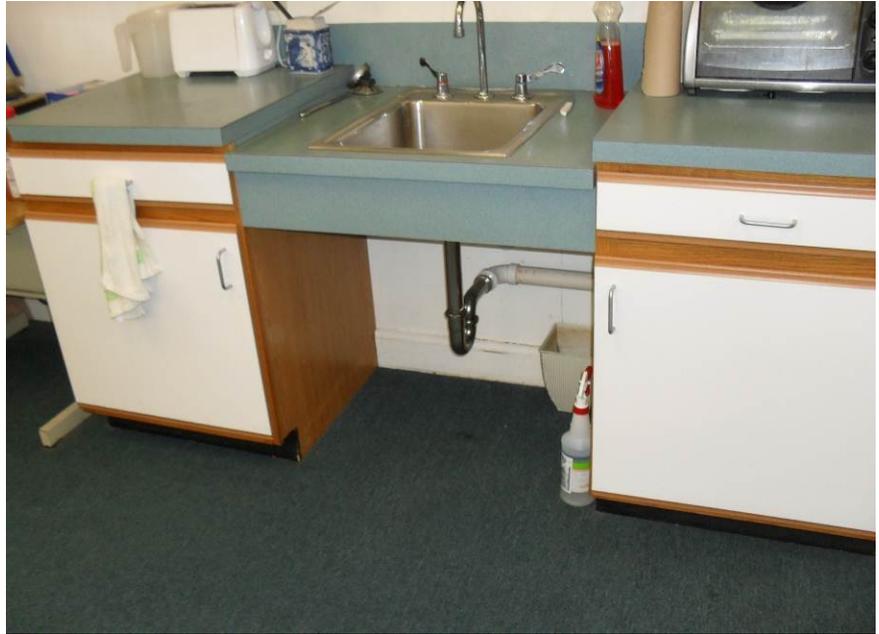
*Drain Line in Conflict with Knee Clearance*

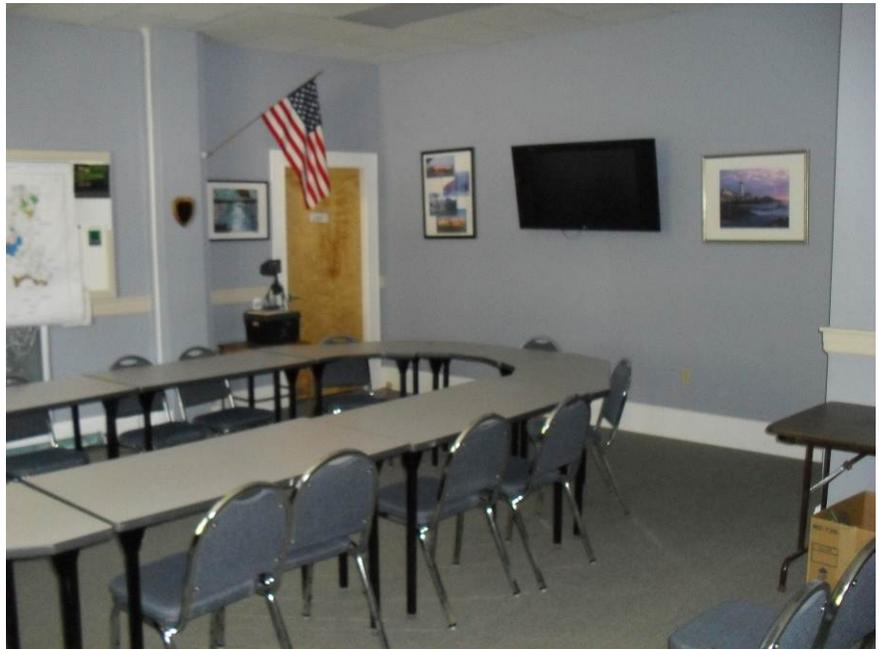
*Conference Room Next to Council Chambers*

Main conference room behind the council bench. The only means of access is through a stairwell.

Recommend when stairwells are renovated for code compliance that this door issue be addressed.

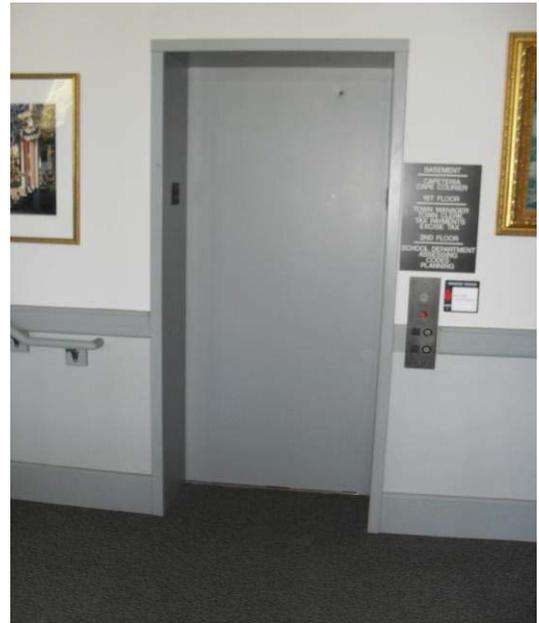
*Elevator Entrance From  
the Council Chambers*

Elevator does meet the intent of ADA. Access to this vertical accessibility system is accomplished by an accessible route though is very remote relative to the defined ADA entrance to the building.. Improved signage would be an assist to the public not familiar with the building. The size of the elevator is not current with the 2005 ADA requirements. The car as it stands is grandfathered until the time it would be relocated then it will be required by law to be sized up accordingly.

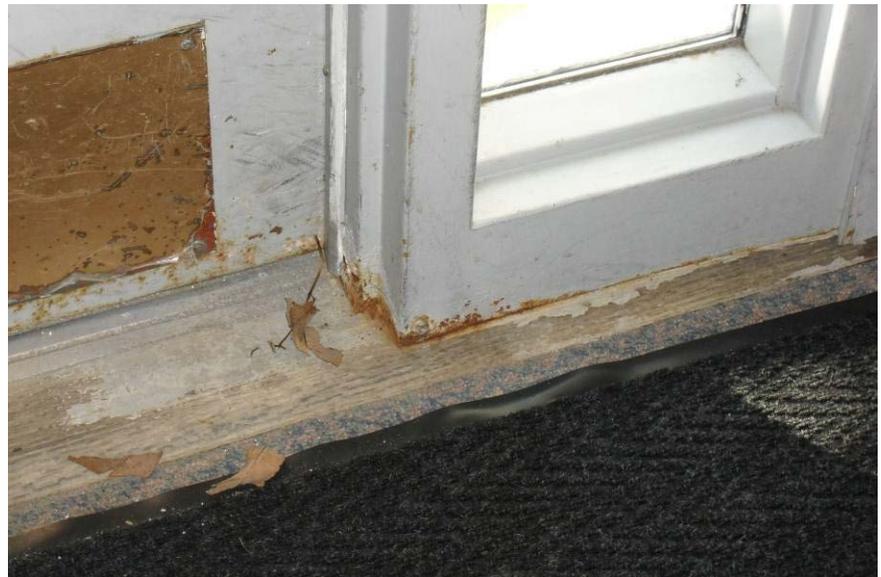
*Side Entrance Door*

The door and frame at this entrance needs to be replaced. Both door and frame are rusted and the exterior trim, although recently painted, should be replaced.

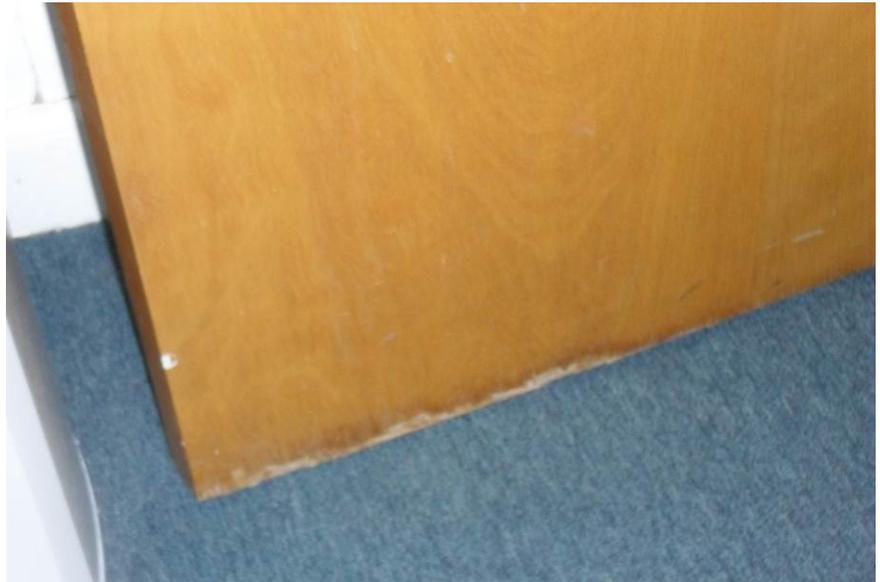
Those doors and frames that were not replaced as part of the renovation project are showing chips along the bottom edge.

These chips cannot be repaired and eventually the veneer will start to delaminate away from the core.

*Chipped Bottom Edge of  
Doors*

Recommend door replacement with kick plates as the maintenance budget would allow.

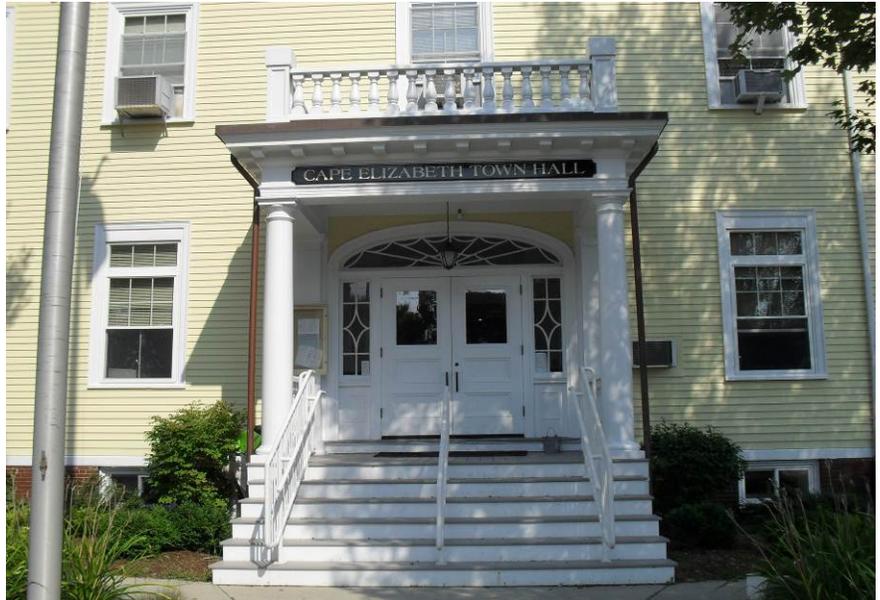
*Recently Repaired and Repainted Front*

The exterior of the building is showing a lot of recent upgrade work relative to painting, windows, flashing, and trim work. We would recommend a maintenance program to maintain the appearance of this building for the town.

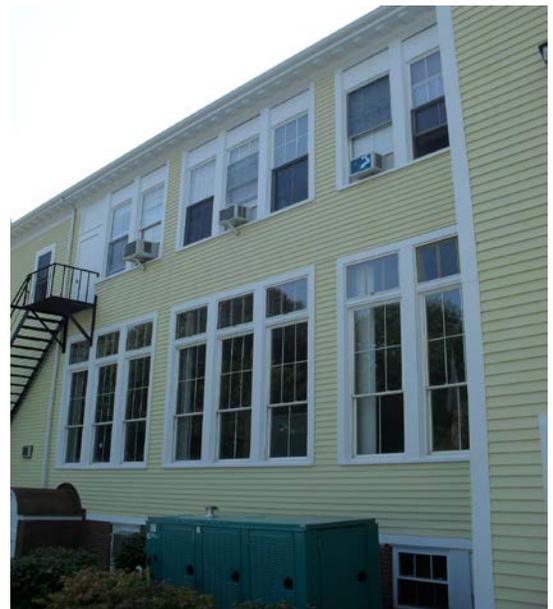
Currently there is a window replacement program in progress. If the goal is to upgrade and renovate the building, we would recommend new blown-in insulation installed from the interior side of the exterior walls. This insulation system for the exterior walls will increase the energy efficiency of the building.
