**Town of Cape Elizabeth**  
Seven Building Facility Study  
*Cape Elizabeth, Maine*

**Introduction****Town of Cape Elizabeth Facilities Study**

*Facility Study Process*

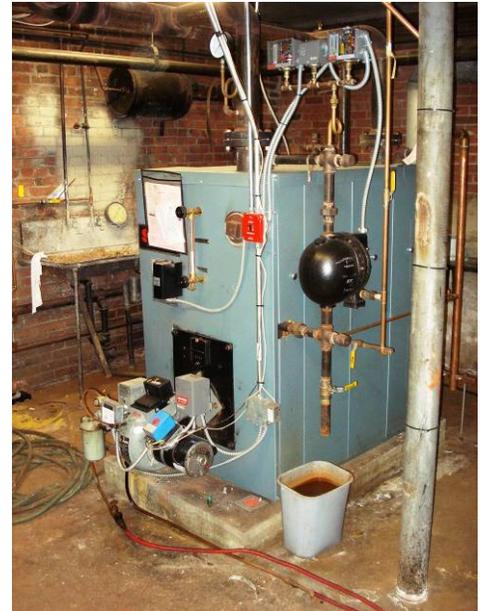
*Boiler 1*

The heating steam is generated from one H.B. Smith series 19A cast iron boiler with a Carlin oil-fired burner. According to the boiler nameplate, the net heat output of the boiler is 2,817 sq. ft. and, based on the State of Maine inspection certificate, was installed in 2003. The boiler appears to be in good condition. The water showing in the sight glass is clear and the burner is interlocked with the Direct Digital Control (DDC) system.

We would recommend re-trimming the steam boiler for conversion to hot water, removal of all steam heating system components and piping, and the installation of a hot water heating system.

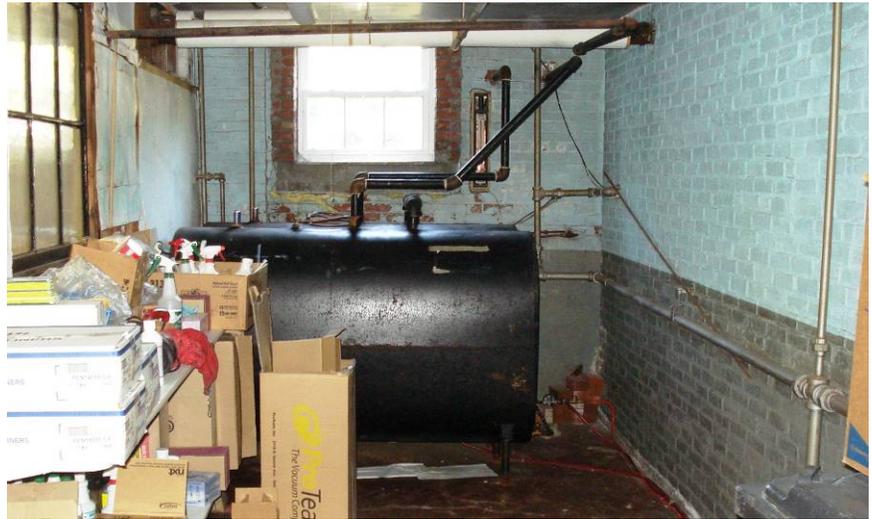
*Oil Tank*

The fuel oil storage does not meet code. Fuel oil is stored in two oil tanks located in a room adjacent to the boiler room. The oil fill pipe is installed closer than two feet to the adjacent window and does not meet code. Fuel lines are installed along the wall, in front of the door and routed into the boiler room through an open hole in the brick wall.

We would recommend the relocation of the fuel oil storage in accordance with code.

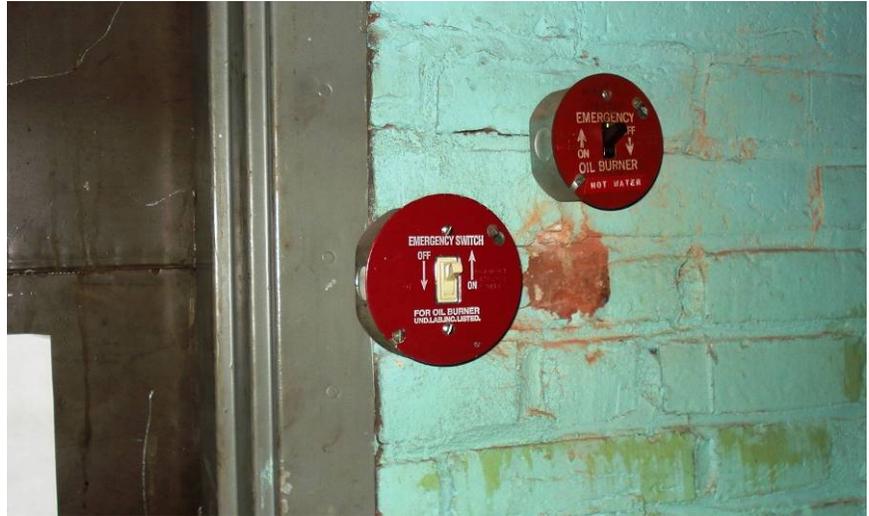
*Oil Burner Emergency Switches*

The emergency switches do not meet code. Two emergency oil burner switches are located outside of the boiler room indicating there may be two separate safety circuits. Code would require a single safety circuit to shut down all devices.

*Right switch is labeled for hot water.*

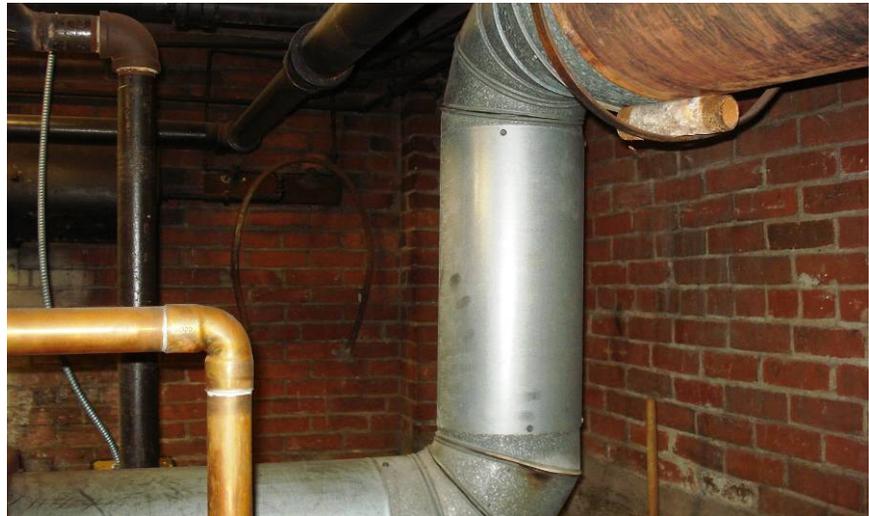
The breeching and chimney system does not meet code. The boiler and domestic hot water heater breechings appear to be a combination of single-wall un-insulated galvanized steel and older single-wall riveted un-insulated steel. The boiler and domestic hot water heater enter the breeching at the same level. The masonry chimney is unlined and does not meet code.

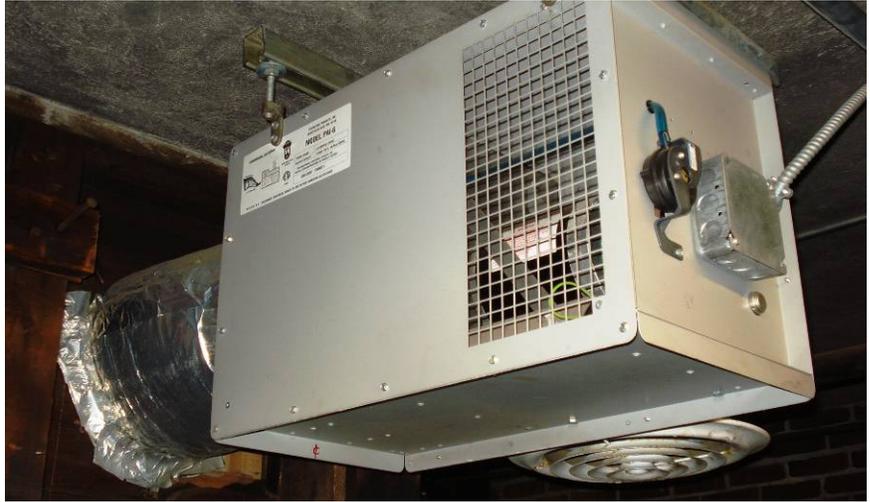
*Forced Combustion Air Fan*

Combustion air is provided through the dedicated Tjernlund Products model PAI-6 commercial combustion air intake fan rigidly mounted directly to the boiler room ceiling. Interlock between the fan and the boilers is unknown.

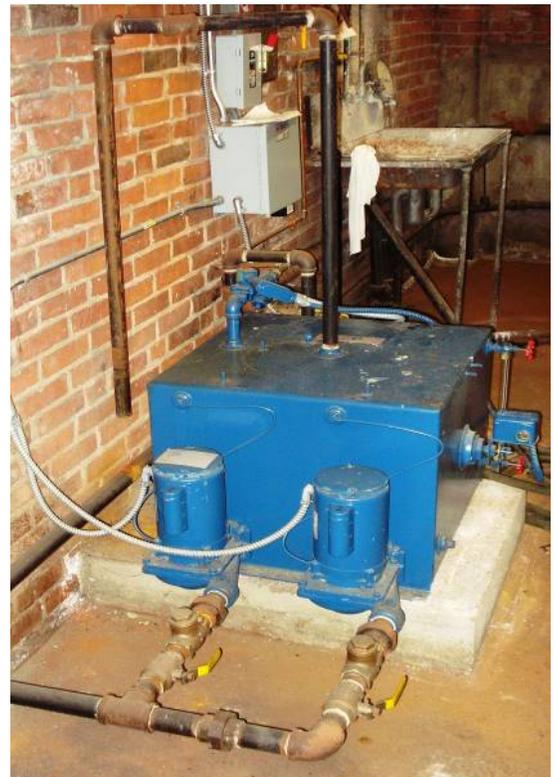
Condensate from the steam heating system is returned to the duplex pump condensate receiver tank located adjacent to the boiler. The condensate tank has been recently replaced. The tank is vented to the boiler room and does not meet code.

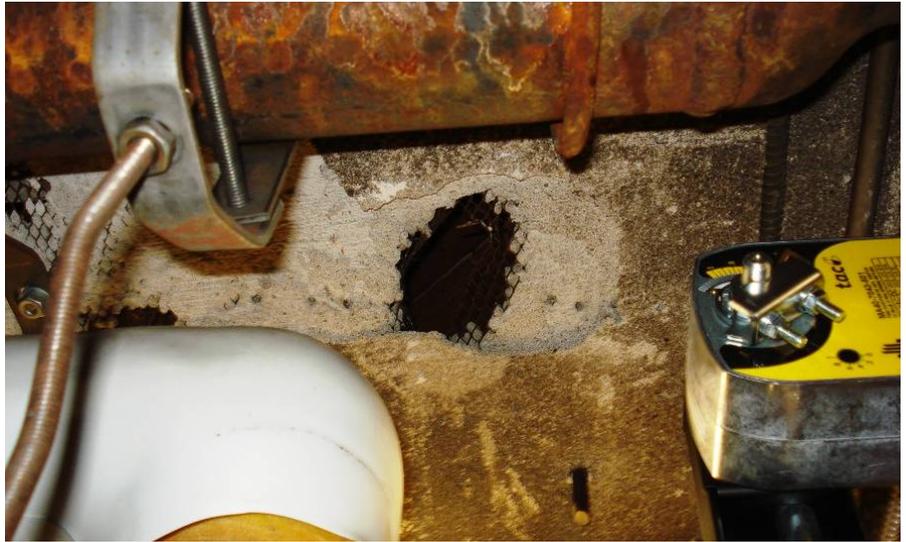
The boiler room is not code compliant.

There are numerous penetrations and openings in the ceiling and walls. A non-fire rated wall has been installed to provide storage space for various combustible paper products. The door to the adjacent spaces is not fire rated.

*Typical Hole on Plaster Ceiling*

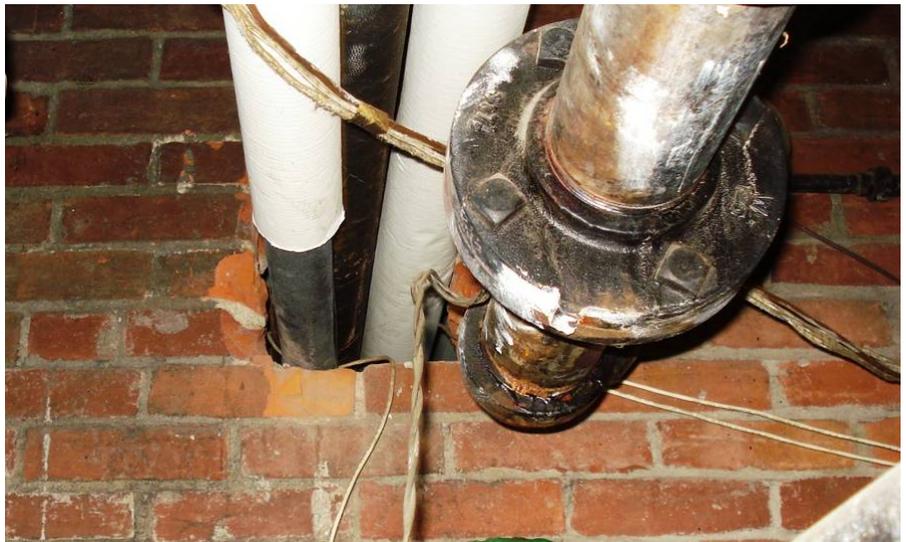
*Typical Boiler Room Wall Penetrations*

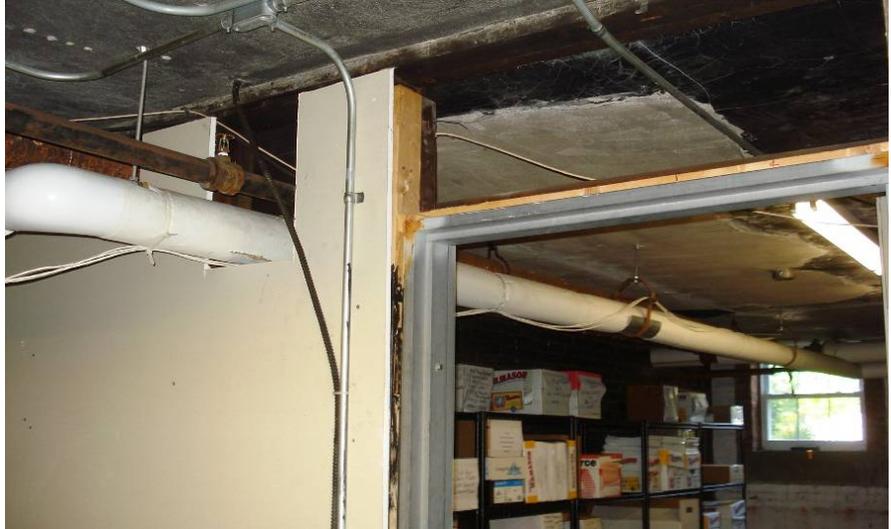
*Noncompliant Wall for Storage Room*

*Note: Combustible products on shelving.*

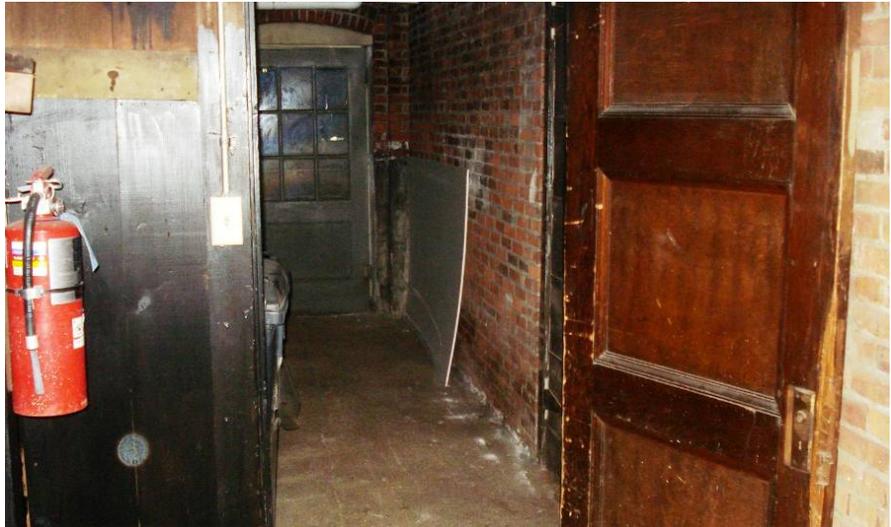
*Noncompliant Wall and Door to Adjacent Areas*

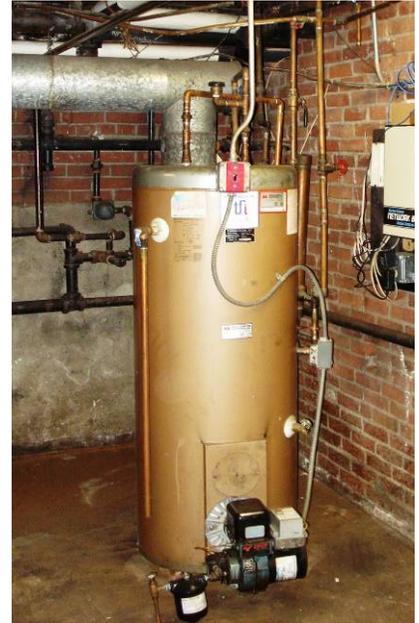
*Oil-fired Domestic Hot Water Heater*

Domestic hot water is generated from an oil-fired hot water heater located in the boiler room. The age and overall condition of the heater is unknown.

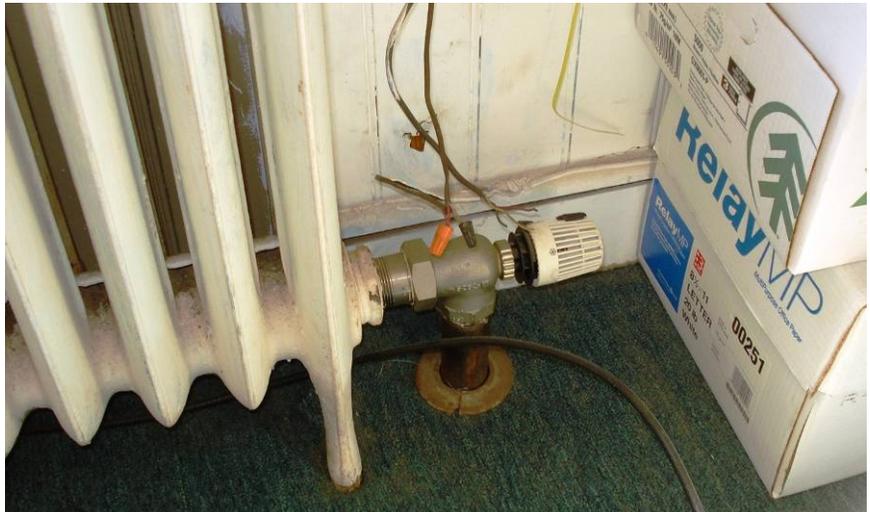
Heating is provided in the building through old-style cast iron steam radiators or cast iron baseboard radiation with a variety of self-contained automatic control valves, electric automatic steam control valves, or no control valves. When the system is heating, the steam radiators would be very hot. Some of the old wiring has been abandoned in place. Some of the wiring connections to the electric valves are exposed. As a whole, there is a substantial lack of controllability.

*Example of Self-Contained Control Valve on Cast Iron Radiator*

*Notice exposed abandoned control wiring at valve.*

As noted above, we would recommend the removal of all steam heating system components and the installation of a hot water heating system.

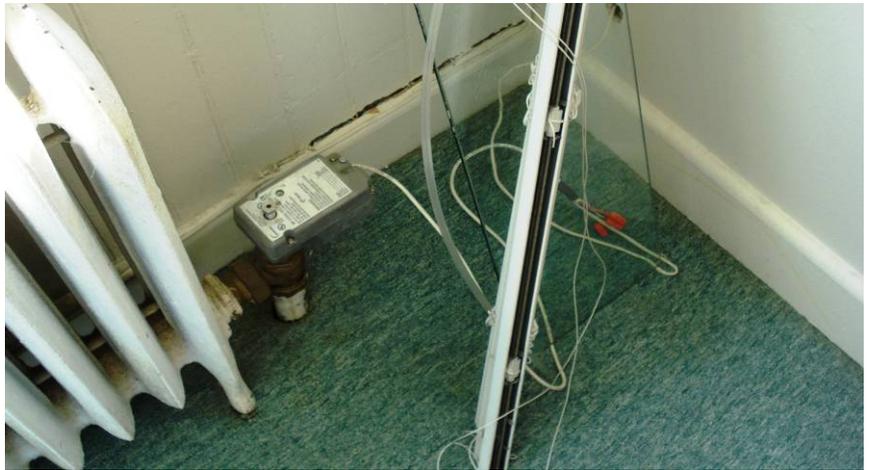
*Example of Electric Automatic Control Valve on Cast Iron Radiator*

*Notice the exposed wiring connection to the right of the valve.*

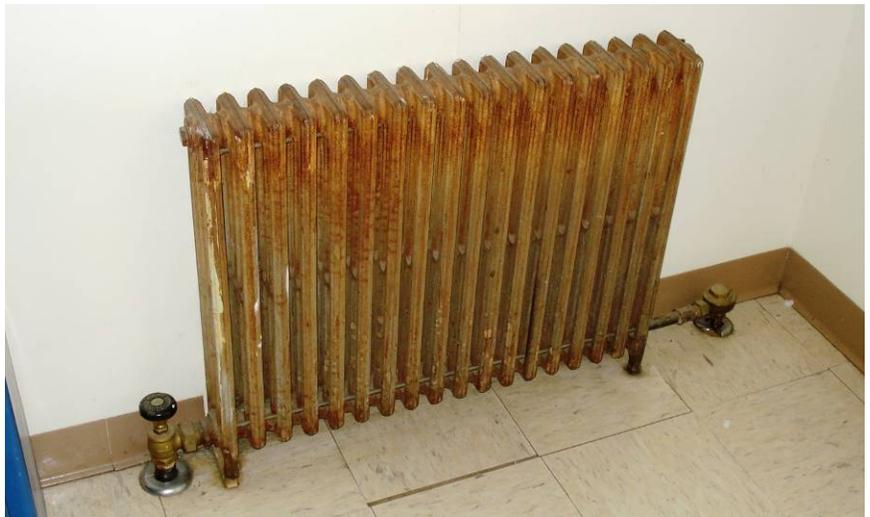
*Example of Steam Radiator Without an Automatic Control Valve*

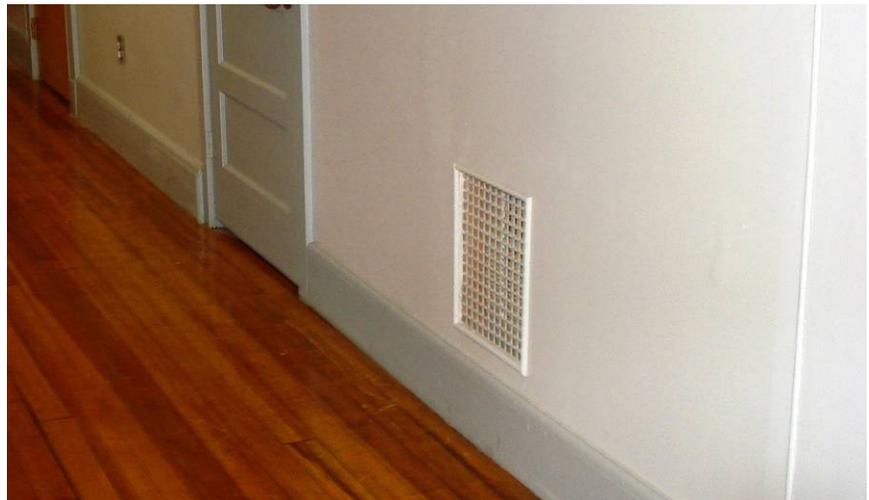
*View of Old Wall Vent*

Currently, in general, there is no mechanical ventilation provided. Occupants open windows for ventilation and fresh air. Cooling is provided in certain areas through the use of window-mounted air conditioning units installed in the operable windows or more permanently installed through the exterior walls of the building.

We would recommend the installation of an engineered ventilation and air conditioning system.

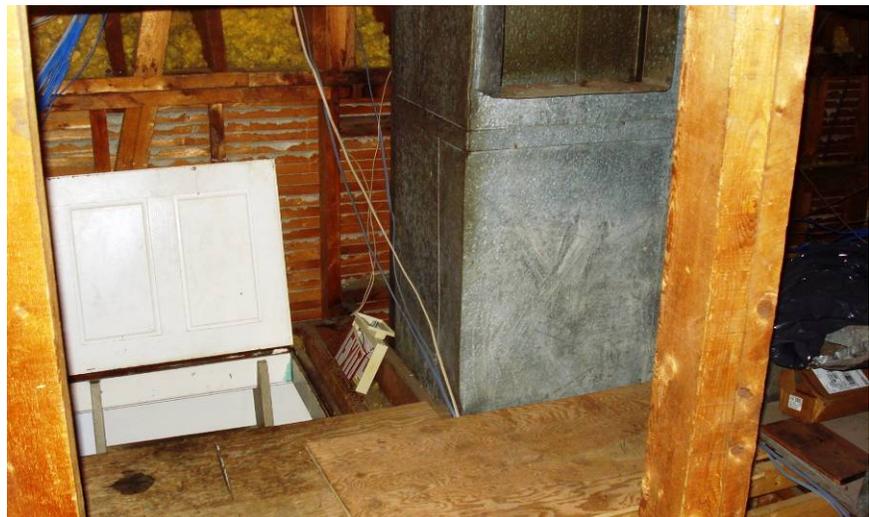
*View of Abandoned  
Ductwork in Attic*

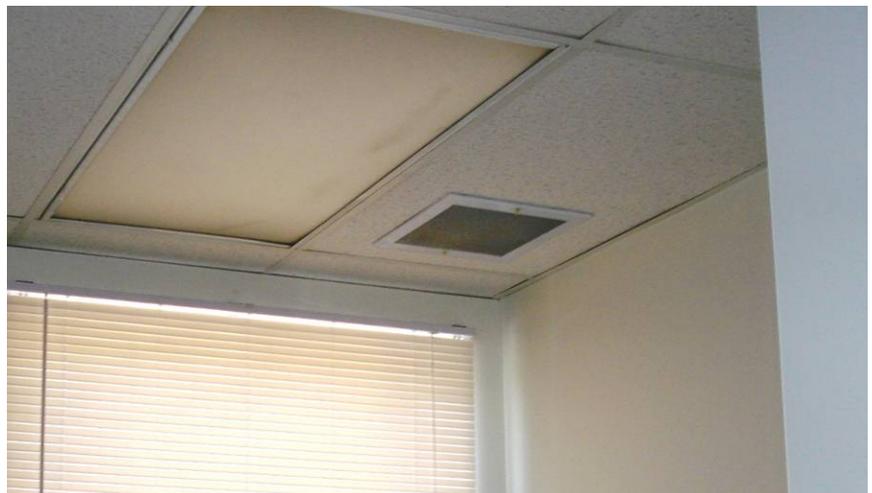
*View of Toilet Ceiling Exhaust Fan*

We would recommend the installation of time delay relays at each exhaust fan to allow the fan to remain operating for a delay period after the lights are turned off.

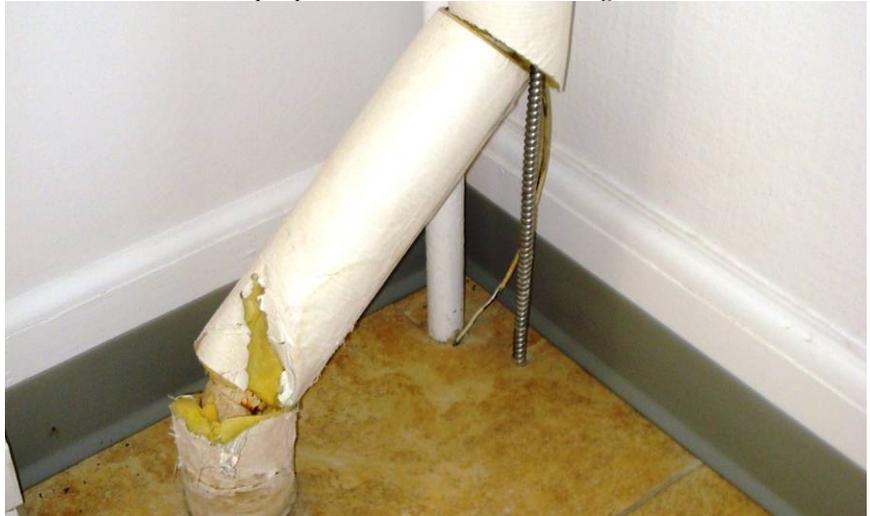
In one of the council chambers toilets there is a section of power and cable wiring installed under the pipe insulation.

*View of Power Wiring  
and Cable Installed  
Under Pipe Insulation*

We would recommend proper installation of the wiring.

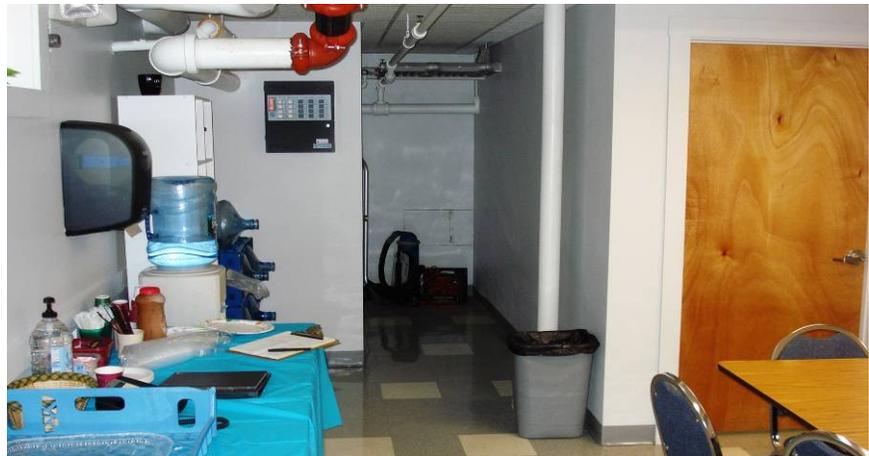
There is no ventilation provided to the tech conference room. Heating is provided through ceiling-mounted cast iron radiators similar to the one at the end of the small corridor. A small dehumidifier has been provided to reduce the humidity levels. The capacity of the dehumidifier is unknown. The discharge of the container is installed through the wall. Termination of the other end is unknown.

*View of Tech Conference Room and Corridor*

We would recommend the installation of proper ventilation for the basement tech conference areas.

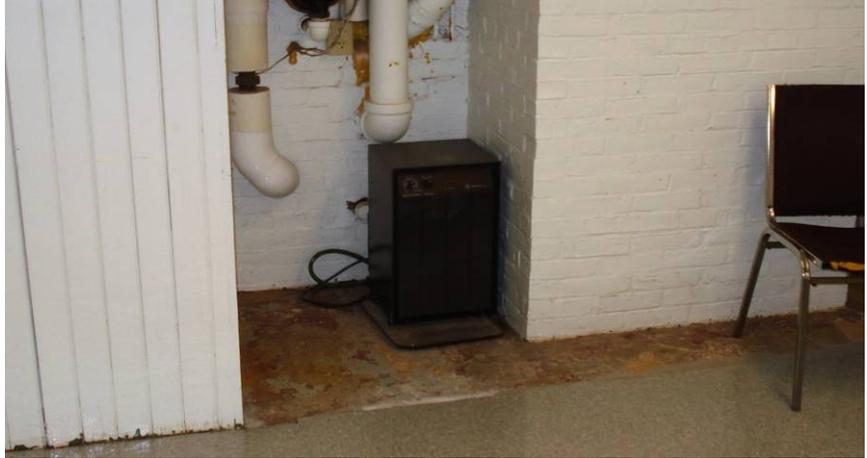
*View of Dehumidifier  
Located in Tech  
Conference Room*

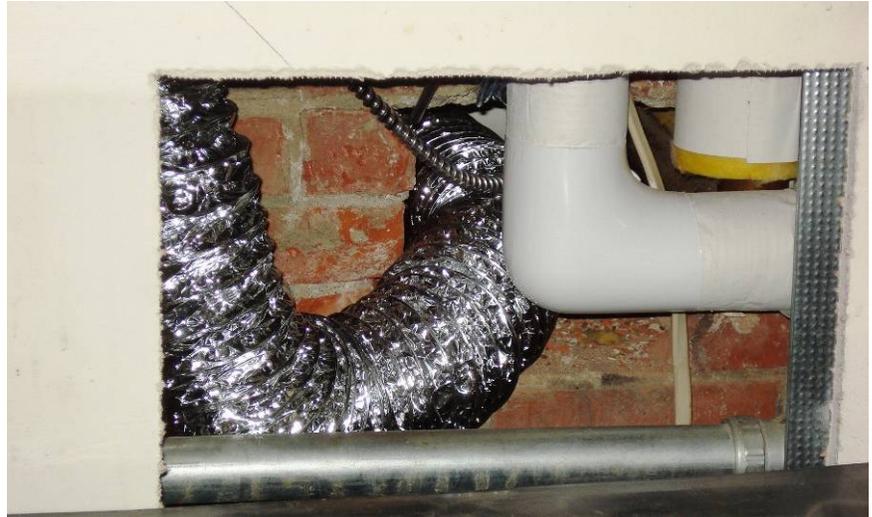
Through the wall of the room to the left of the ground floor elevator entry, we observed flexible duct and an inline fan typically used for dryer exhaust. If this is being used as drier exhaust, it does not meet code.

*View of Possible Dryer Duct Installed Through Wall*

We would recommend further review and possible corrective action.

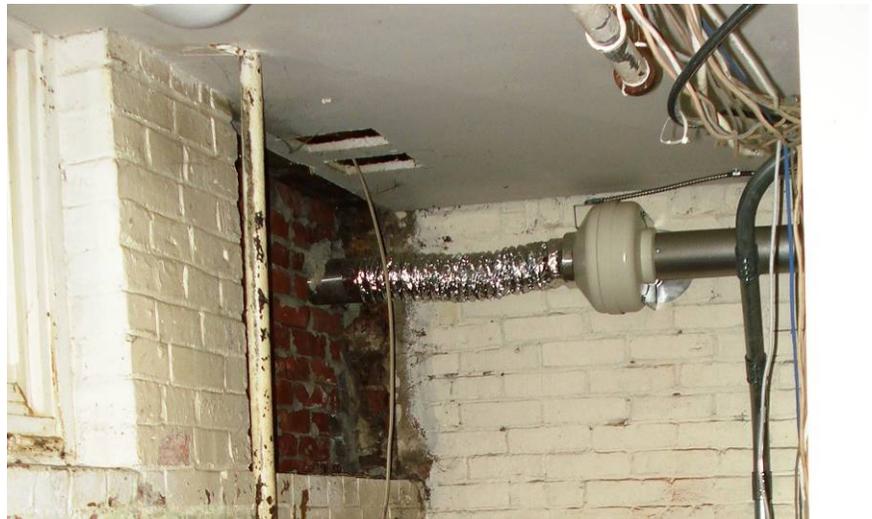
*View of Drier-Type In-Line Exhaust Fan*

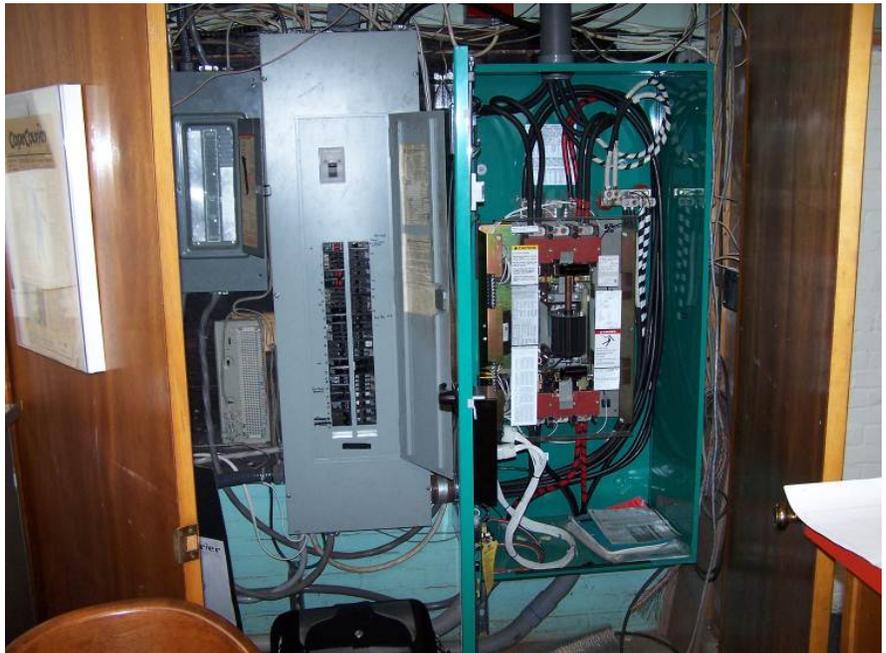
The main service consists of secondary conductors from the exterior meter directly feeding the normal side of a 400A automatic transfer switch; no service disconnecting means was observed. National Electrical Code requires service entrance conductors to be provided with a service disconnecting means. Currently there is no way to safely perform maintenance on the transfer switch without having Central Maine Power Company disconnect power to the building.

*Main Panel &  
Automatic Transfer  
Switch*

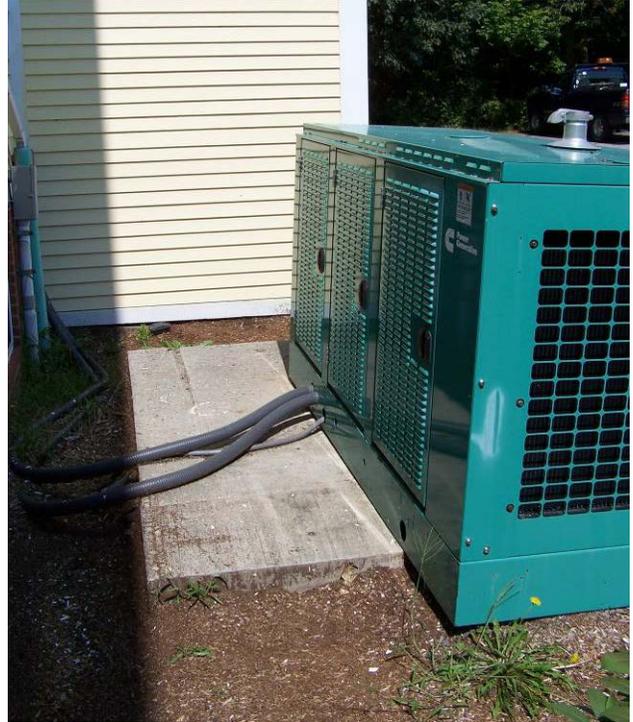
The standby portion of the automatic transfer switch is connected to an exterior 100kW 120/240V 1 phase 3 wire self-contained Cummins Onan propane gas generator. The generator was observed to have shifted from its concrete base.

*Standby Generator*

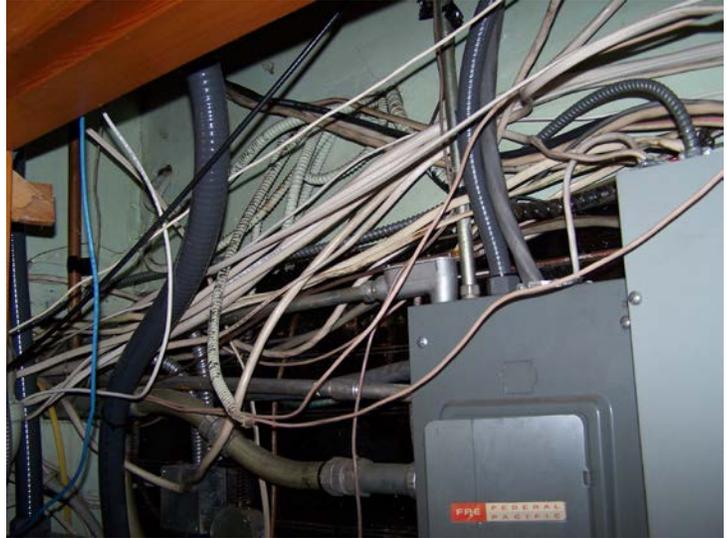
Some of the distribution equipment appears to be in poor condition and many different wiring types were observed including knob and tube, cloth covered, romex (some with undersized ground conductors), metal clad, and single conductors in conduit. Many code violations were observed including multiple open junction boxes, undersized grounding conductor, minimum clearances not met, and unsupported cables.

*Wiring above Main  
Distribution Panel*

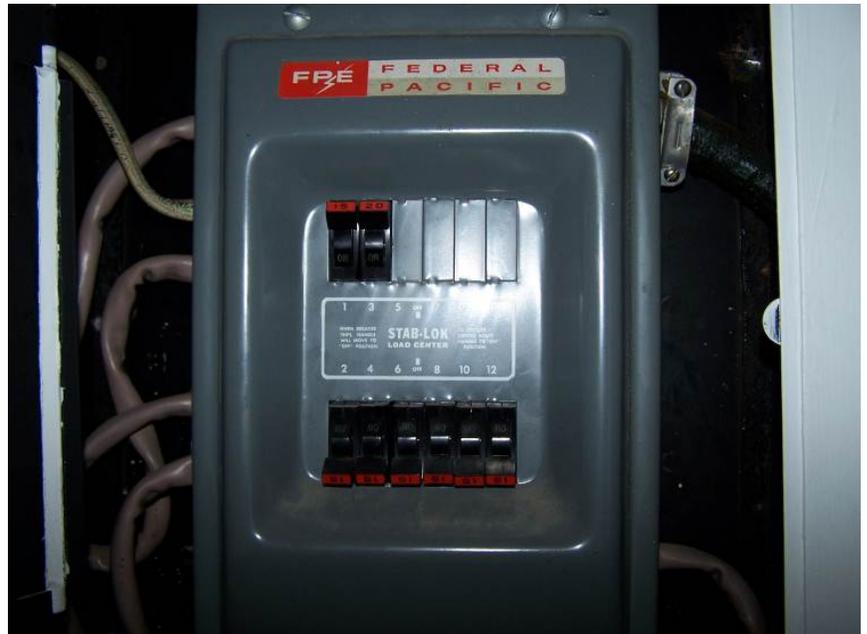
*Federal Pacific Stab-Lok  
Loadcenter*

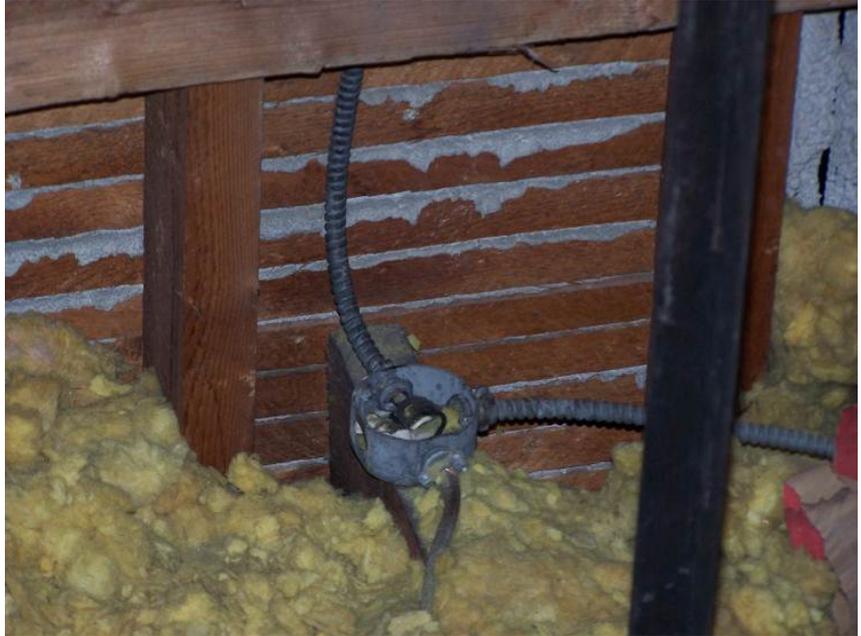
*Open Junction Box*

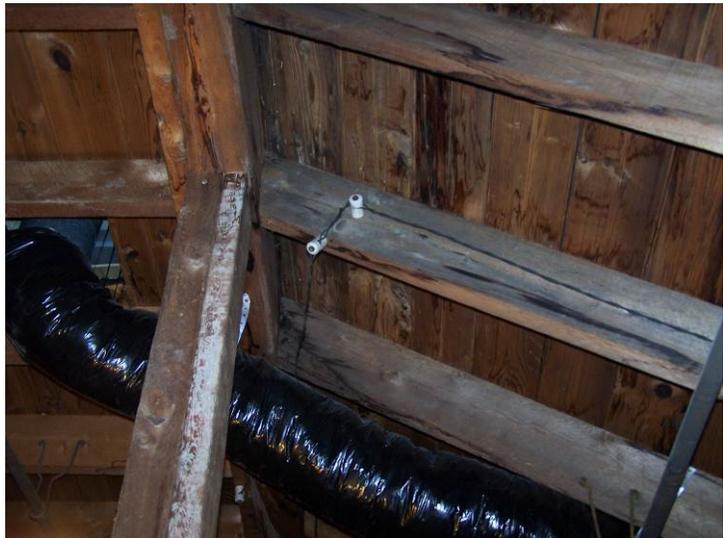
*Knob and Tube wiring*

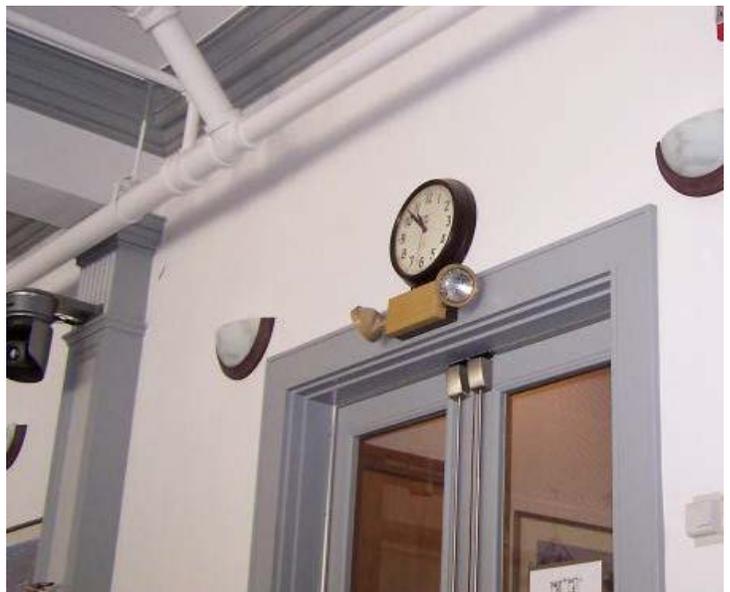
Emergency lighting was observed throughout the building. These units are surface wall mounted self-contained battery units with remote heads (EBUs). Generally EBU's are in serviceable condition with some updates. Several are showing signs of age. Coverage is good in most areas.

*Life Safety Lighting*

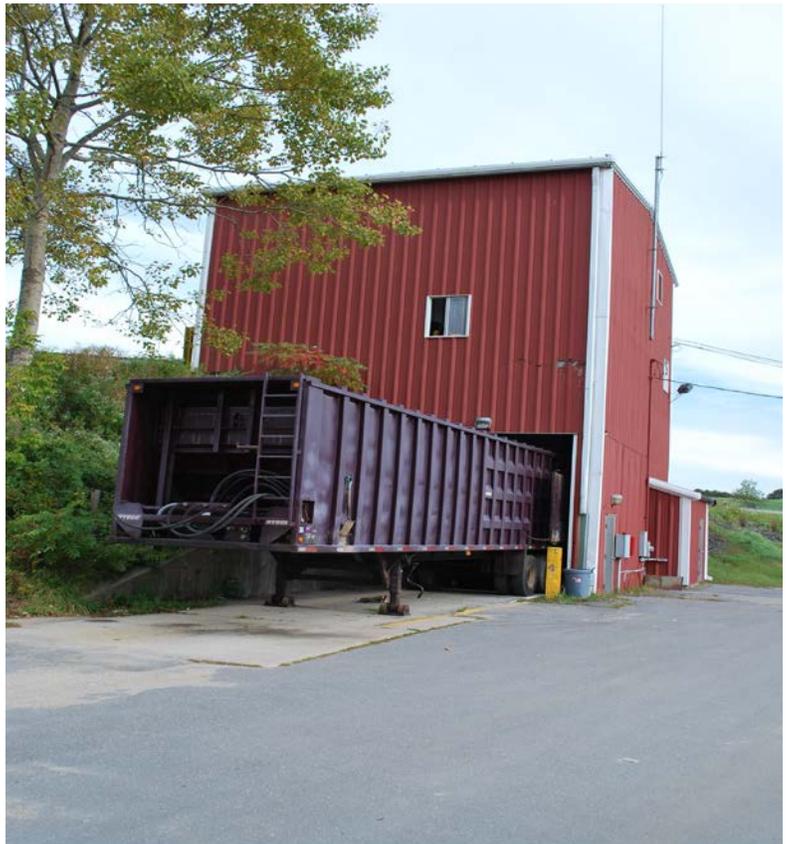
The building is a pre-engineered metal framed structure on a structural concrete slab and foundation. The metal siding and roof panels are exposed fastened to purlins between the column structures. The building design accommodates a lower compactor trailer system for trash removal to another site. The interior steel frame is showing some minor rust but no visible short term issues with the structure.

*View of Compactor*

We would recommend an approximate \$5,000 budget be carried for this remedial work. We would also recommend a budget of \$100,000 to replace the compactor support frame.

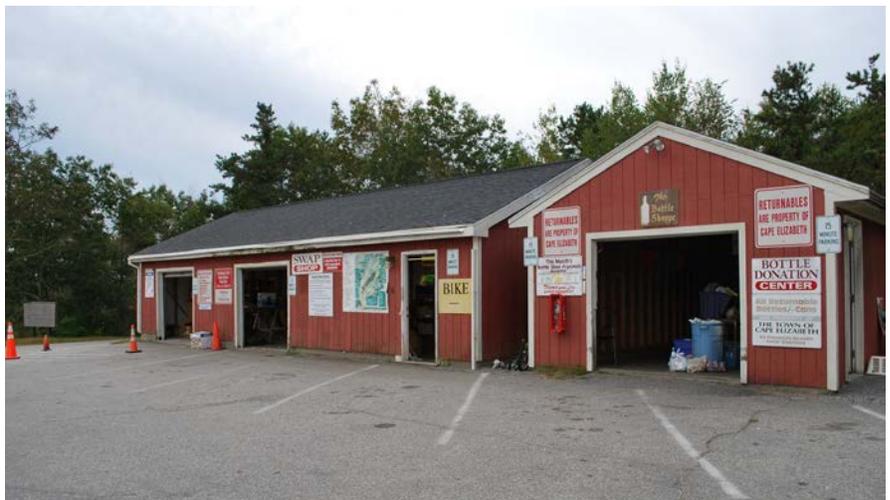
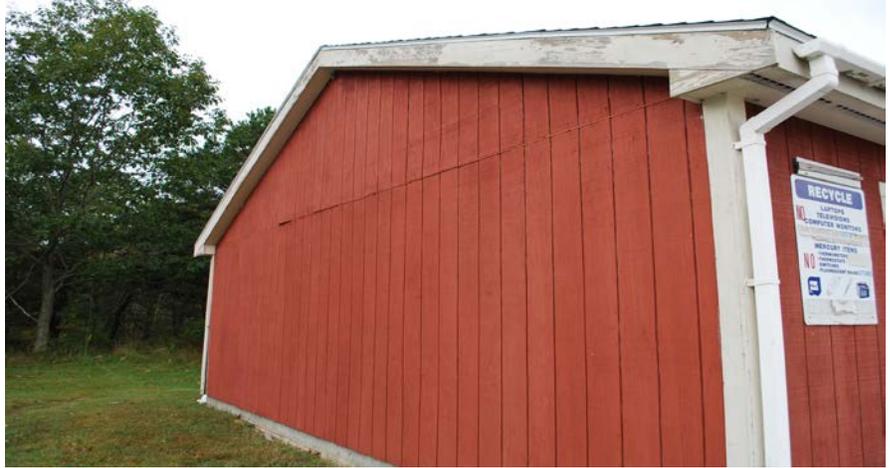
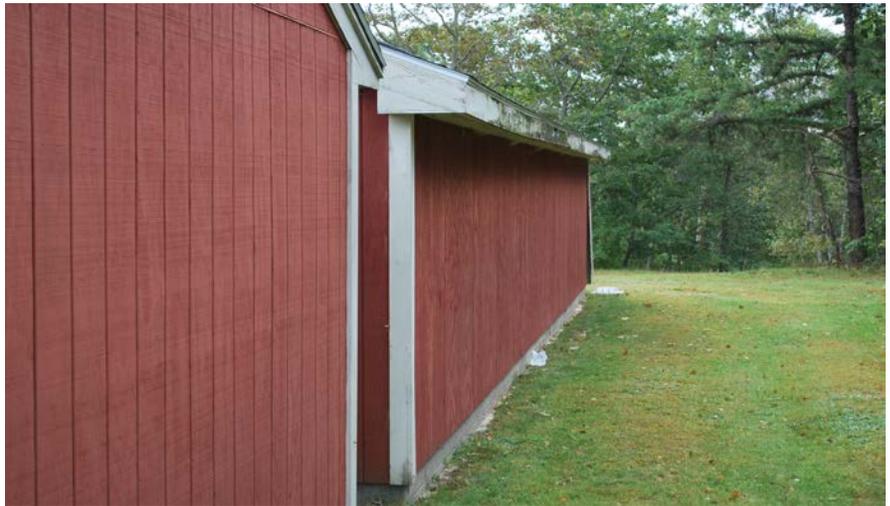
The roof shingles are in good shape and should last for a long period of time. The plywood siding and wood trim systems are in various stages of deterioration and should be considered for replacement within a short period of time.

We would recommend an approximate \$25,000 budget should be carried for this remedial work.
